Navajo Abandoned Uranium Mine

Site Screen Report

Mine Name: Casey No. 3
Mine ID: 373

August 2011

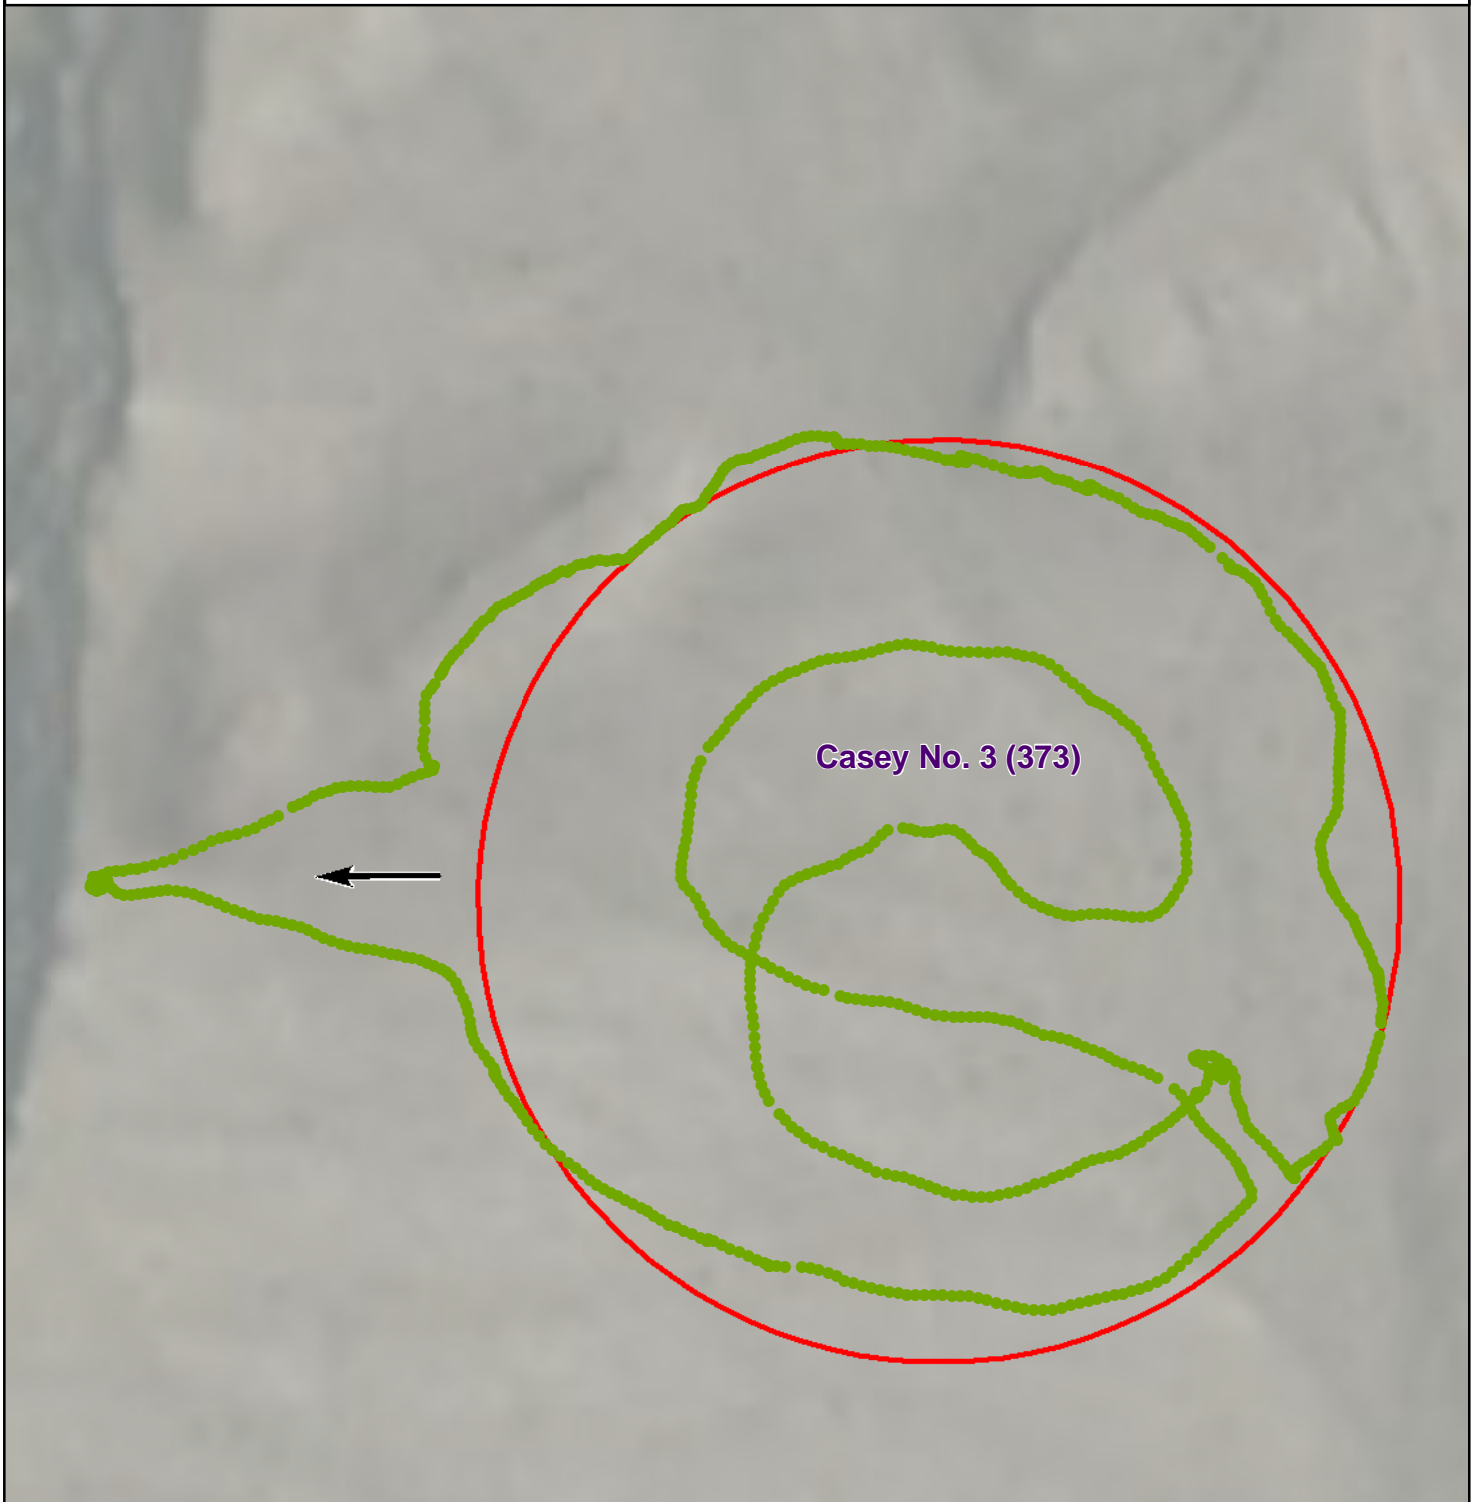
**Figure 1 - Gamma Radiation Measurements, Above Two Times Background
Casey No. 3 (373)
Coalmine Mesa Chapter, Navajo Nation**

Highest gamma radiation measurement: 16,818 counts per minute (cpm)

Background Average: 11,212 cpm **Two Times Background:** 22,424 cpm

A total of 998 gamma radiation measurements were collected from the mine site, ranging from 10,169 cpm to 16,818 cpm. The measurements are represented in Figures 1 and 2.
