Navajo Abandoned Uranium Mine

Site Screen Report

Mine Name: Tract 24 Mine - A
Mine ID: 391

April 2012

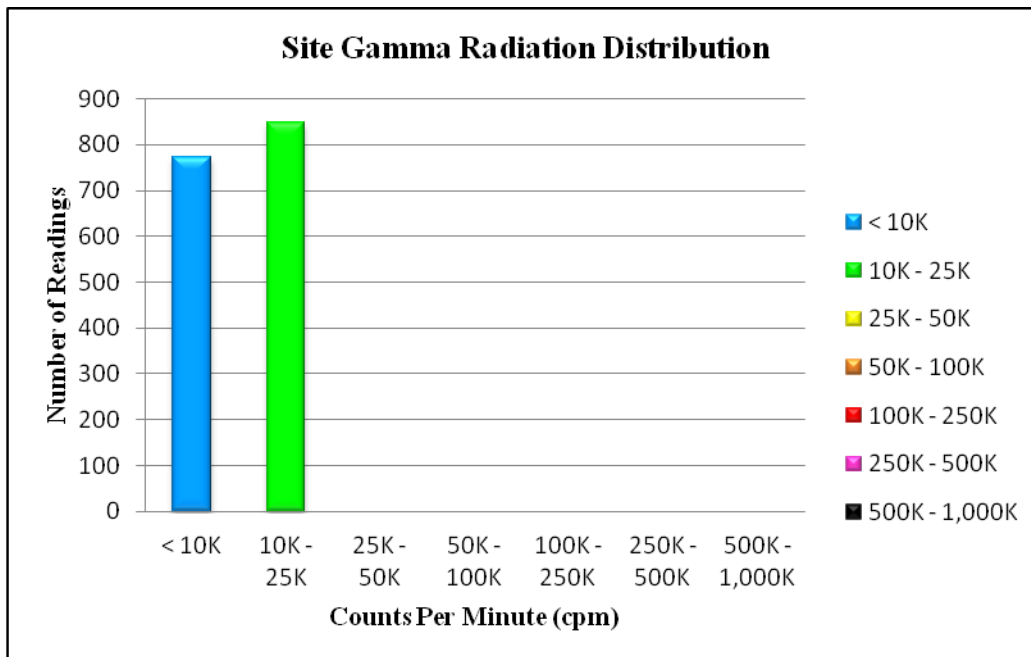
Distribution Chart and Statistics:

Site Gamma Radiation Statistics	
Number of Readings	1,623
Minimum (cpm)	4,873
Maximum (cpm)	23,461
Mean (cpm)	10,943
Median (cpm)	10,204
Standard Deviation	3,682

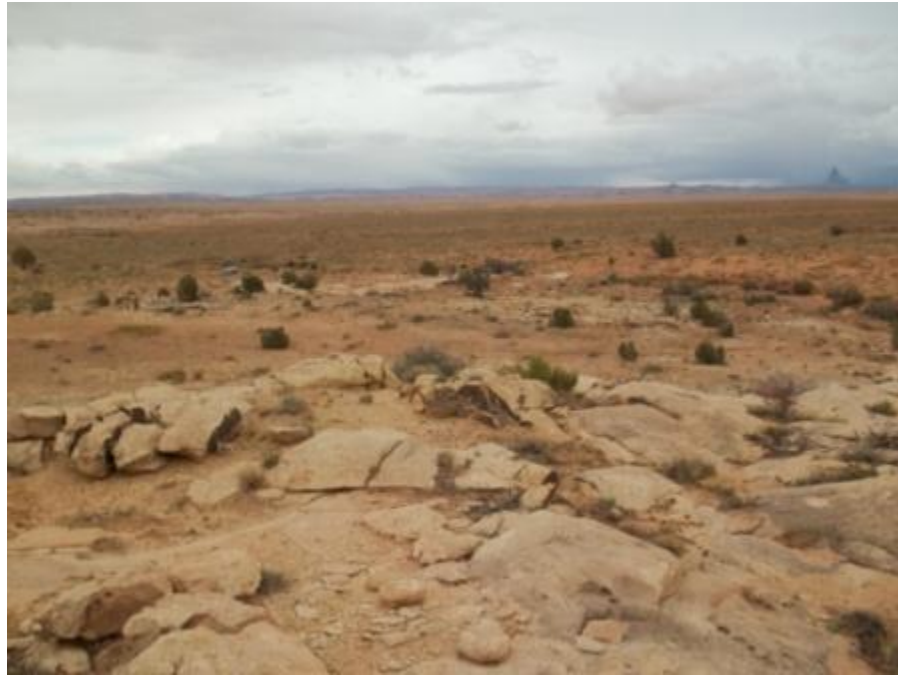
Photo 1

Mine Site #391

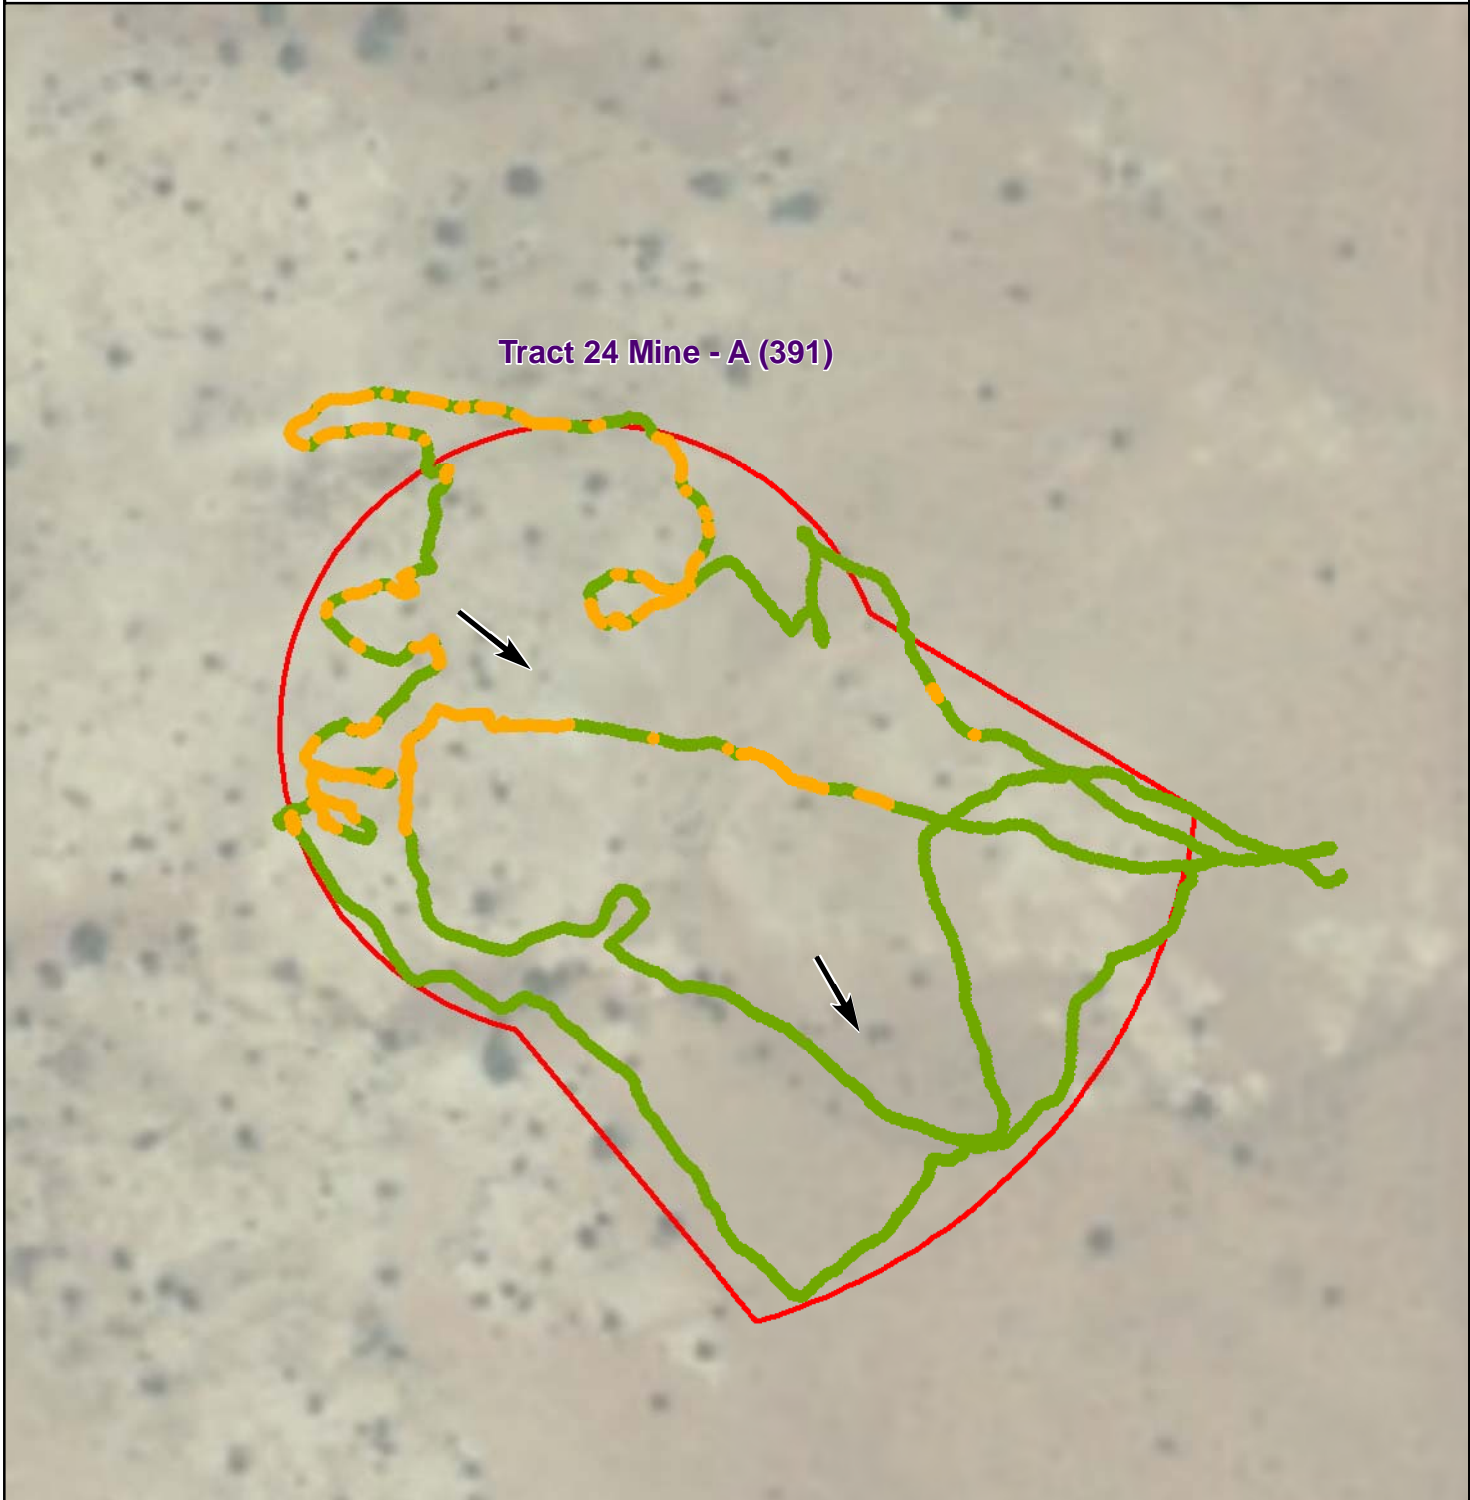
**Figure 1 - Gamma Radiation Measurements, Above Two Times Background
 Tract 24 Mine - A (391)
 Oljato Chapter, Navajo Nation**

Gamma Radiation Measurements

- < 2X Background
- > 2X Background

Measured as counts per minute (cpm)

Average background 6,786 cpm

A total of 1,623 gamma radiation measurements were collected from the mine site, ranging from 4,873 cpm to 23,461 cpm. The measurements are represented in Figures 1 and 2.

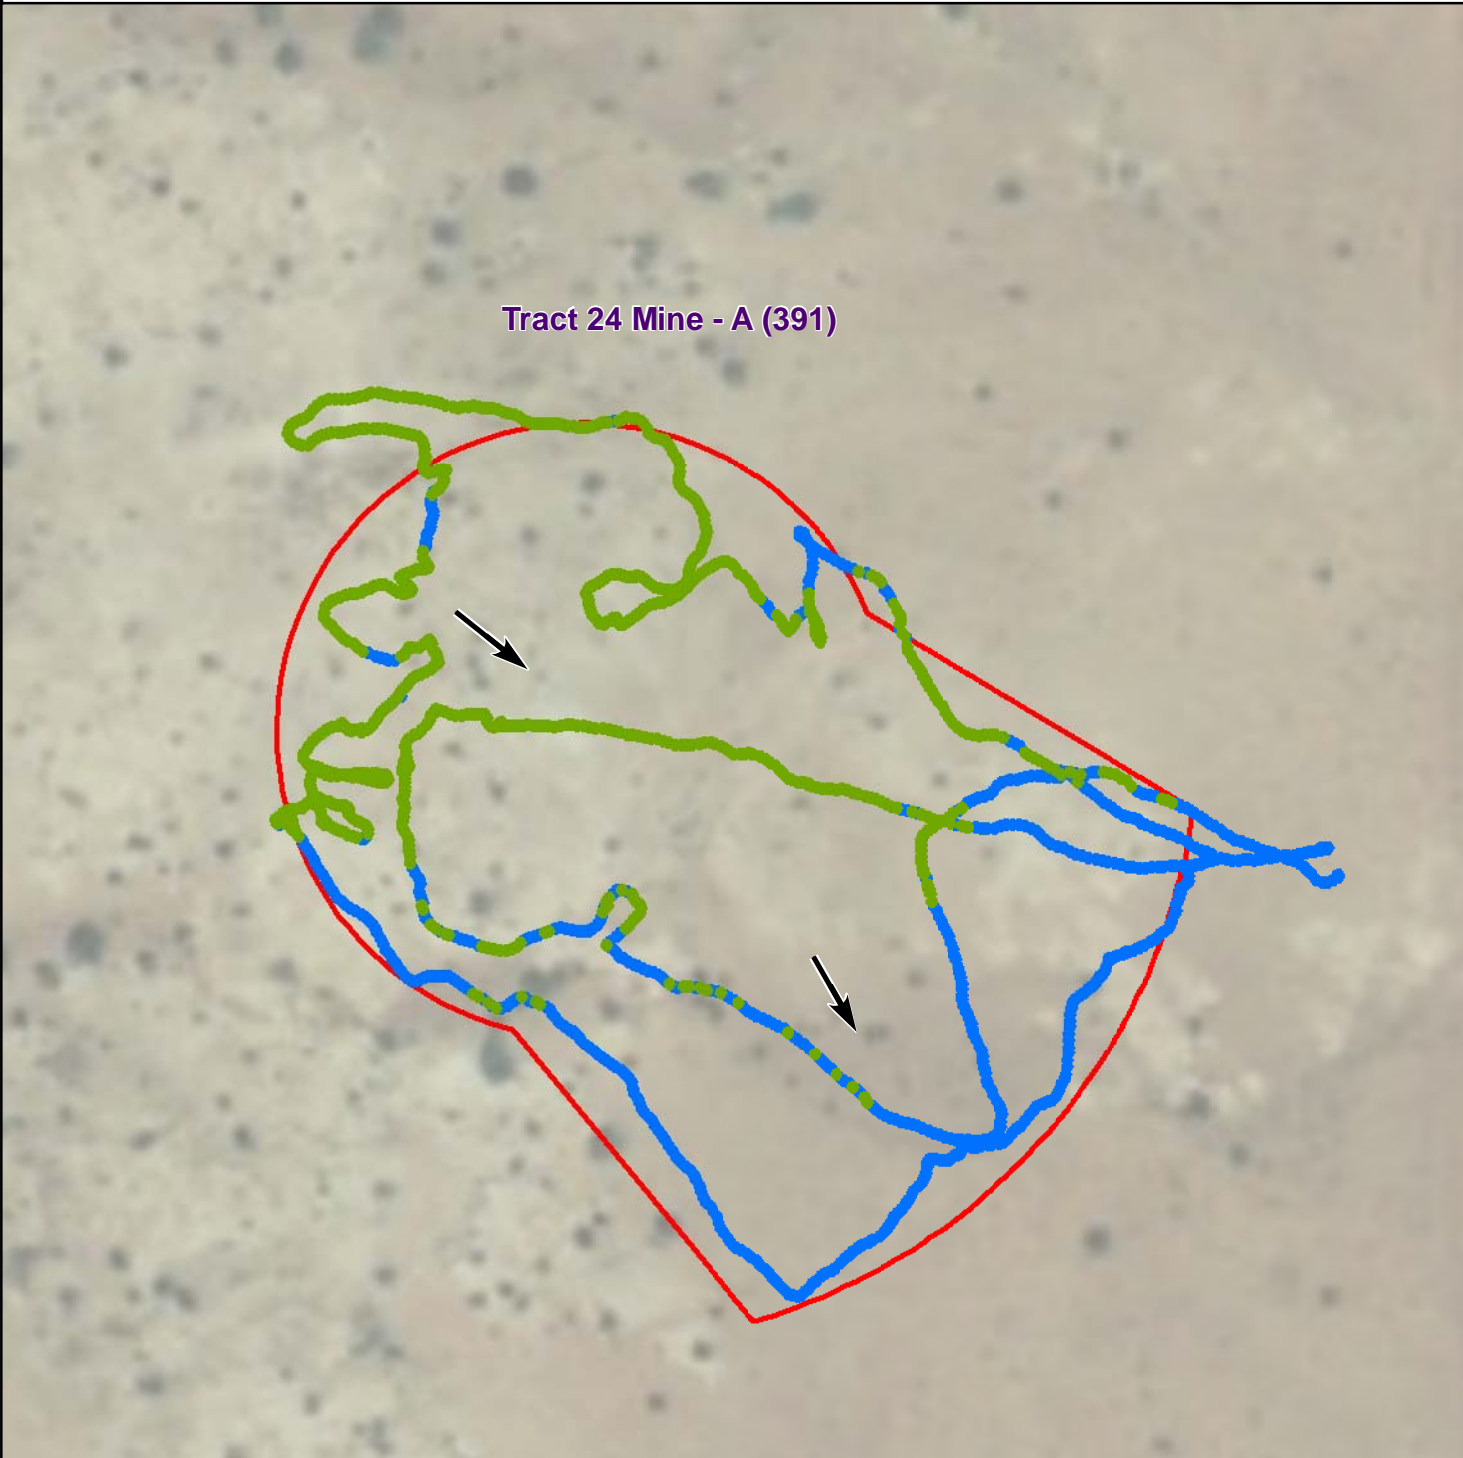
**Figure 2 - Gamma Radiation Measurements
Tract 24 Mine - A (391)
Oljato Chapter, Navajo Nation**

Gamma Radiation Measurements

- 0 - 10,000 cpm
- 10,000 - 25,000 cpm
- 25,000 - 50,000 cpm
- 50,000 - 100,000 cpm
- 100,000 - 250,000 cpm
- 250,000 - 500,000 cpm
- 500,000 - 1,000,000 cpm

Average background 6,786 cpm

Measured as counts per minute (cpm)
