Navajo Abandoned Uranium Mine

Site Screen Report

Mine Name: Tract 24 Mine - B
Mine ID: 392

Weston Solutions, Inc.

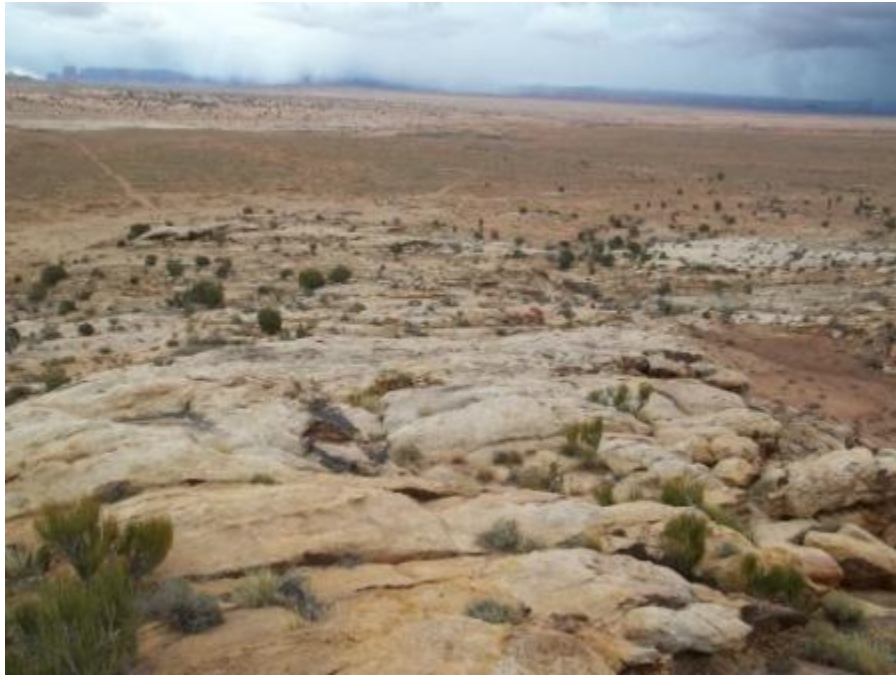
Photo 1

Mine Site #392

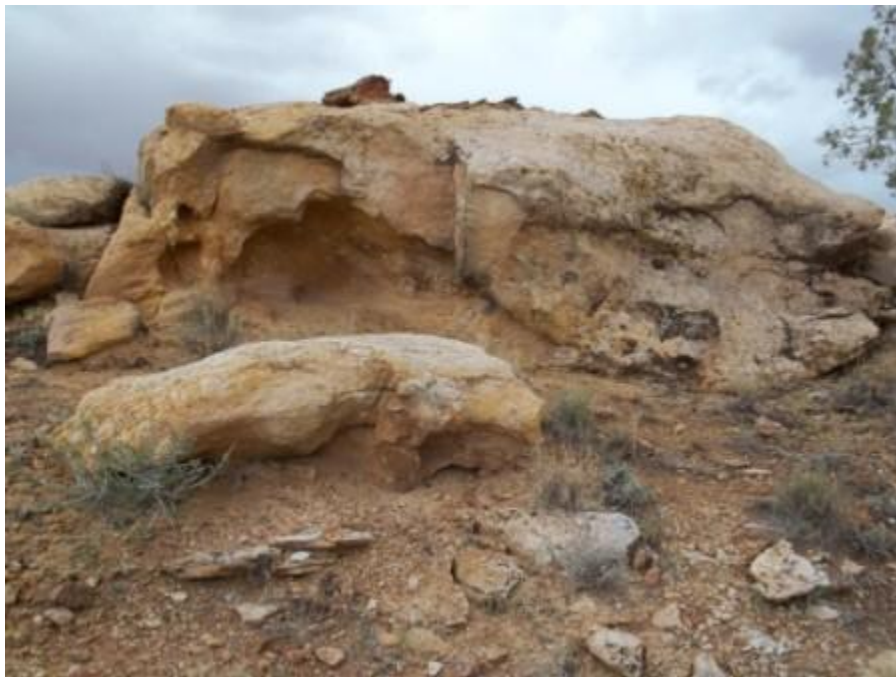
Photo 2

Mine Site #392
