Navajo Abandoned Uranium Mine

Site Screen Report

Joe Ben 2 AUM Site

March 2010

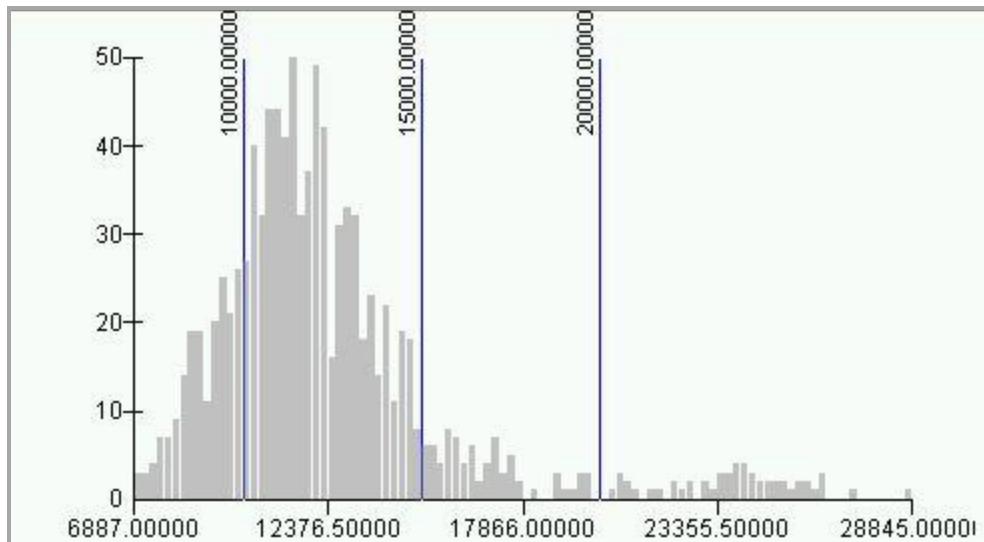
The following chart and statistics were generated by ESRI ArcGIS 9.3.1, and show the general distribution of the site gamma radiation measurements. The horizontal X axis represents the gamma radiation reading levels in cpm (lowest levels to the left). The vertical Y axis represents the frequency of each gamma radiation level.

Count:	1000
Minimum:	6887.00000
Maximum:	28845.00000
Sum:	12441219.00000
Mean:	12441.21900
Median:	11730.50000
Standard Deviation:	3510.31642

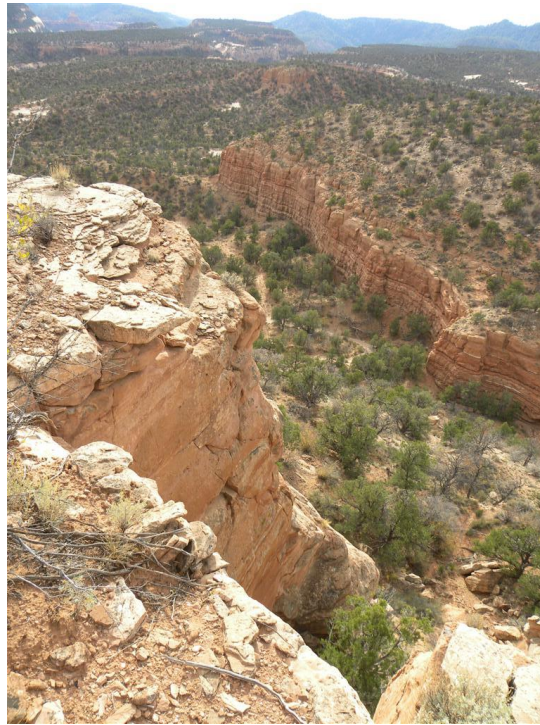
Photo 1. Direction towards mine site

Weston was unable to access the site; due to steep grades all known paths to the site were impassible. Measurements were collected in the vicinity of the site, approximately 200' east of the site boundary. A total of 1,000 gamma radiation measurements were collected near the mine site, ranging from 6,887 cpm to 28,845 cpm. The measurements are represented in Figures 1 and 2.

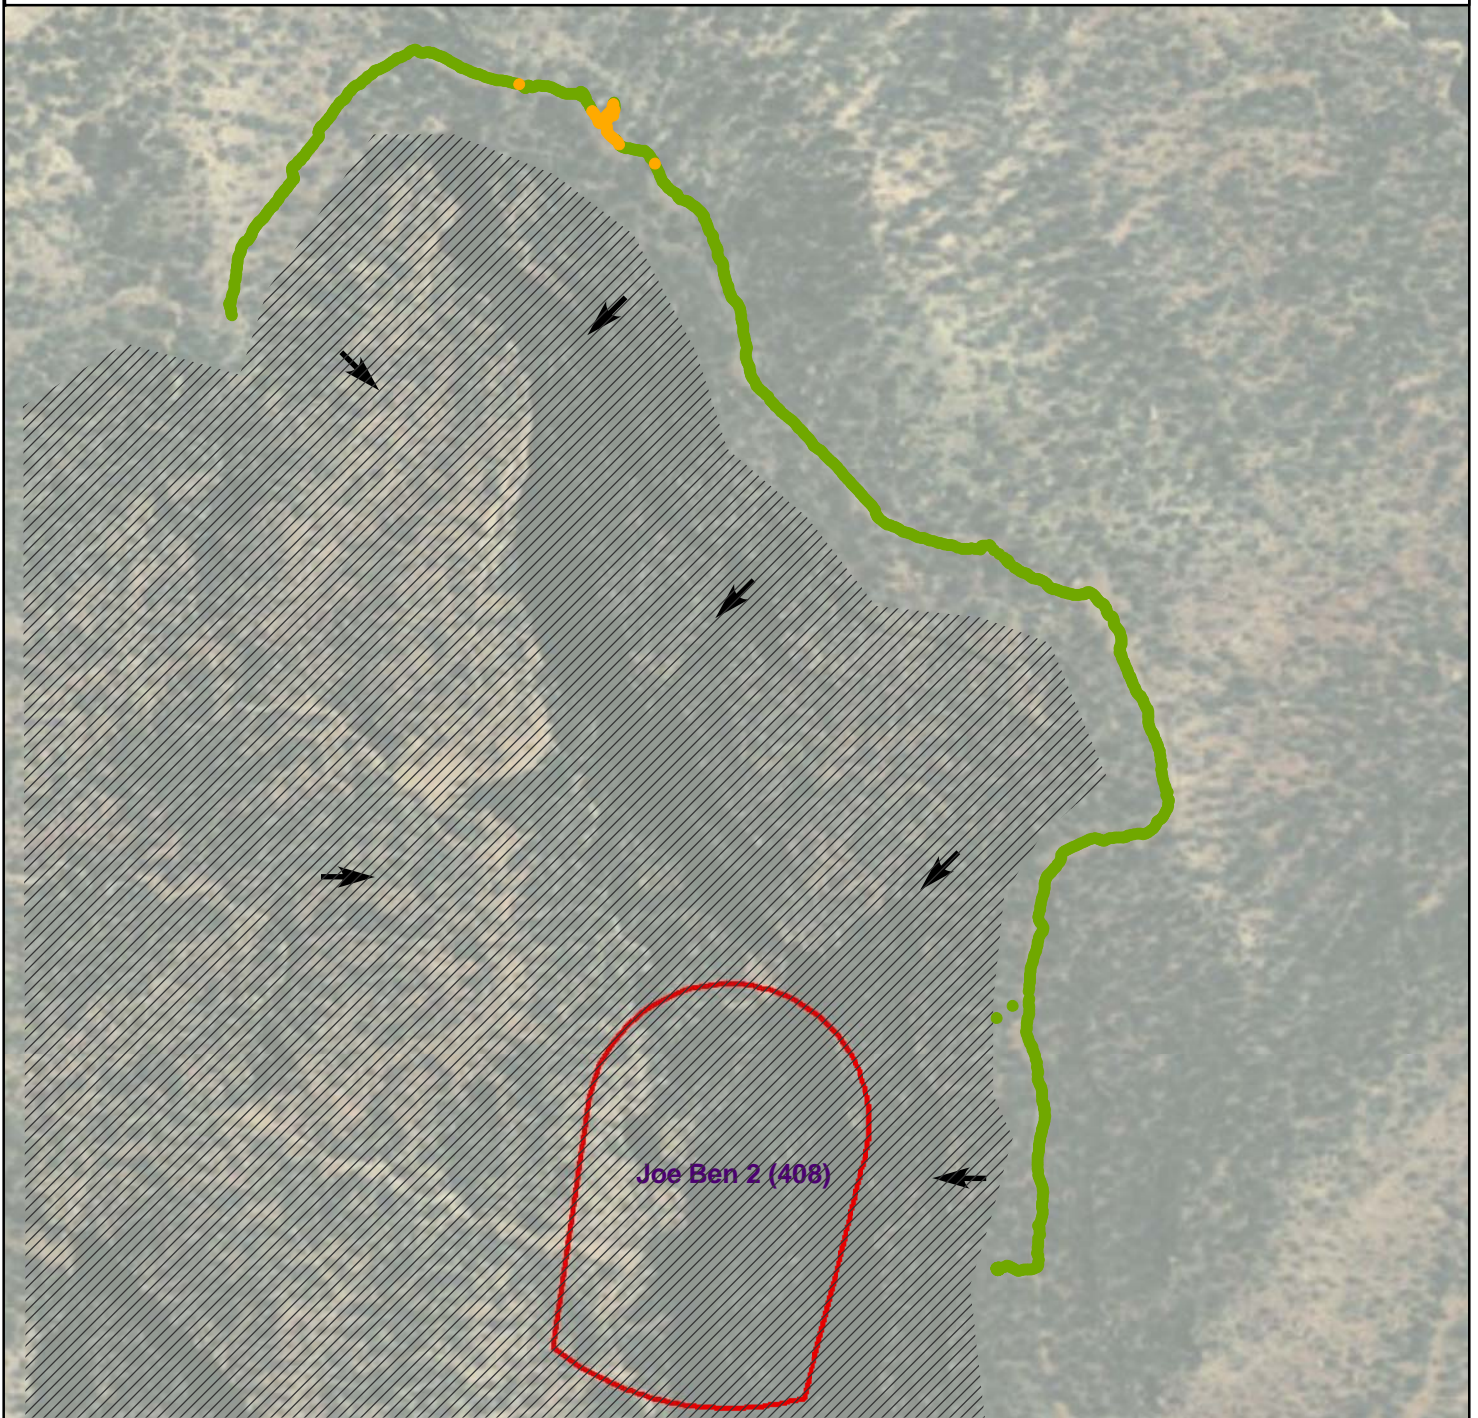
**Figure 1 - Gamma Radiation Measurements, Above Two Times Background
Joe Ben 2 (408)
Sanostee Chapter, Navajo Nation, Arizona**

Weston was unable to access the site during the October 2009 site screenings.
All known paths leading towards the site were impassable. See site screen report for documentation.

Gamma survey conducted 10/2009
Measured as counts per minute (cpm)

Average background = 9,300 cpm

Inaccessible due to steep grades

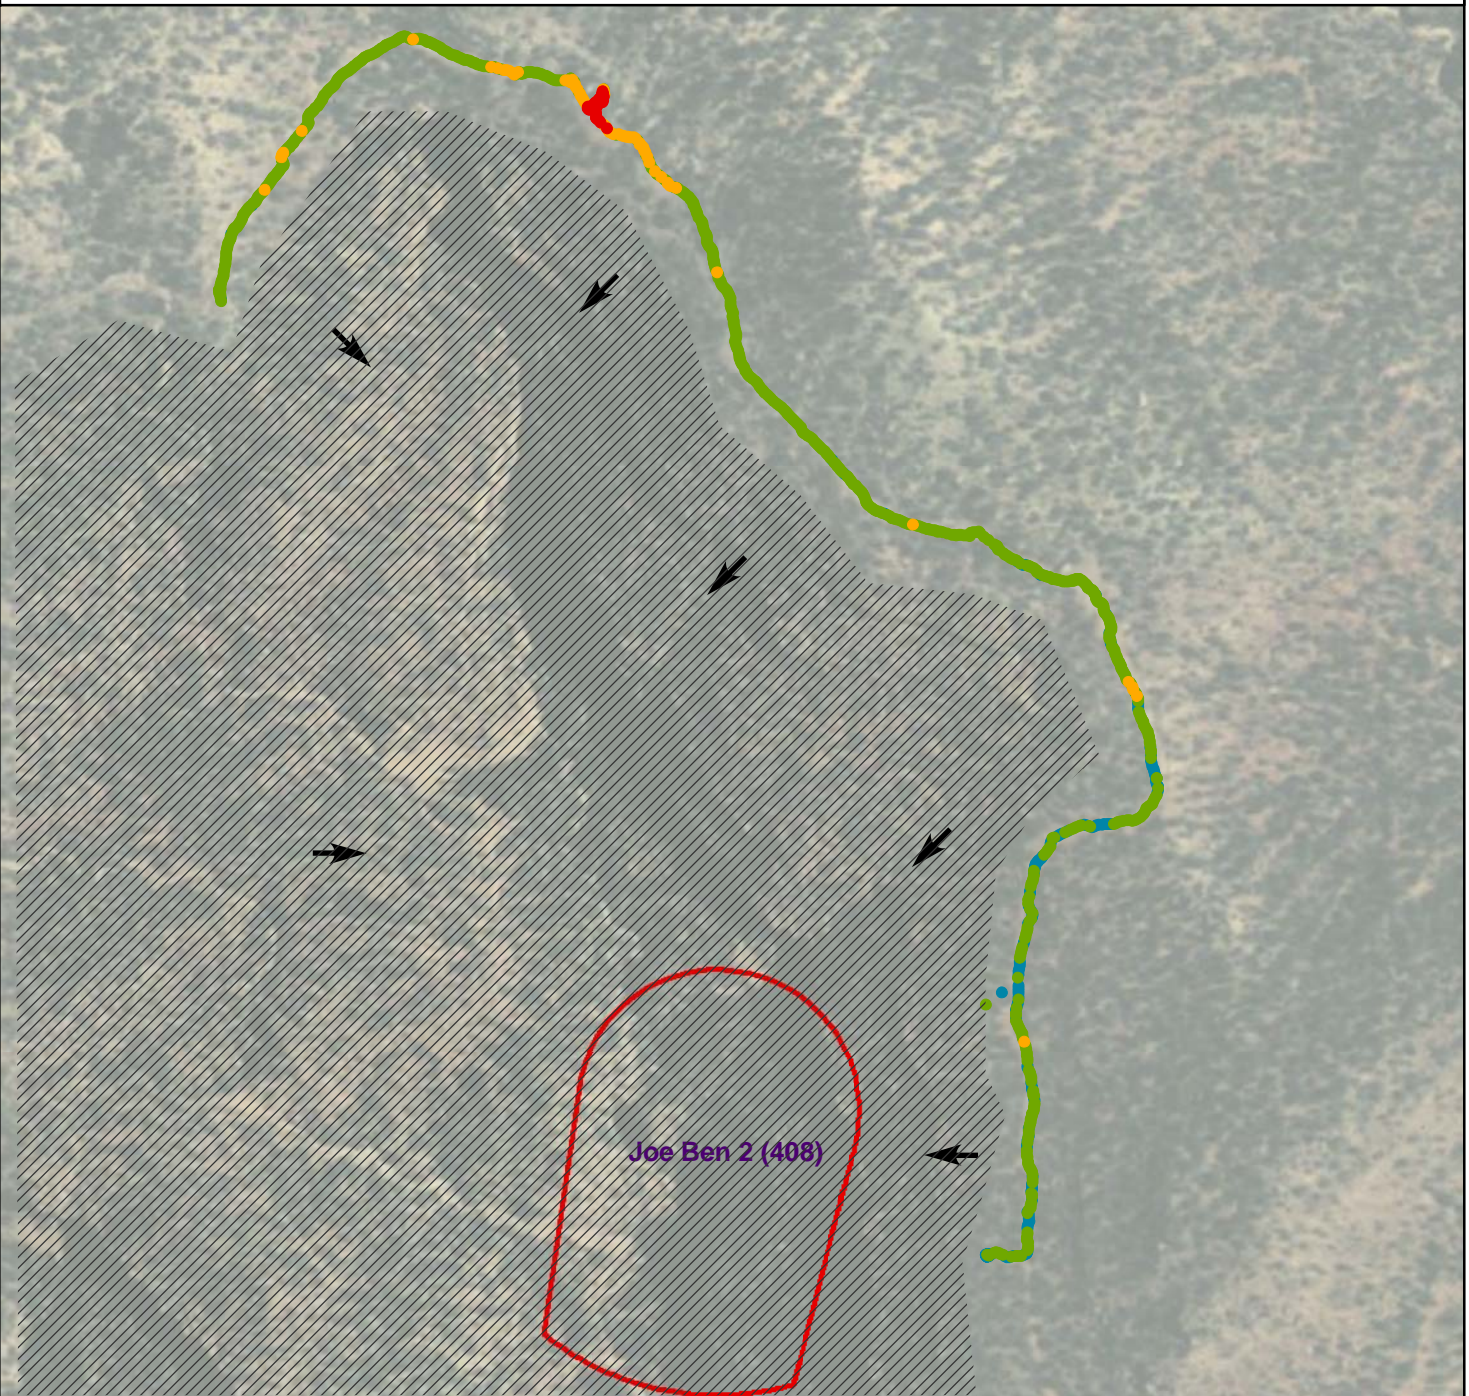
**Figure 2 - Gamma Radiation Measurements
Joe Ben 2 (408)
Sanostee Chapter, Navajo Nation, Arizona**

Weston was unable to access the site during the October 2009 site screenings.
All known paths leading towards the site were impassable. See site screen report for documentation.

Inaccessible due to steep grades

**Gamma survey conducted 10/2009
Measured as counts per minute (cpm)**

Average background = 9,300 cpm
