# Navajo Abandoned Uranium Mine

## Site Screen Report

## West Mesa Mine AUM Site

**March 2010**

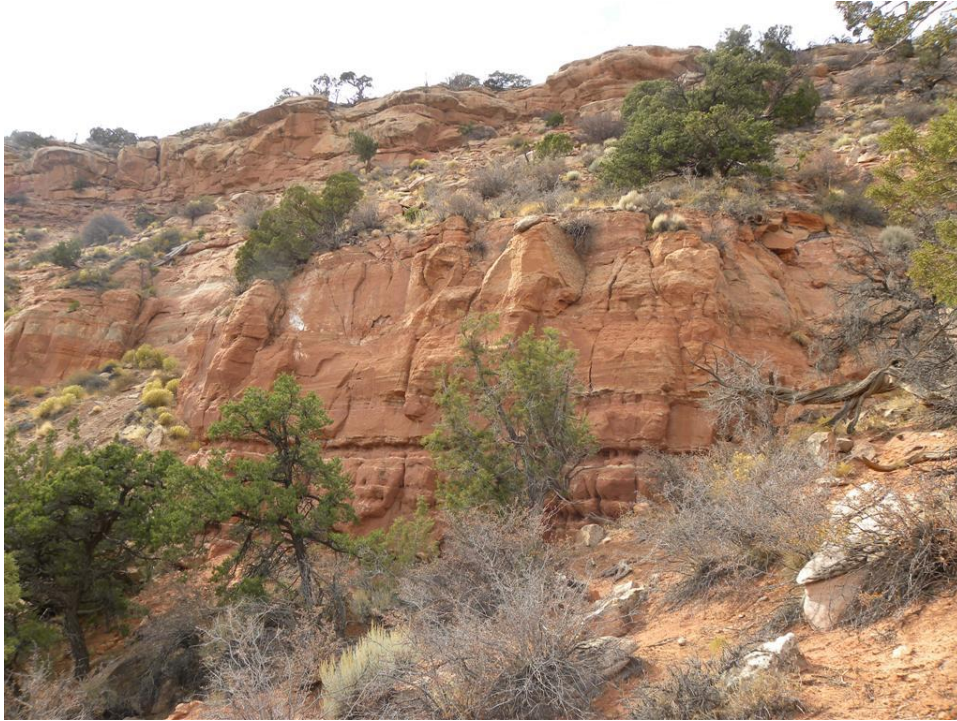
Photo 1. Cliff and debris area

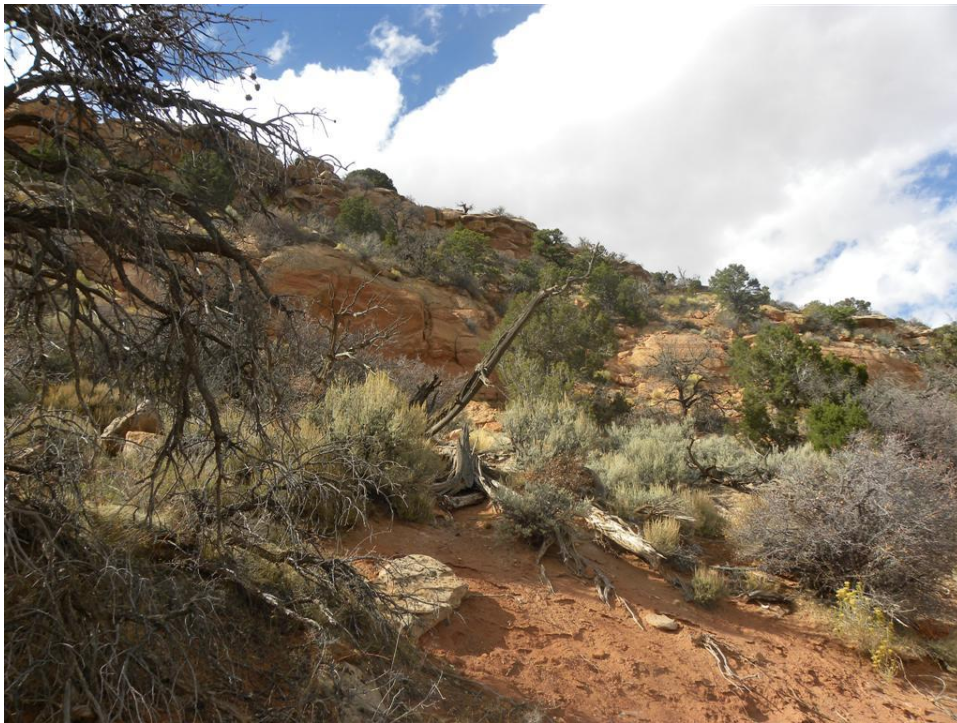
Photo 2. Mine site

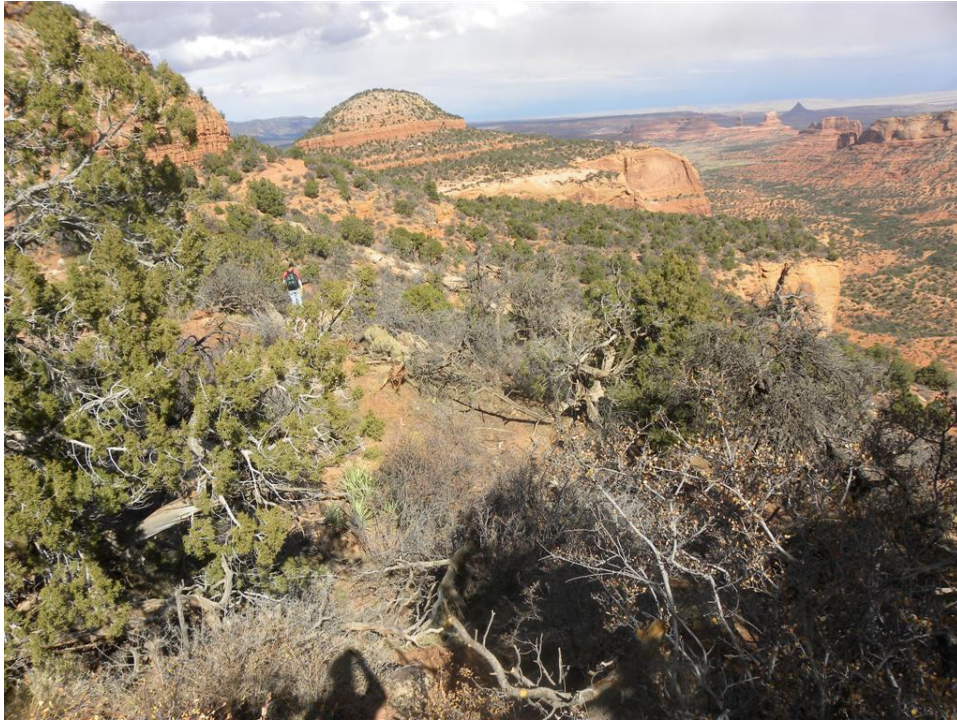
Photo 3. Mine site

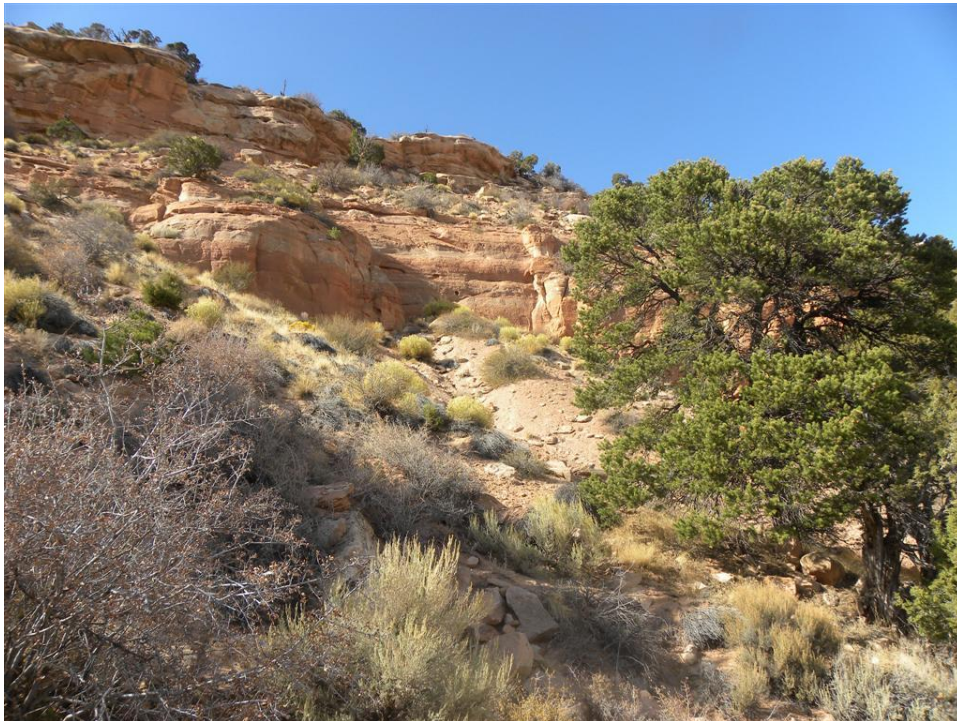
Waste pile extending down road, 80' x 100', with a total estimated volume of 1,481 yd<sup>3</sup>

Photo 4. Waste pile along slope

Unreclaimed waste pile

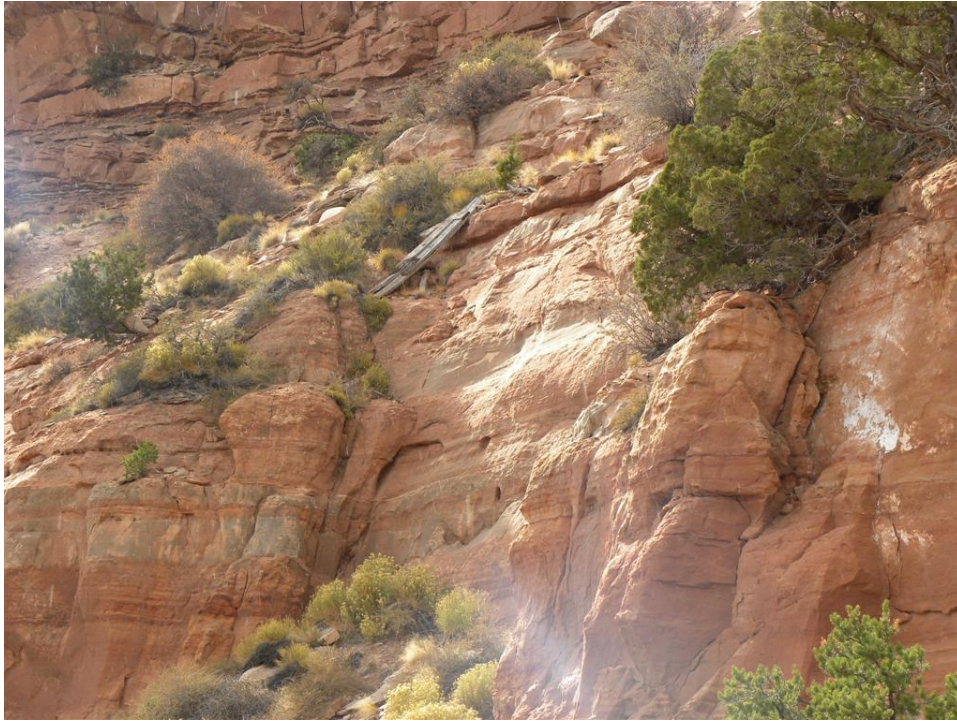
Some wood mining debris

Photo 5. Wood debris along cliff face
