Navajo Abandoned Uranium Mine

Site Screen Report

Mesa III, Northwest Mine AUM Site

March 2010

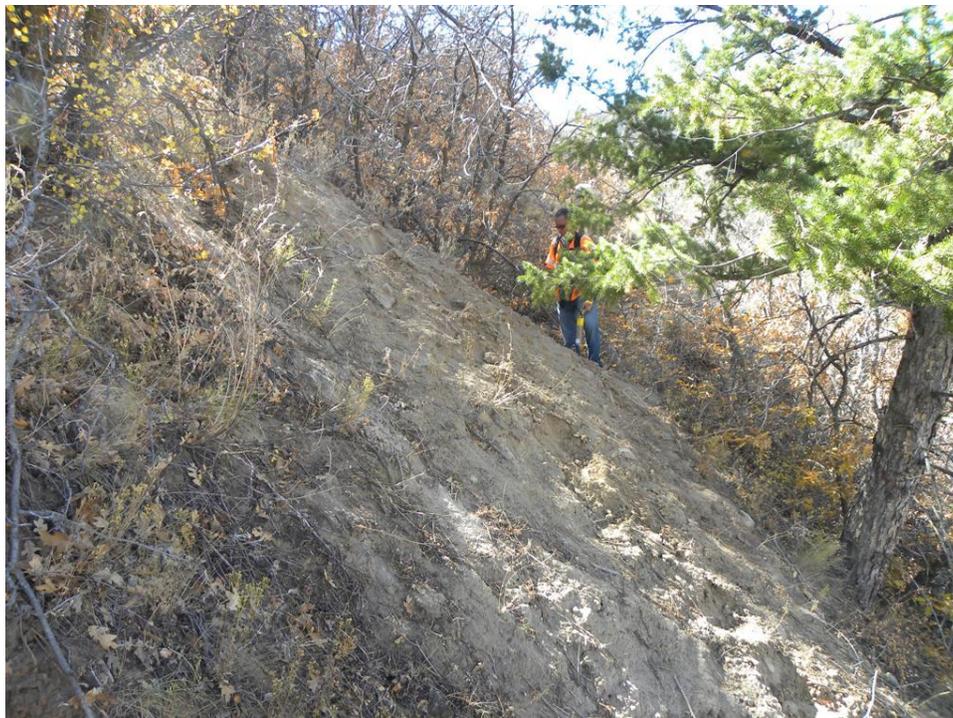
Photo 2. Mine site incline

Wooden beam remnants, drainage pipe, mining debris extends through vegetation down steep decline
