Navajo Abandoned Uranium Mine

Site Screen Report

Phillip Dee 1 AUM Site

August 2010

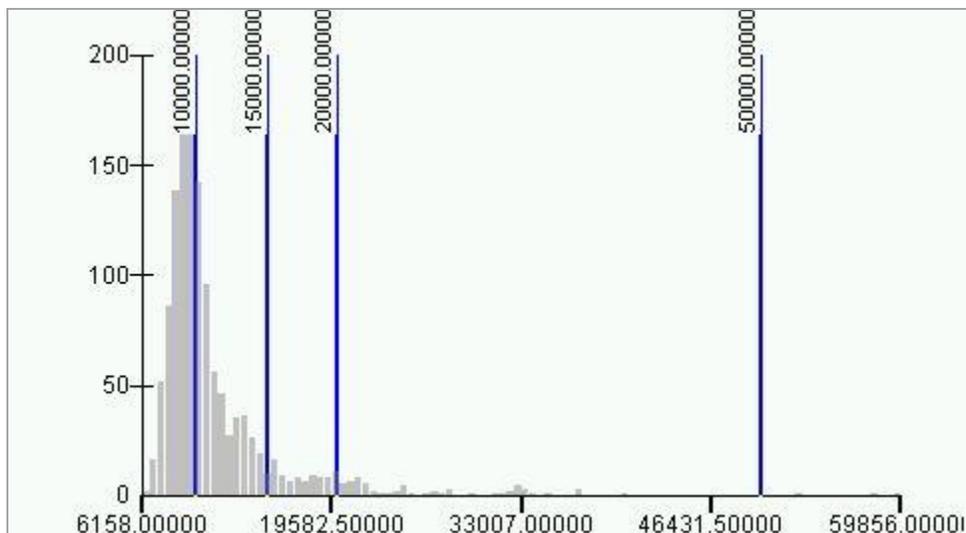
Distribution Chart and Statistics:

The following chart and statistics were generated by ESRI ArcGIS 9.3.1, and show the general distribution of the site gamma radiation measurements. The horizontal X axis represents the gamma radiation reading levels in cpm (lowest levels to the left). The vertical Y axis represents the frequency of each gamma radiation level.

Count:	1279
Minimum:	6158.00000
Maximum:	59856.00000
Sum:	14522741.00000
Mean:	11354.76231
Median:	9909.00000
Standard Deviation:	4850.05918

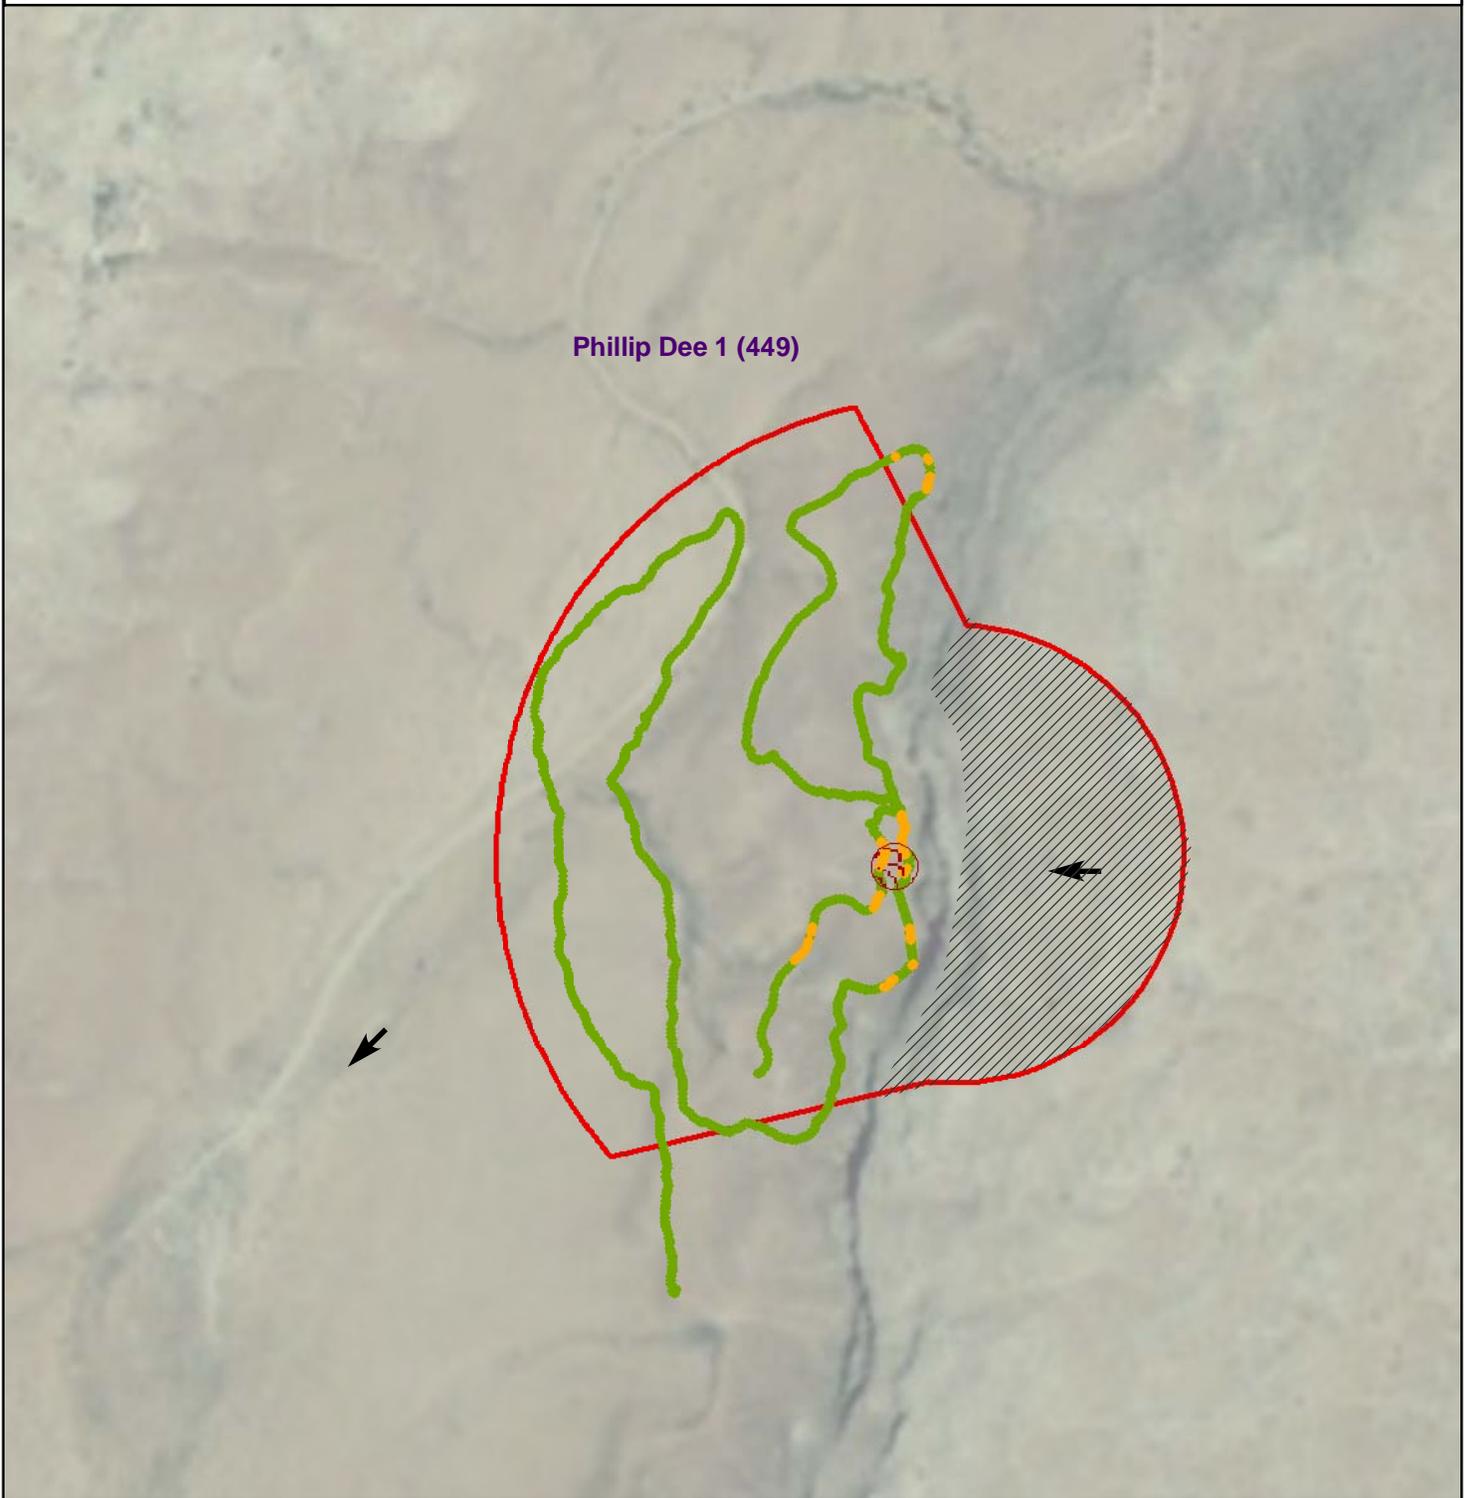
**Figure 1 - Gamma Radiation Measurements, Above Two Times Background
Phillip Dee 1 (449)
Red Mesa Chapter, Navajo Nation**

Gamma survey conducted 06/2010
Measured as counts per minute (cpm)

Average background = 9,186 cpm

A total of 1,279 gamma radiation measurements were collected from the mine site, ranging from 6,158 cpm to 59,856 cpm. Measurements collected in the vicinity of the waste debris were found at levels up to approximately 60,000 cpm. The measurements are represented in Figures 1 and 2.

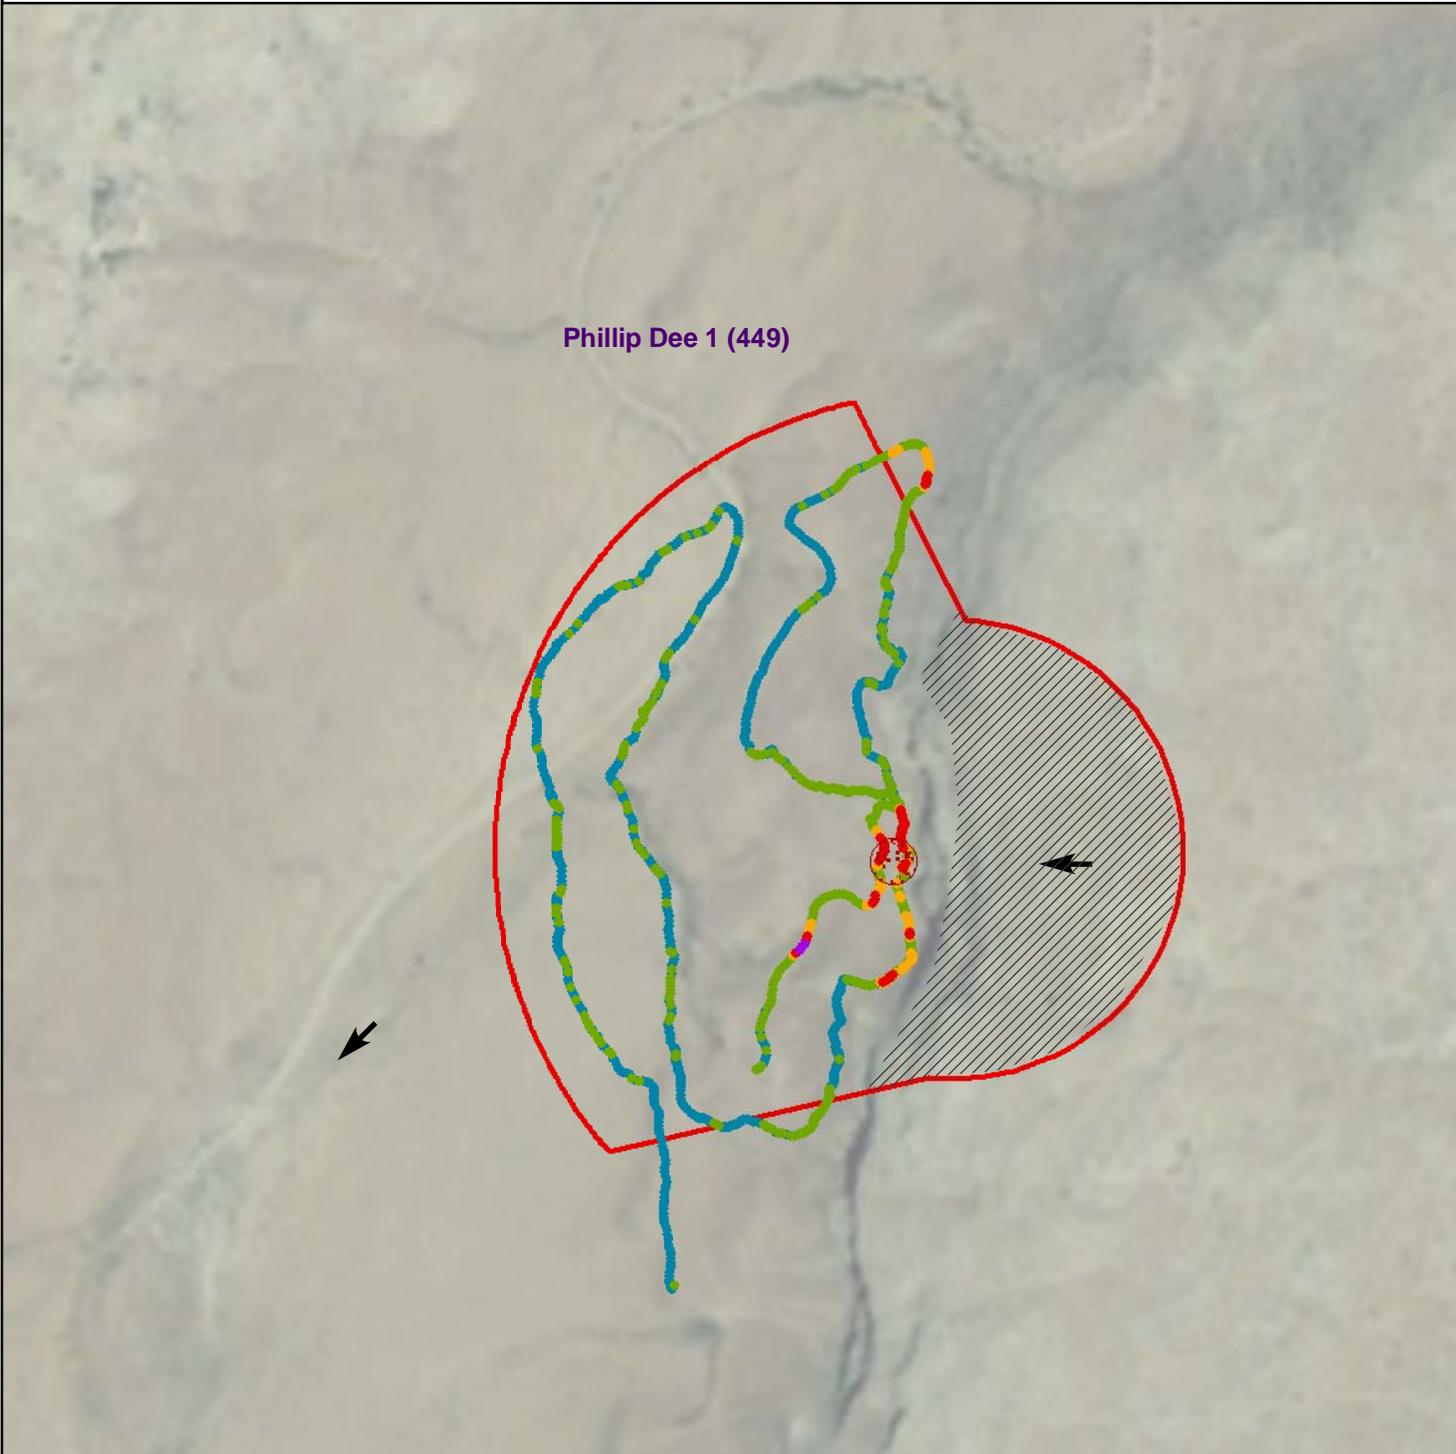
**Figure 2 - Gamma Radiation Measurements
Phillip Dee 1 (449)
Red Mesa Chapter, Navajo Nation**

Gamma survey conducted 06/2010
Measured as counts per minute (cpm)

Average background 9,186 cpm
