Navajo Abandoned Uranium Mine

Site Screen Report

Section 9 Lease AUM Site

Weston Solutions, Inc.

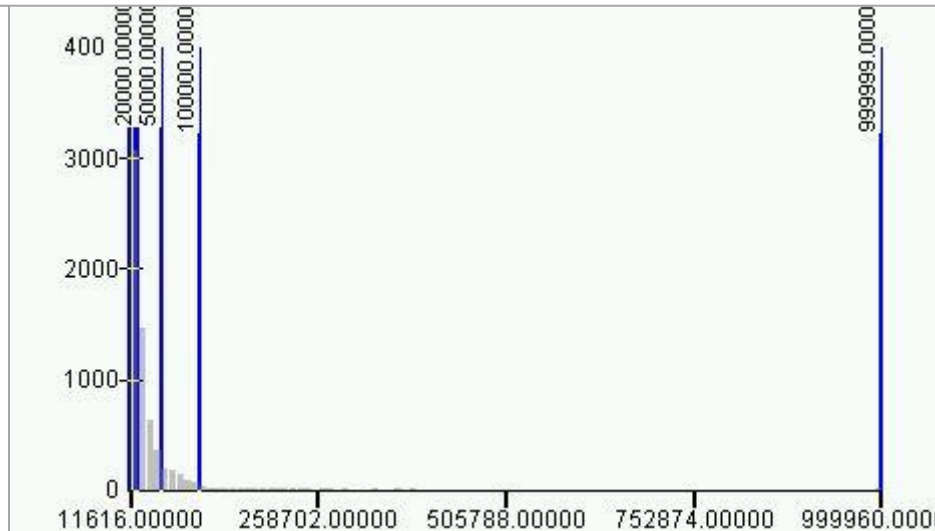
The following chart and statistics were generated by ESRI ArcGIS 9.3.1, and show the general distribution of the site gamma radiation measurements. The horizontal X axis represents the gamma radiation reading levels in cpm (lowest levels to the left). The vertical Y axis represents the frequency of each gamma radiation level.

Count:	6717
Minimum:	11616.00000
Maximum:	999960.00000
Sum:	332315799.00000
Mean:	49473.84234
Median:	22558.00000
Standard Deviation:	92138.62204

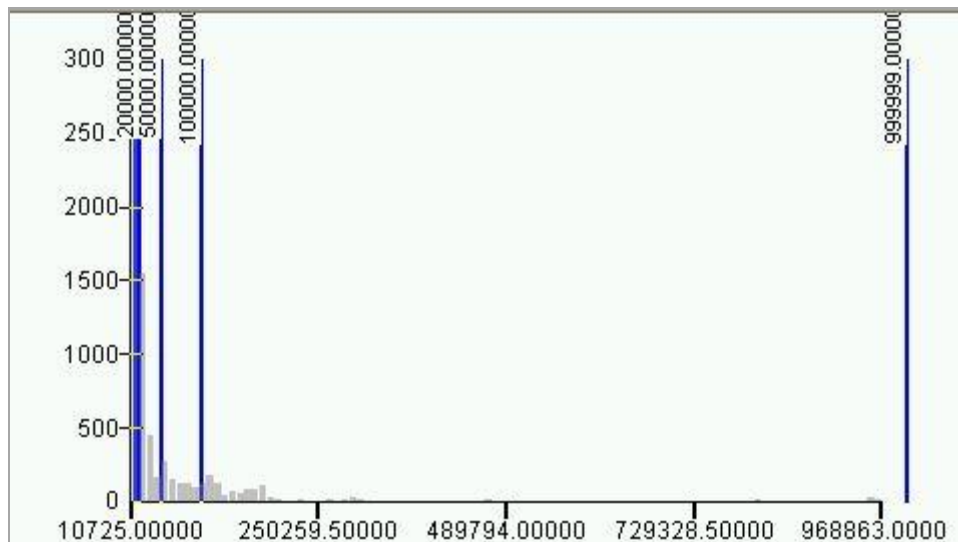
The following chart and statistics were generated by ESRI ArcGIS 9.3.1, and show the general distribution of the site gamma radiation measurements. The horizontal X axis represents the gamma radiation reading levels in cpm (lowest levels to the left). The vertical Y axis represents the frequency of each gamma radiation level.

Count:	7037
Minimum:	10725.00000
Maximum:	968863.00000
Sum:	414257471.00000
Mean:	58868.47677
Median:	22469.00000
Standard Deviation:	105611.70106

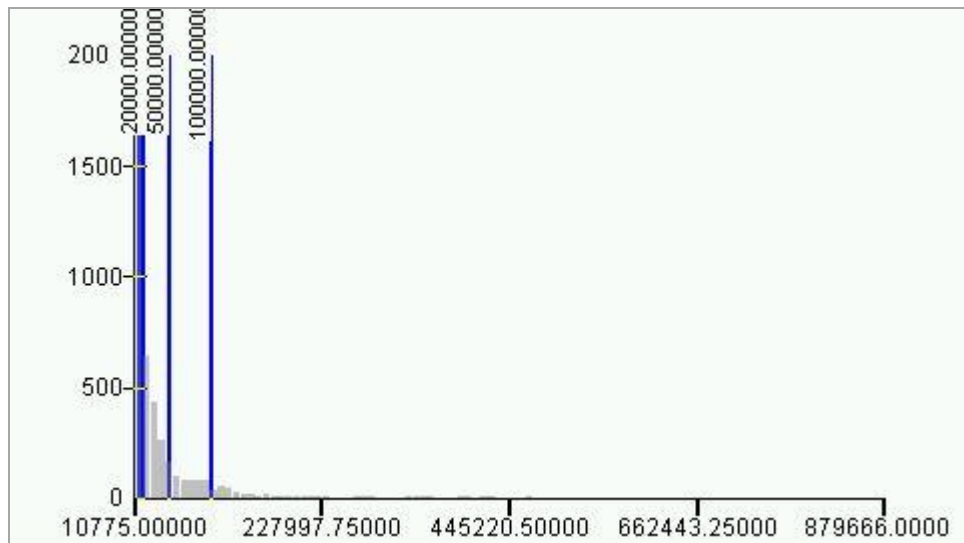
The following chart and statistics were generated by ESRI ArcGIS 9.3.1, and show the general distribution of the site gamma radiation measurements. The horizontal X axis represents the gamma radiation reading levels in cpm (lowest levels to the left). The vertical Y axis represents the frequency of each gamma radiation level.

Count:	4040
Minimum:	10775.00000
Maximum:	879666.00000
Sum:	207376058.00000
Mean:	51330.70743
Median:	22562.00000
Standard Deviation:	80056.99470

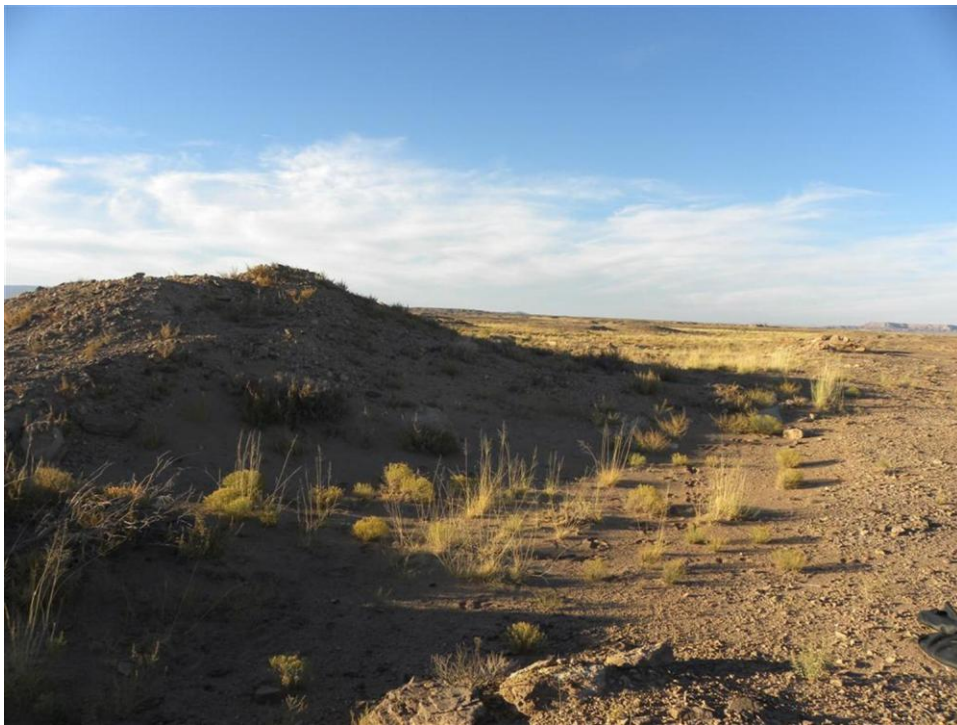
Waste piles spread throughout entire central part of site, primarily surrounding the concrete structure foundation, total estimated size of 1,000' x 250' x 5'

Photo 2. Section 9 Lease, Site #457, waste pile

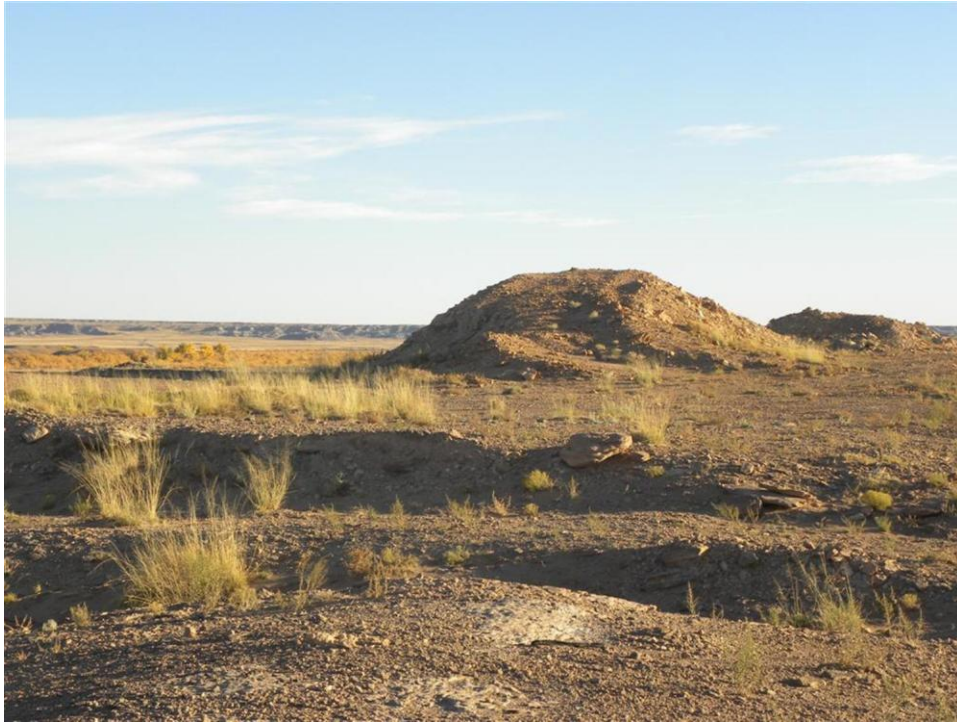
Photo 3. Section 9 Lease, Site #457, waste piles

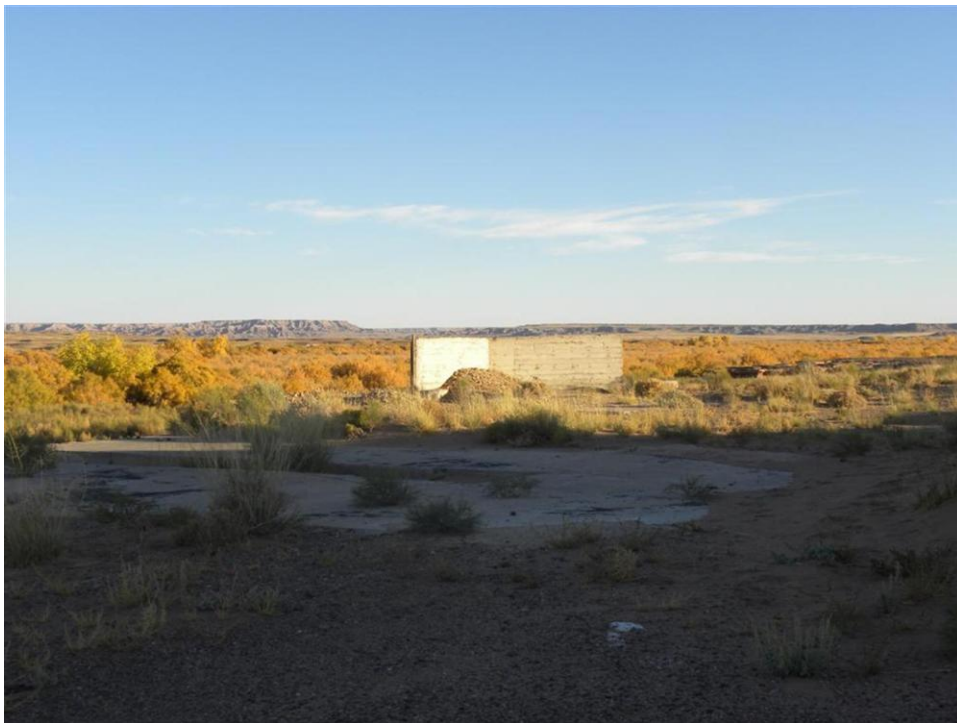
A concrete foundation and 2 walls from a former structure were found in the center of the site, the foundation was spread out between 2 levels, covering an estimated area of 100' x 50'. Two of the walls were still partially intact. The lower wall is approximately 30' high. Two chutes are still visible leading between the levels. A smaller 20' x 20' foundation was found approximately 300' south of large foundation. Other various metal and wood debris was found throughout site.

Photo 4. Section 9 Lease, Site #457, concrete structure area

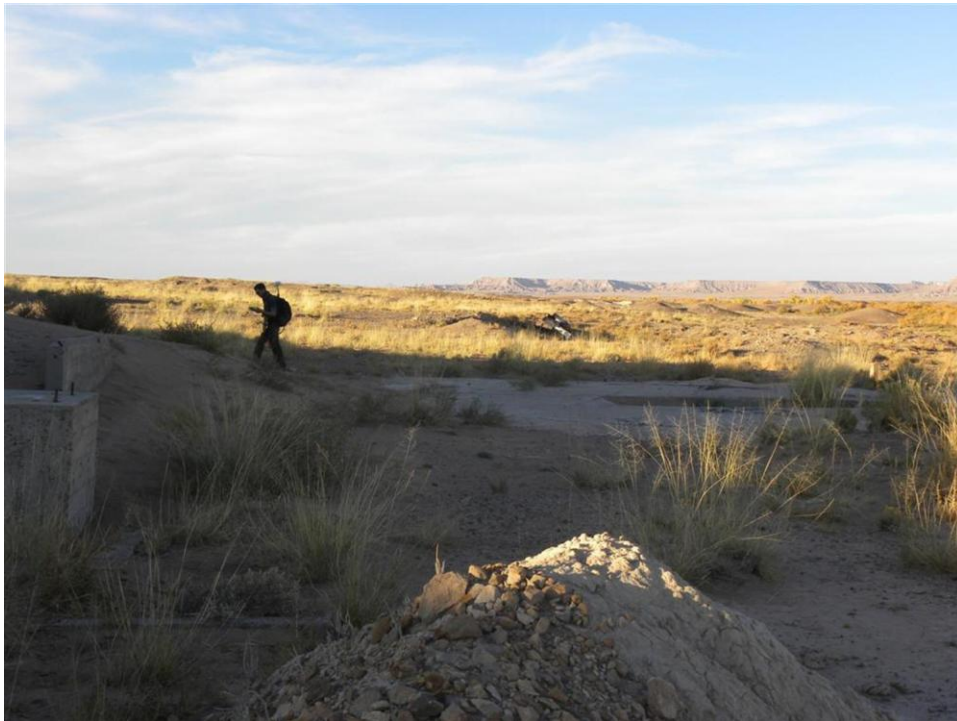
Waste piles atop the foundation area were found at levels up to 1,000,000 cpm

Photo 8. Section 9 Lease, Site #457, concrete structure area waste pile

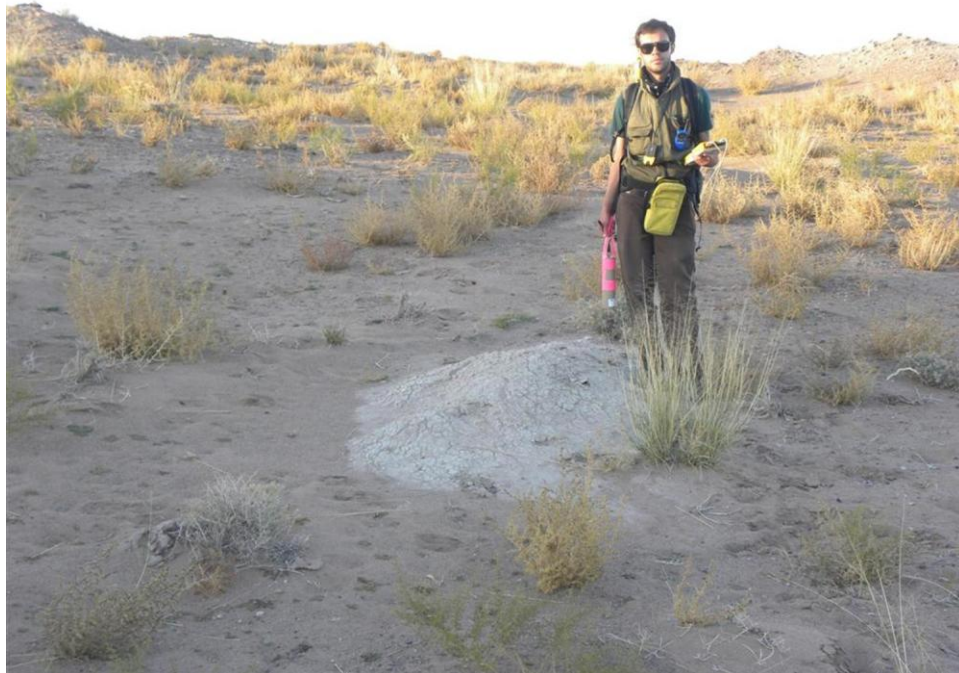
Photo 12. Section 9 Lease, Site #457, concrete structure area waste pile, gamma readings approximately 1,000,000 cpm

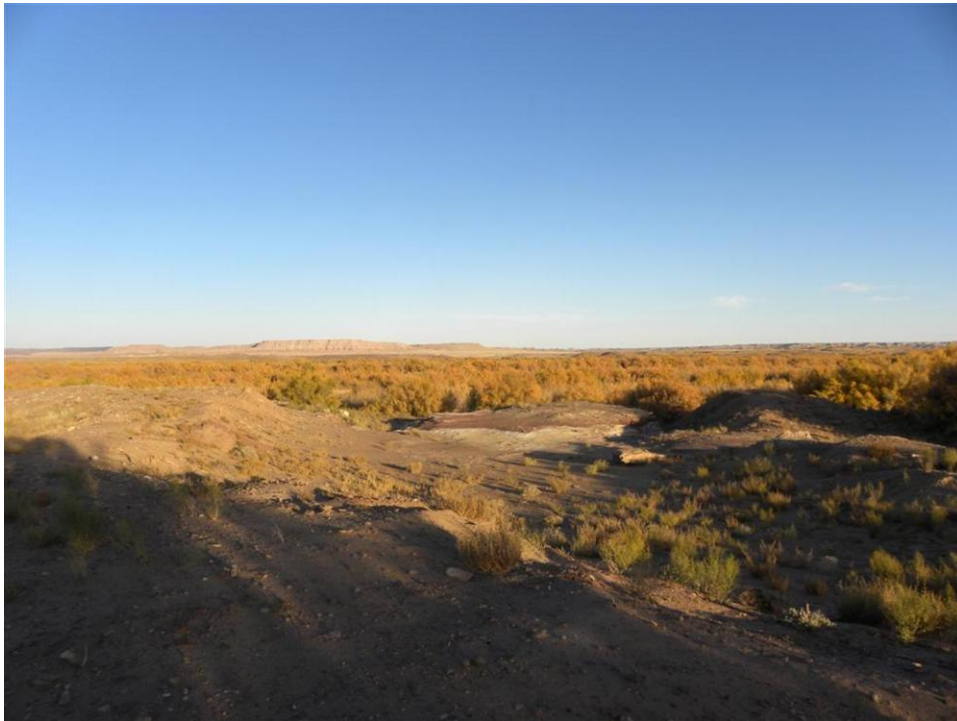
Photo 16. Section 9 Lease, Site #457, former pond area

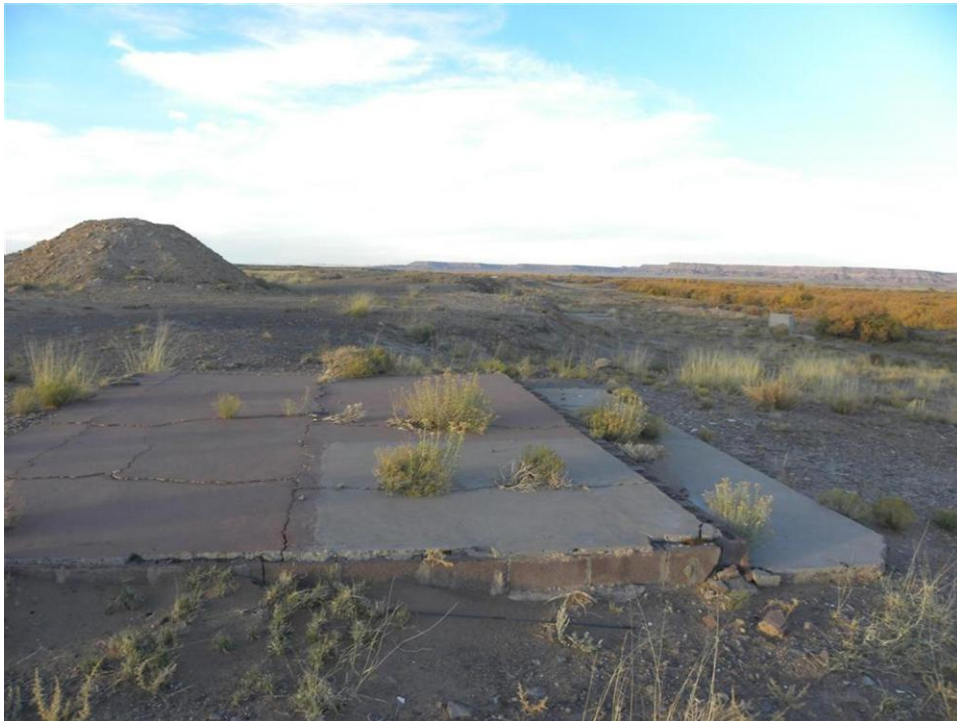
Photo 20. Section 9 Lease, Site #457, foundation south of concrete structure area

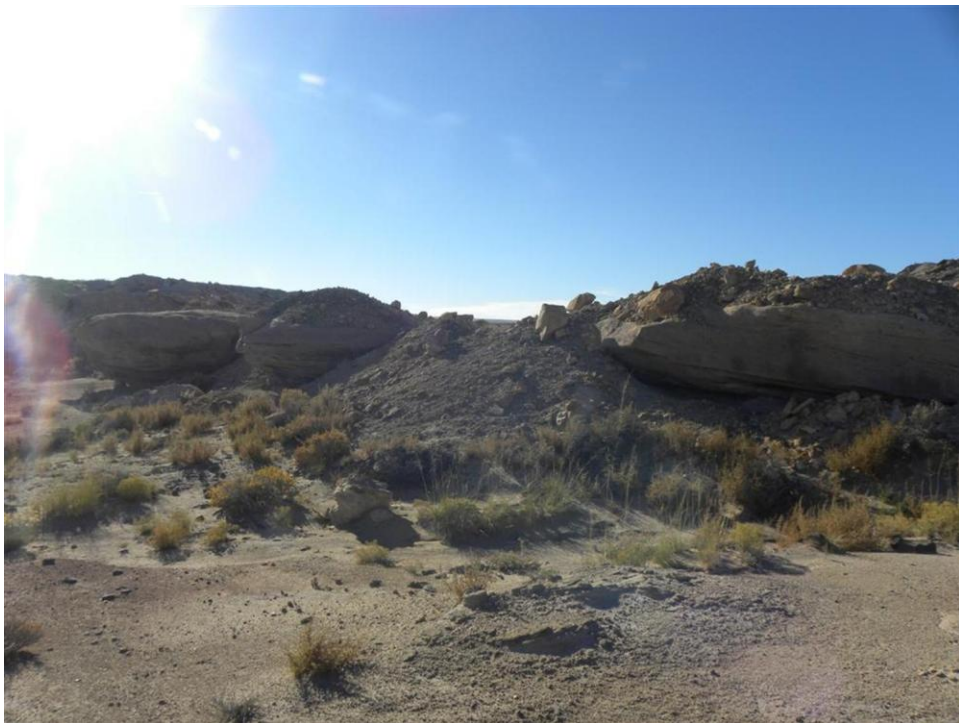
Majority of site is a large waste pile, extends S past the site boundaries, estimated size of 750' x 300' x 5'

Photo 26. Section 9 Lease, Site #458, waste pile

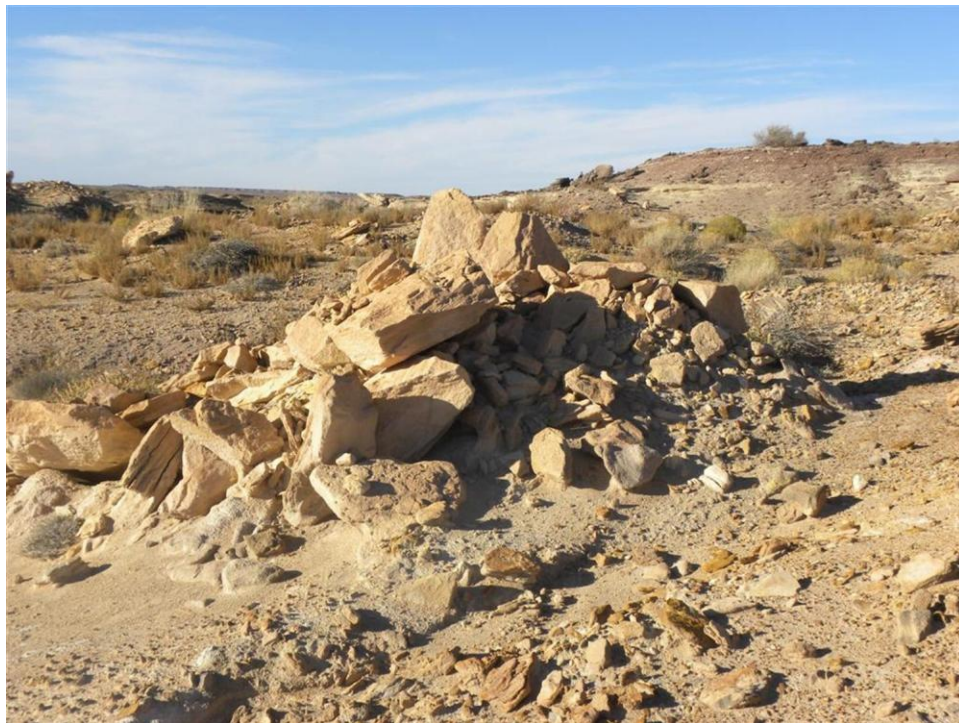
A total of 7,037 gamma radiation measurements were collected from the mine site, ranging from 10,725 cpm to 968,863 cpm. The measurements collected along the edge of the waste rock area were found at a maximum level of approximately 150,000 cpm, in the center of the waste rock area at a maximum level of approximately 1,000,000 cpm, and at possible pit area at a maximum level of approximately 300,000 cpm. The measurements are represented in Figures 1, 2, 5, and 6.

Photo 30. Section 9 Lease, Site #458, waste pile, gamma readings approximately 1,000,000 cpm

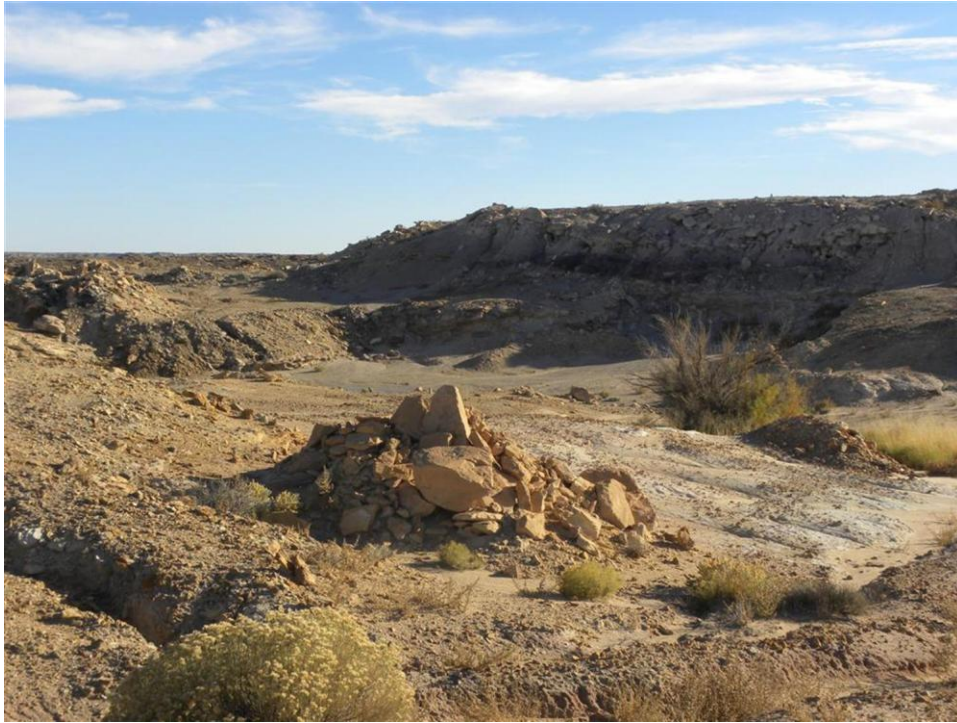
Mining debris spread out (drill rods); possible pit area in center of waste area

Photo 31. Section 9 Lease, Site #458, center of waste area and possible pit

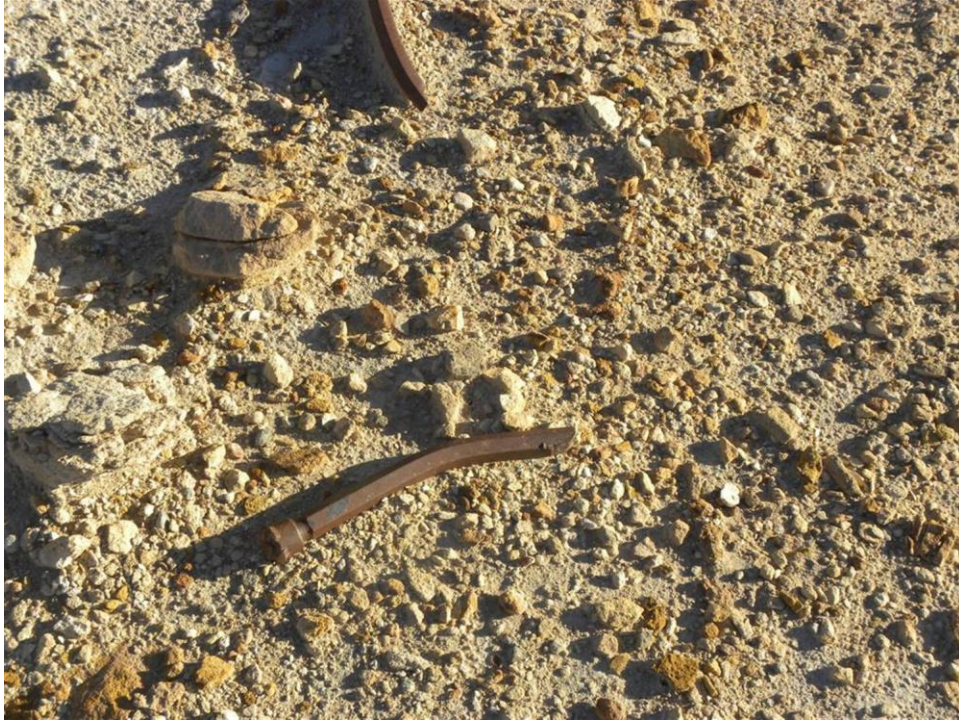
Photo 33. Section 9 Lease, Site #458, mining evidence

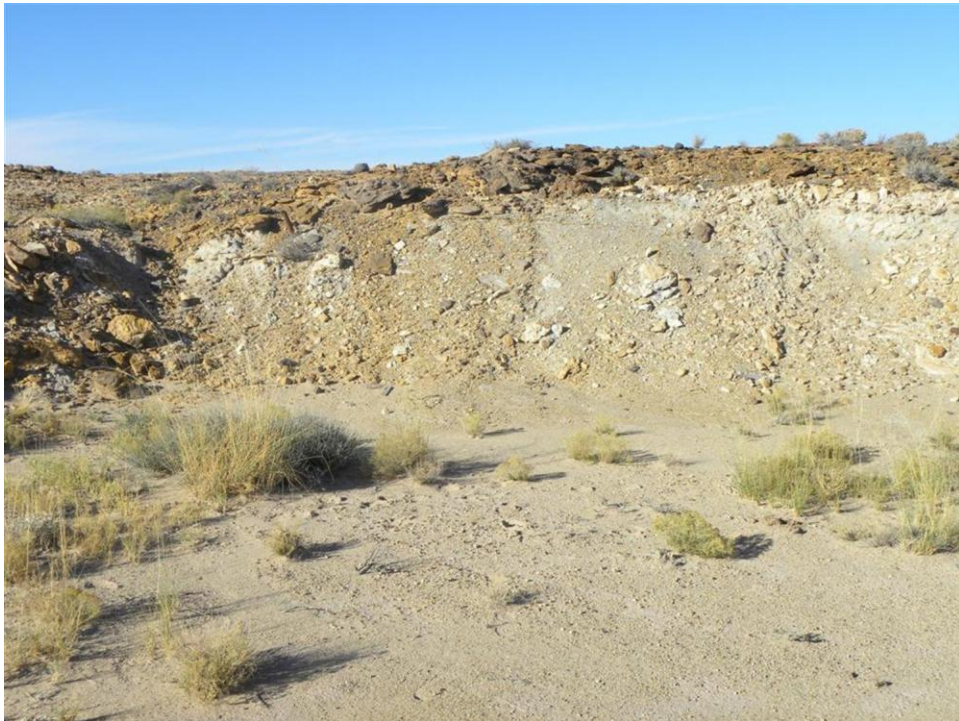
7 Waste piles: 2 small piles 6' x 4' x 2.5', yellow-brown upstream of N gully; 1 medium pile, 10' x 8' x 4', yellow brown upstream of N gully; 4 large piles, 20' diameter x 15' h, yellow brown, near open pit

Photo 34. Section 9 Lease, Site #459, waste piles

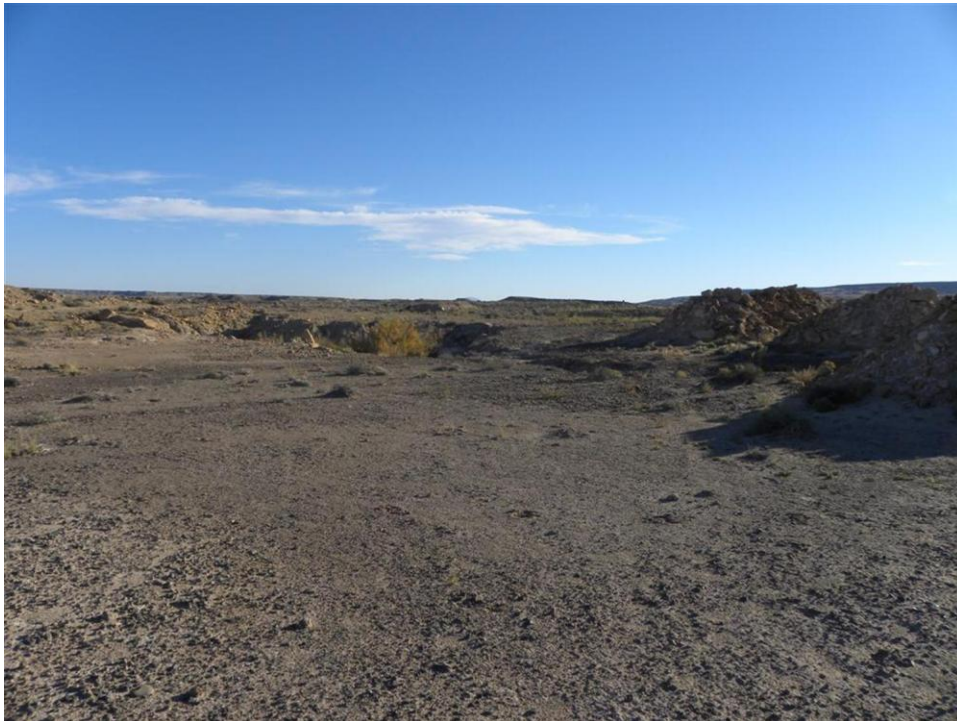
Open Pit 60' x 80' x 15' depth, sandy bottom with vegetation

Photo 38. Section 9 Lease, Site #459, possible pit area with waste piles

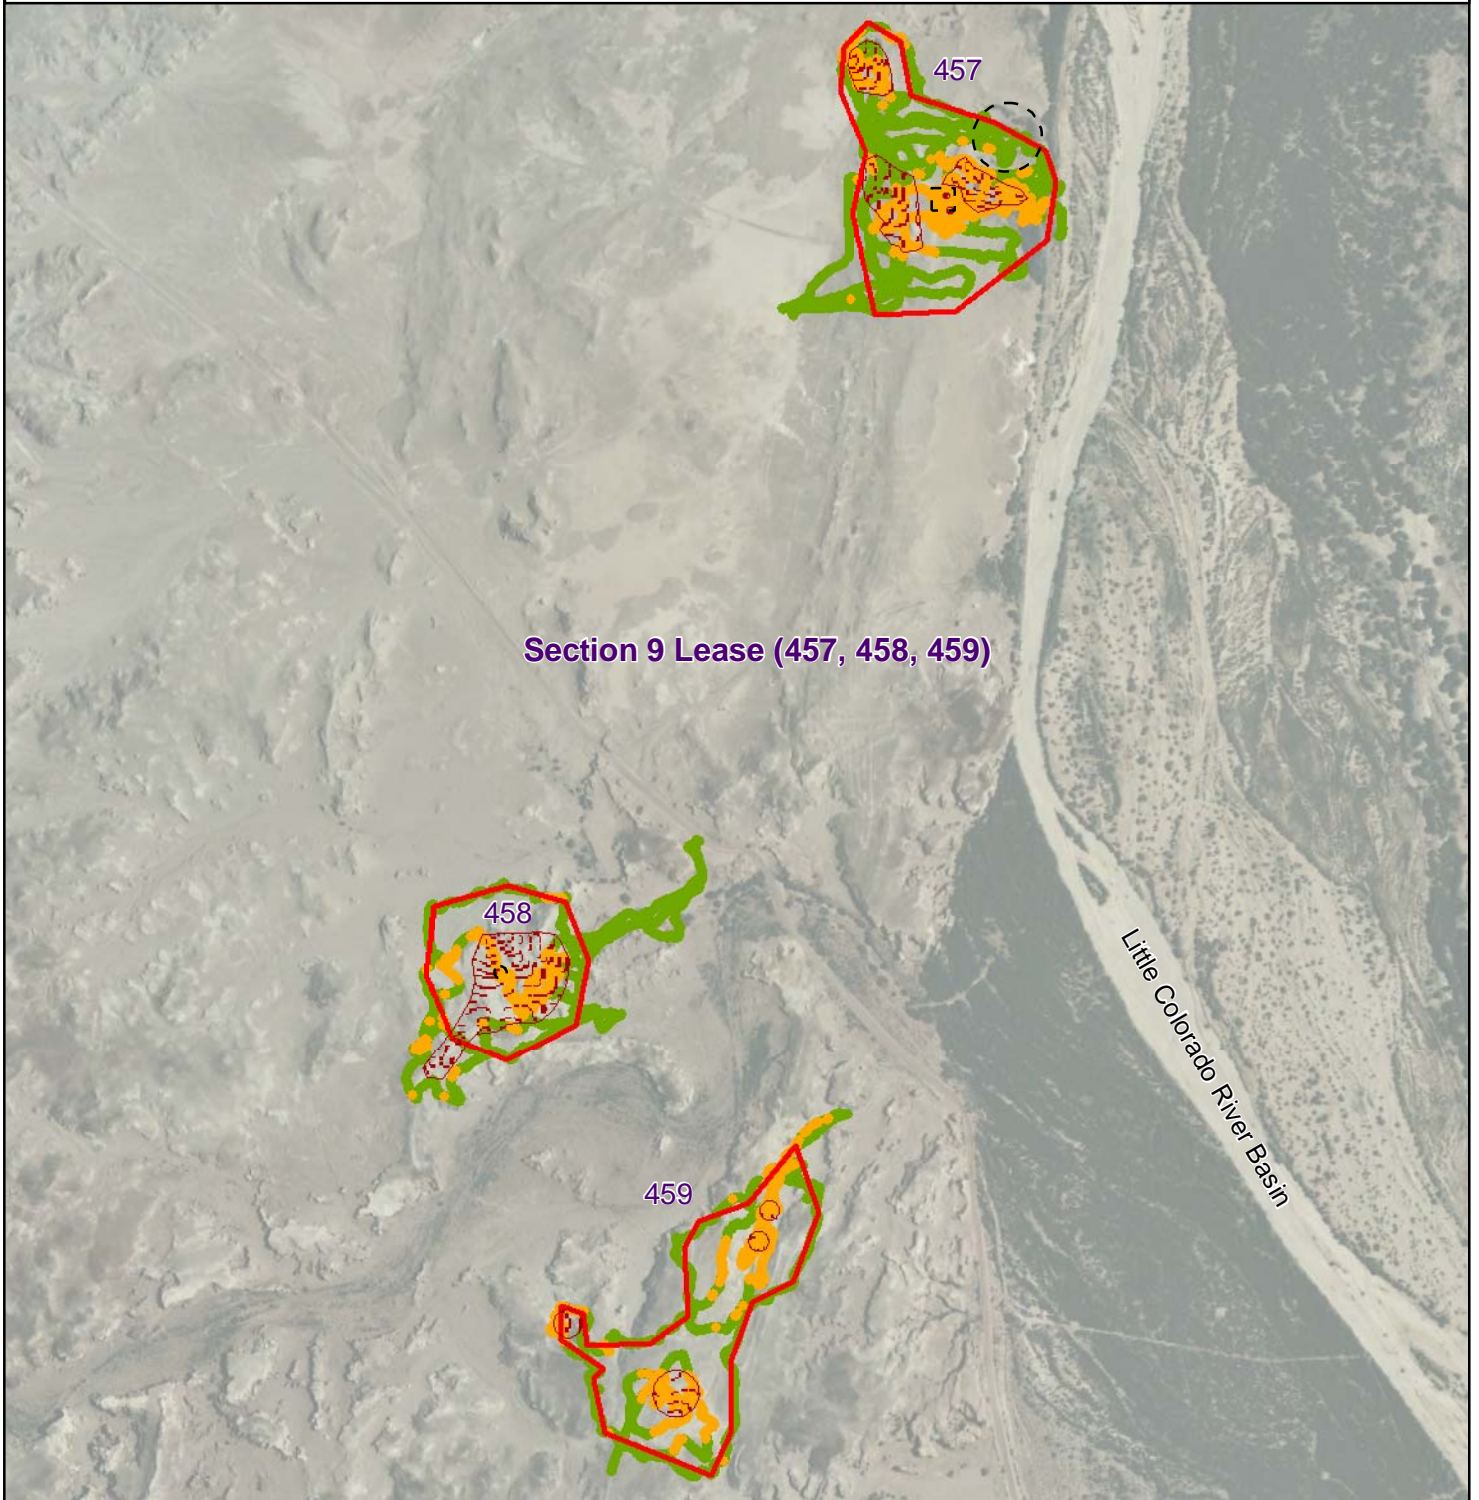
**Figure 1 - Gamma Radiation Measurements, Above Two Times Background
Section 9 Lease (457, 458, 459)
Coconino County, Arizona**

Gamma survey conducted 11/2010
Measured as counts per minute (cpm)

Average background 15,626 cpm

A total of 6,717 gamma radiation measurements were collected from the mine site, ranging from 11,616 cpm to 999,960 cpm. The measurements collected throughout the concrete structure foundation area were found at levels ranging from approximately 50,000 cpm (bare cement foundation) to 1,000,000 cpm (small dirt piles atop foundation), at the waste piles throughout the site at levels ranging from approximately 40,000 cpm to 1,000,000 cpm, and at the former pond area and downstream drainage at maximum levels of approximately 100,000 cpm. The measurements are represented in Figures 1, 2, 3, and 4.

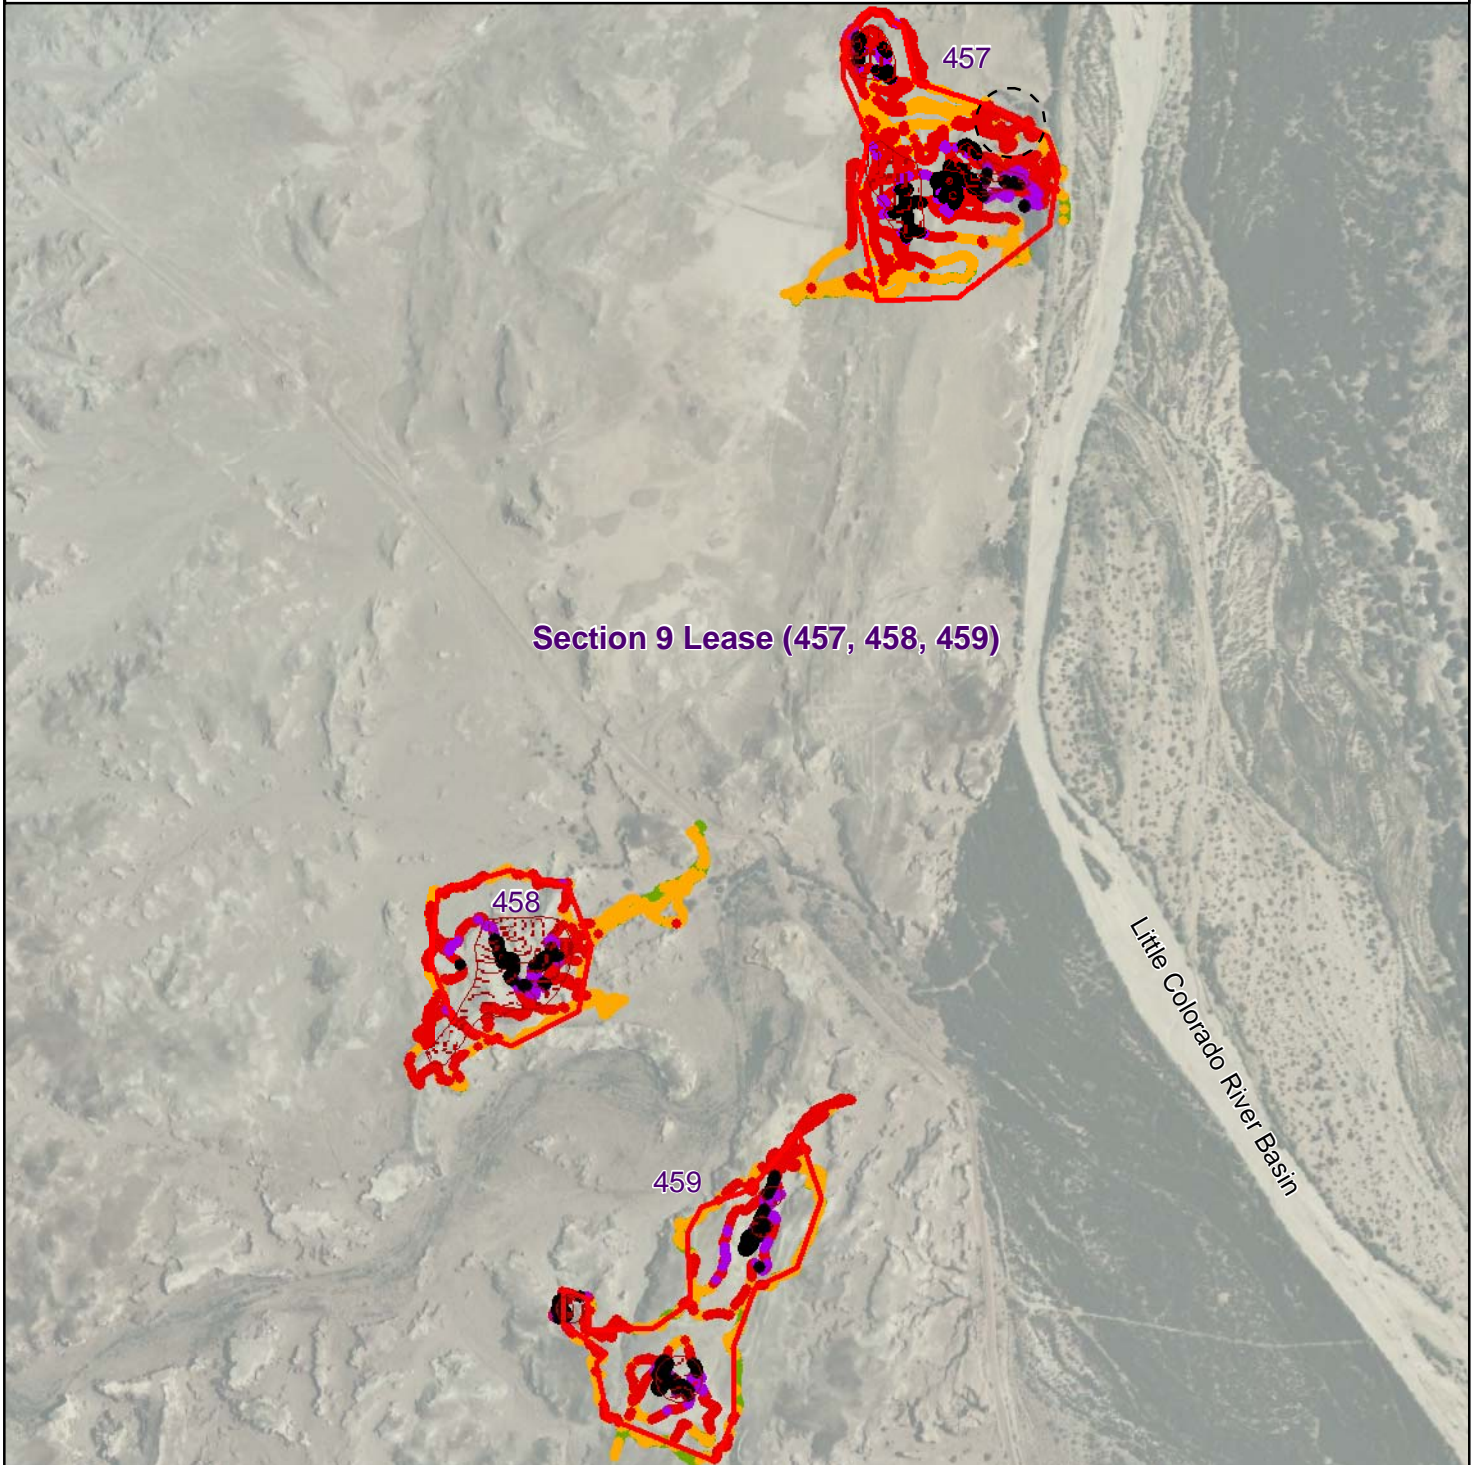
**Figure 2 - Gamma Radiation Measurements
Section 9 Lease (457, 458, 459)
Coconino County, Arizona**

Gamma survey conducted 11/2010
Measured as counts per minute (cpm)

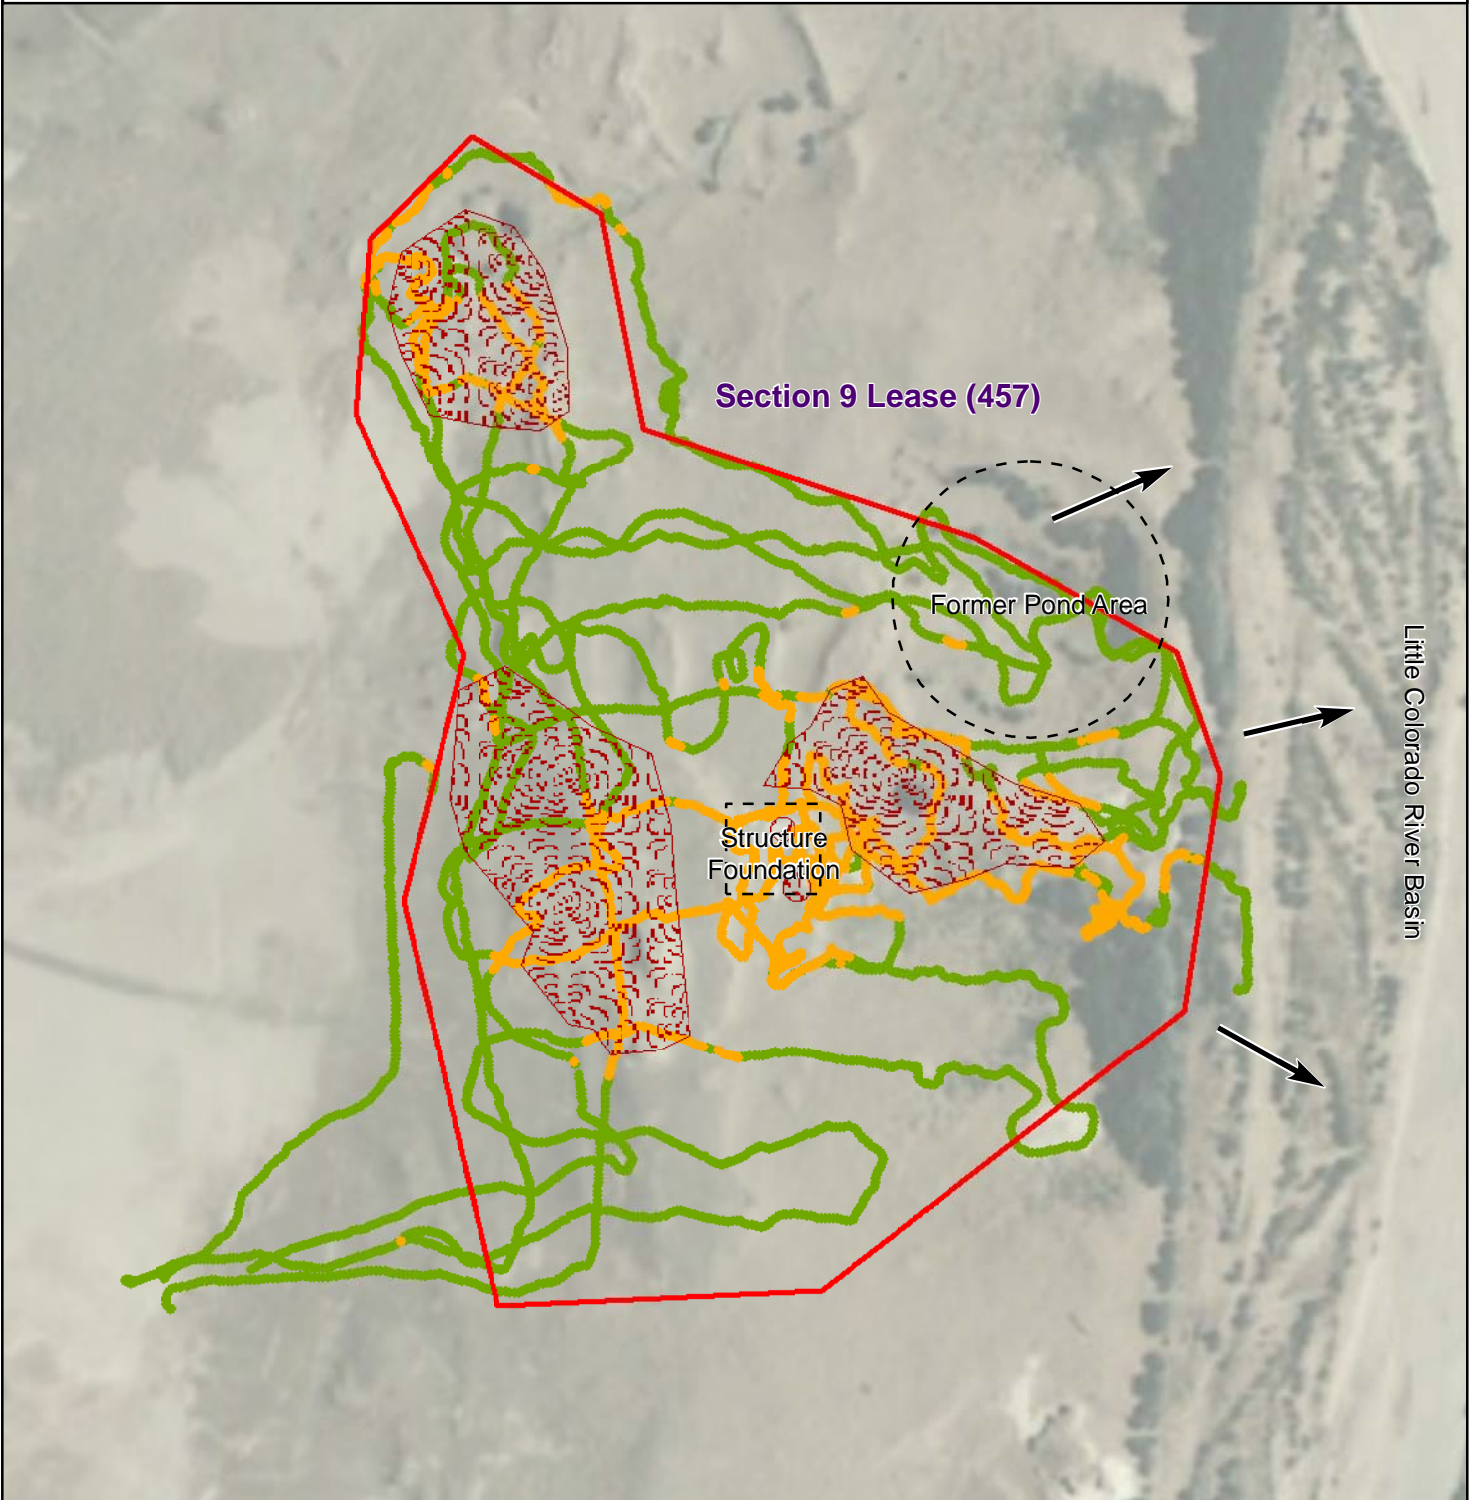
**Figure 3 - Gamma Radiation Measurements, Above Two Times Background
Section 9 Lease (457)
Coconino County, Arizona**

Gamma survey conducted 11/2010
Measured as counts per minute (cpm)

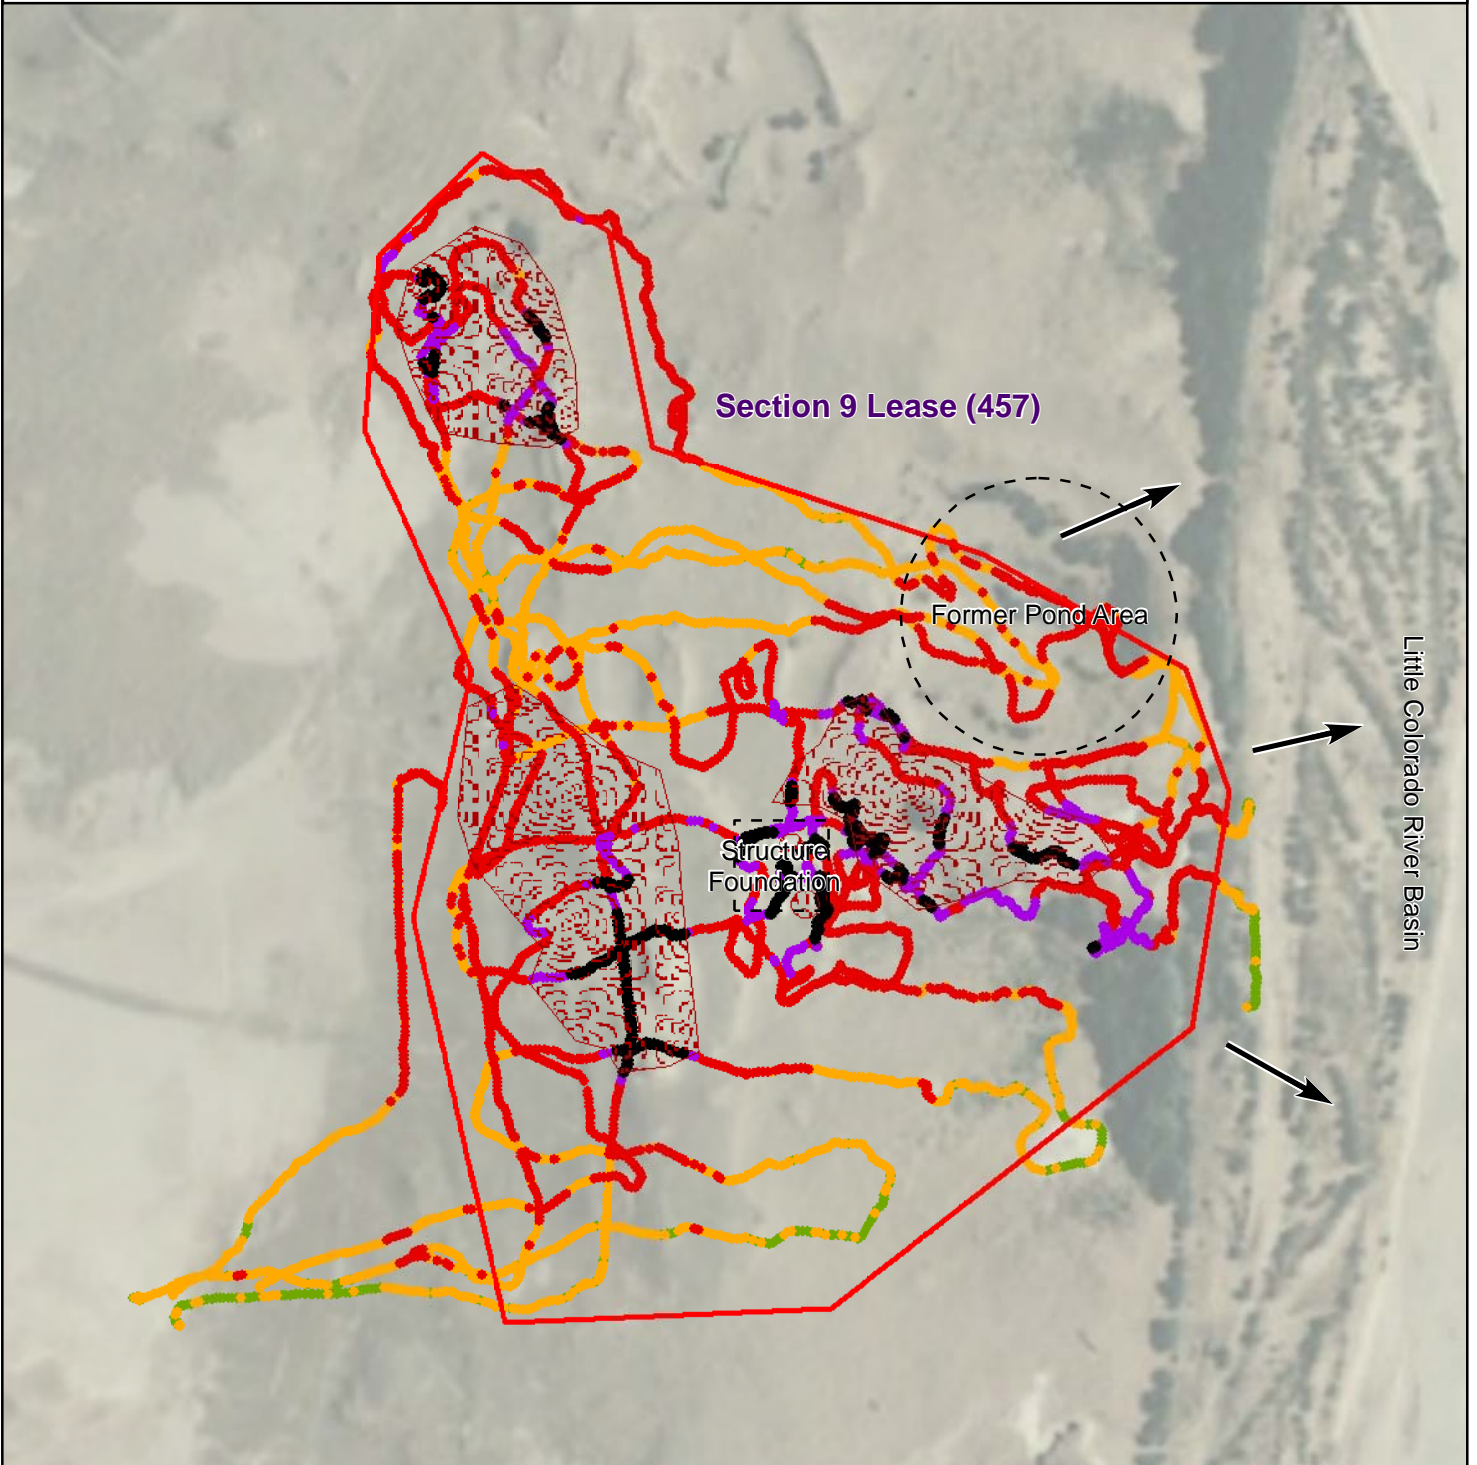
**Figure 4 - Gamma Radiation Measurements
Section 9 Lease (457)
Coconino County, Arizona**

Gamma survey conducted 11/2010
Measured as counts per minute (cpm)

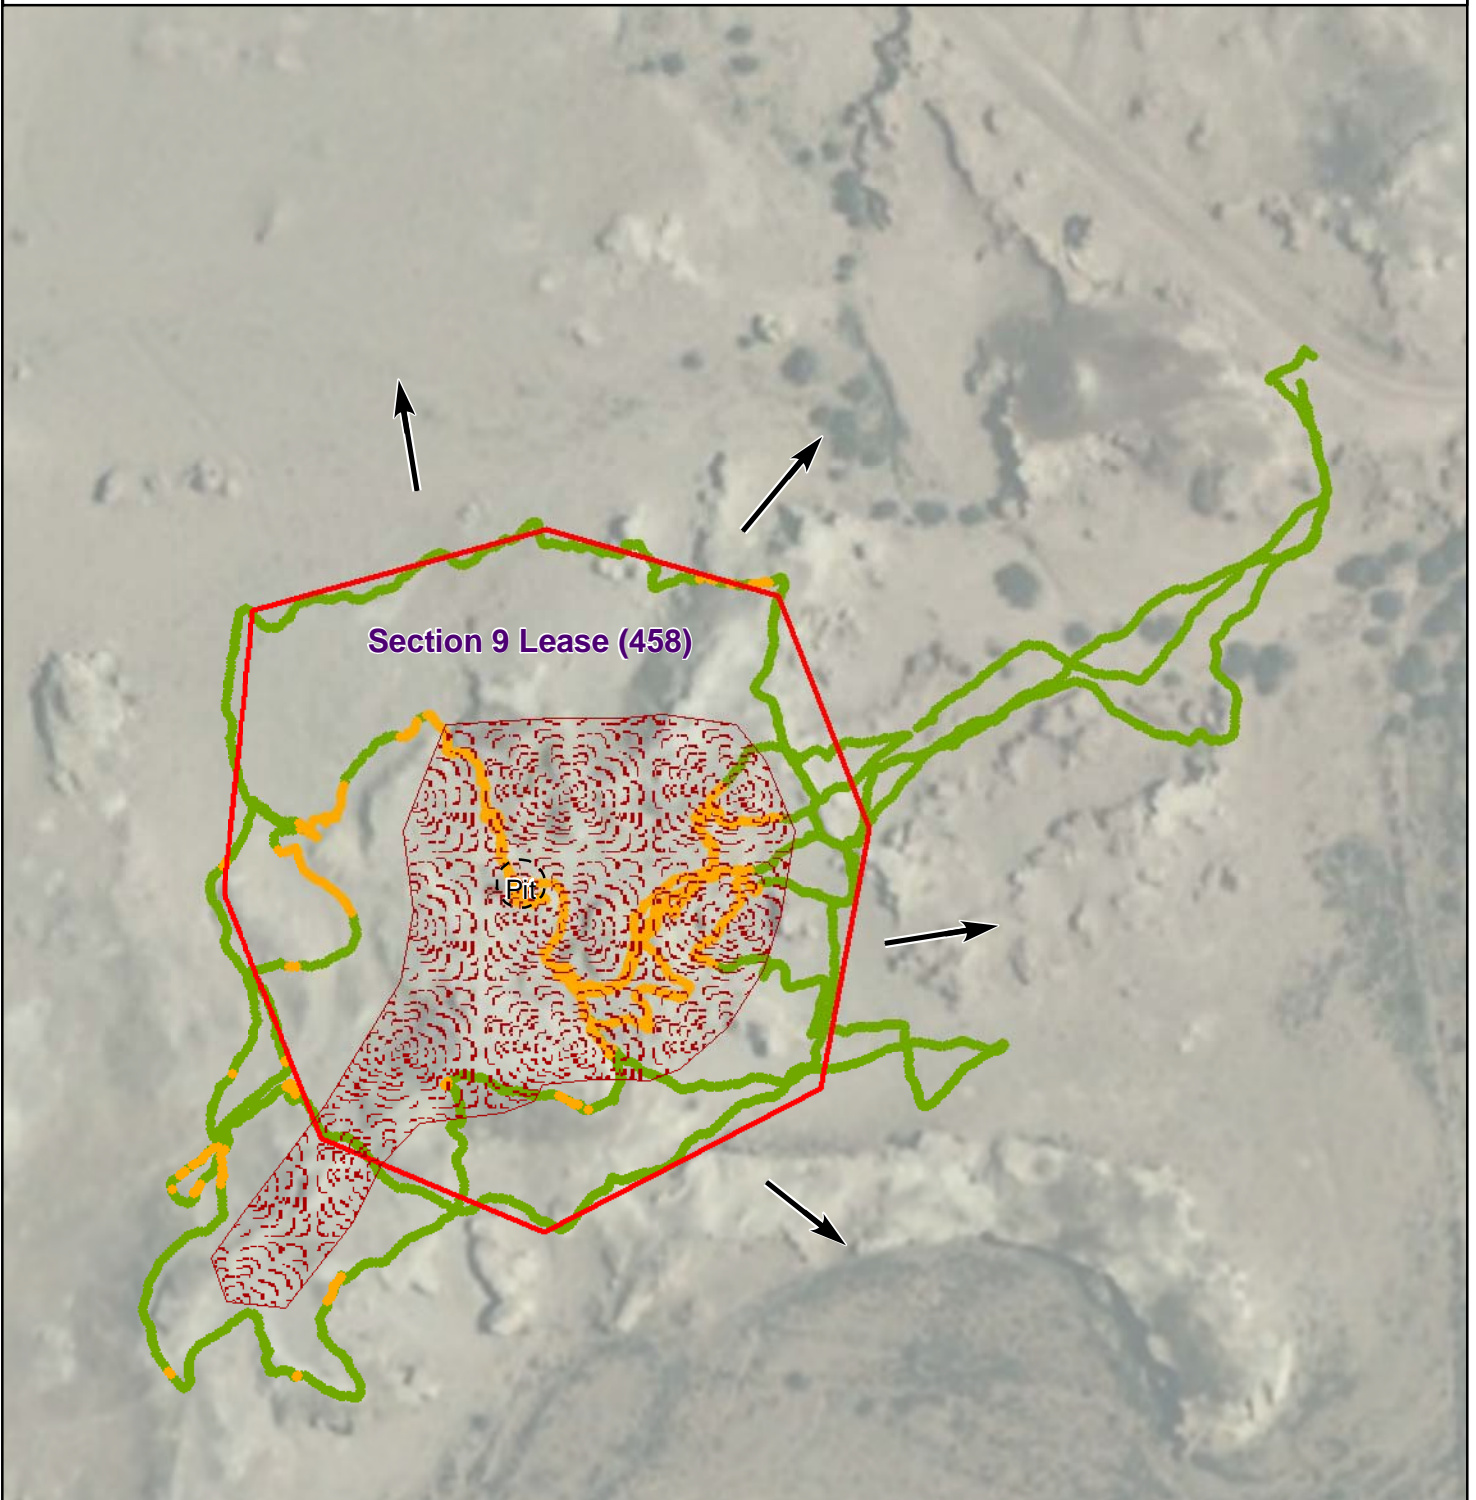
**Figure 5 - Gamma Radiation Measurements, Above Two Times Background
Section 9 Lease (458)
Coconino County, Arizona**

Gamma survey conducted 11/2010
Measured as counts per minute (cpm)
