Navajo Abandoned Uranium Mine

Site Screen Report

Section 9 Lease AUM Site

Weston Solutions, Inc.

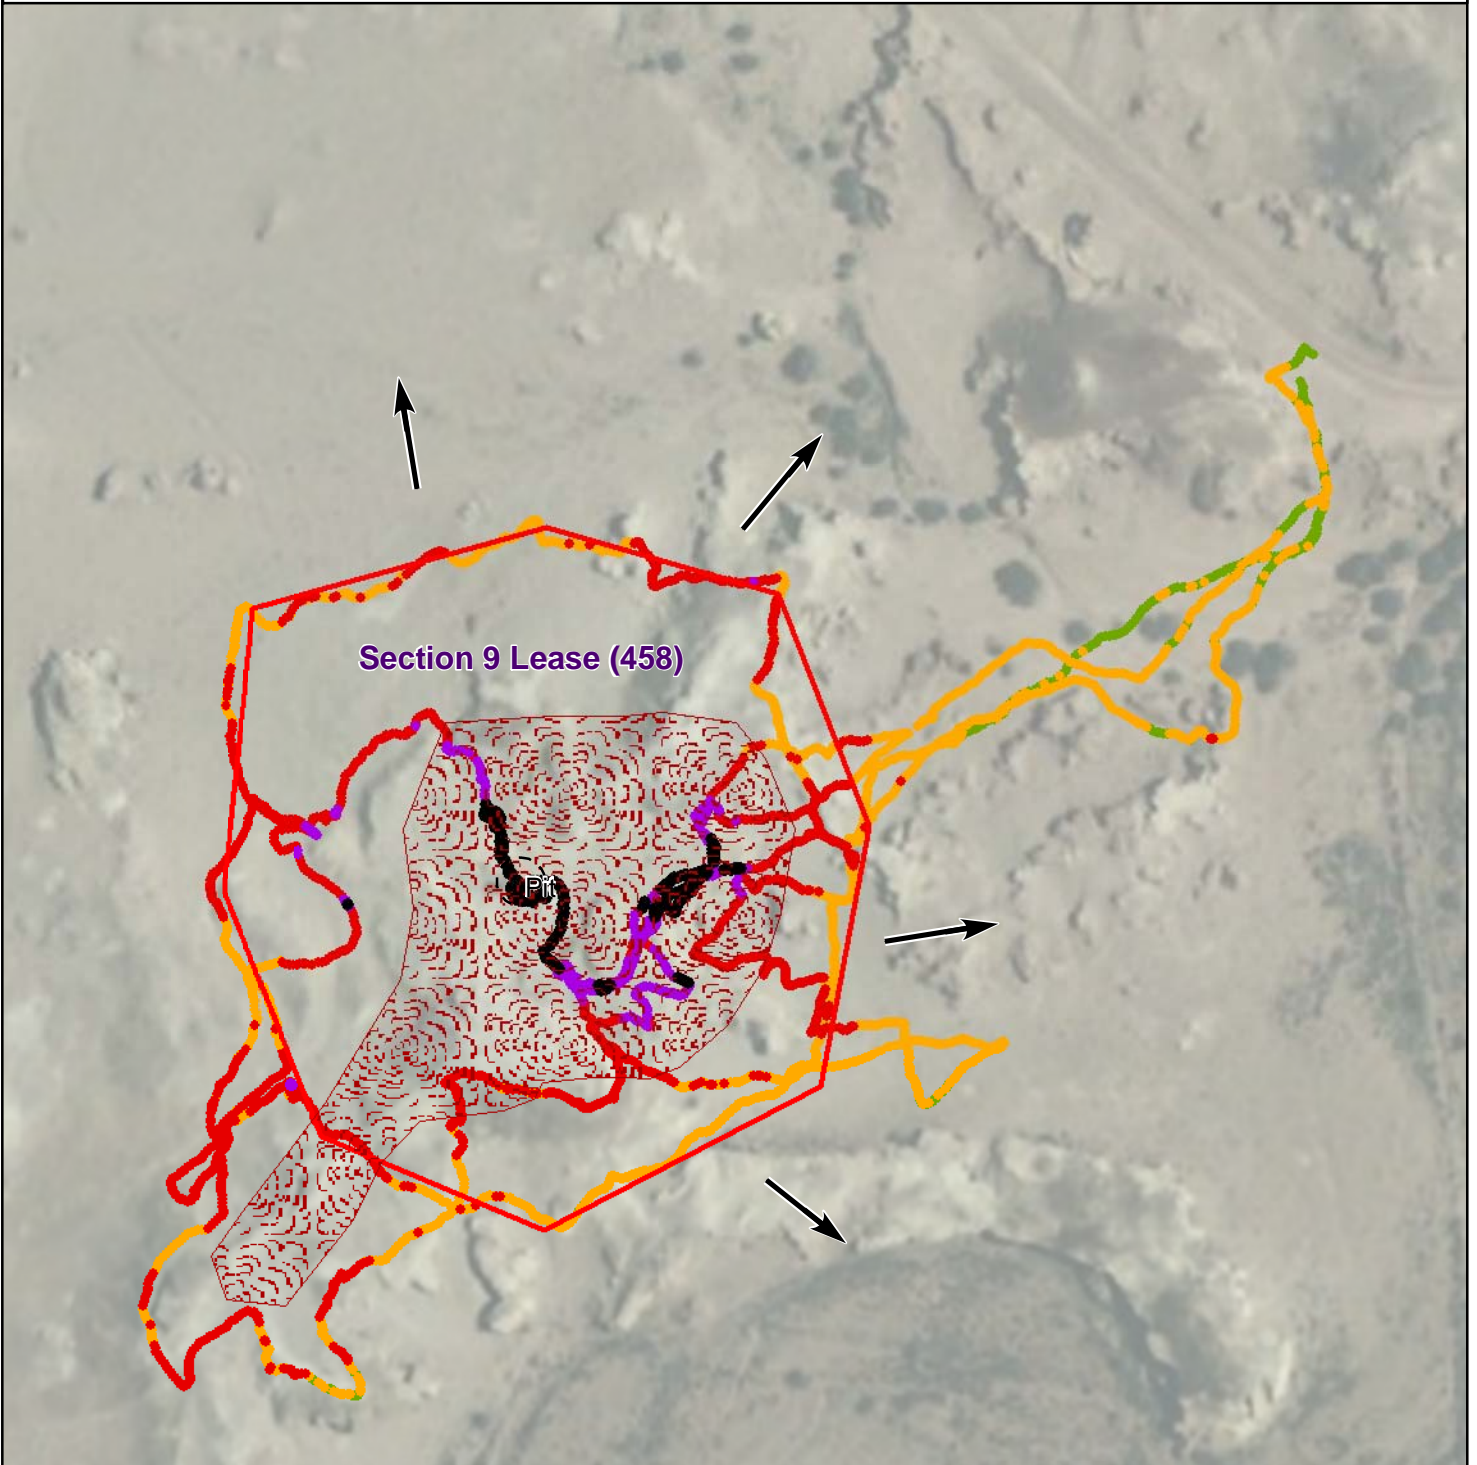
**Figure 6 - Gamma Radiation Measurements
Section 9 Lease (458)
Coconino County, Arizona**

**Gamma survey conducted 11/2010
Measured as counts per minute (cpm)**

A total of 7,037 gamma radiation measurements were collected from the mine site, ranging from 10,725 cpm to 968,863 cpm. The measurements collected along the edge of the waste rock area were found at a maximum level of approximately 150,000 cpm, in the center of the waste rock area at a maximum level of approximately 1,000,000 cpm, and at possible pit area at a maximum level of approximately 300,000 cpm. The measurements are represented in Figures 1, 2, 5, and 6.

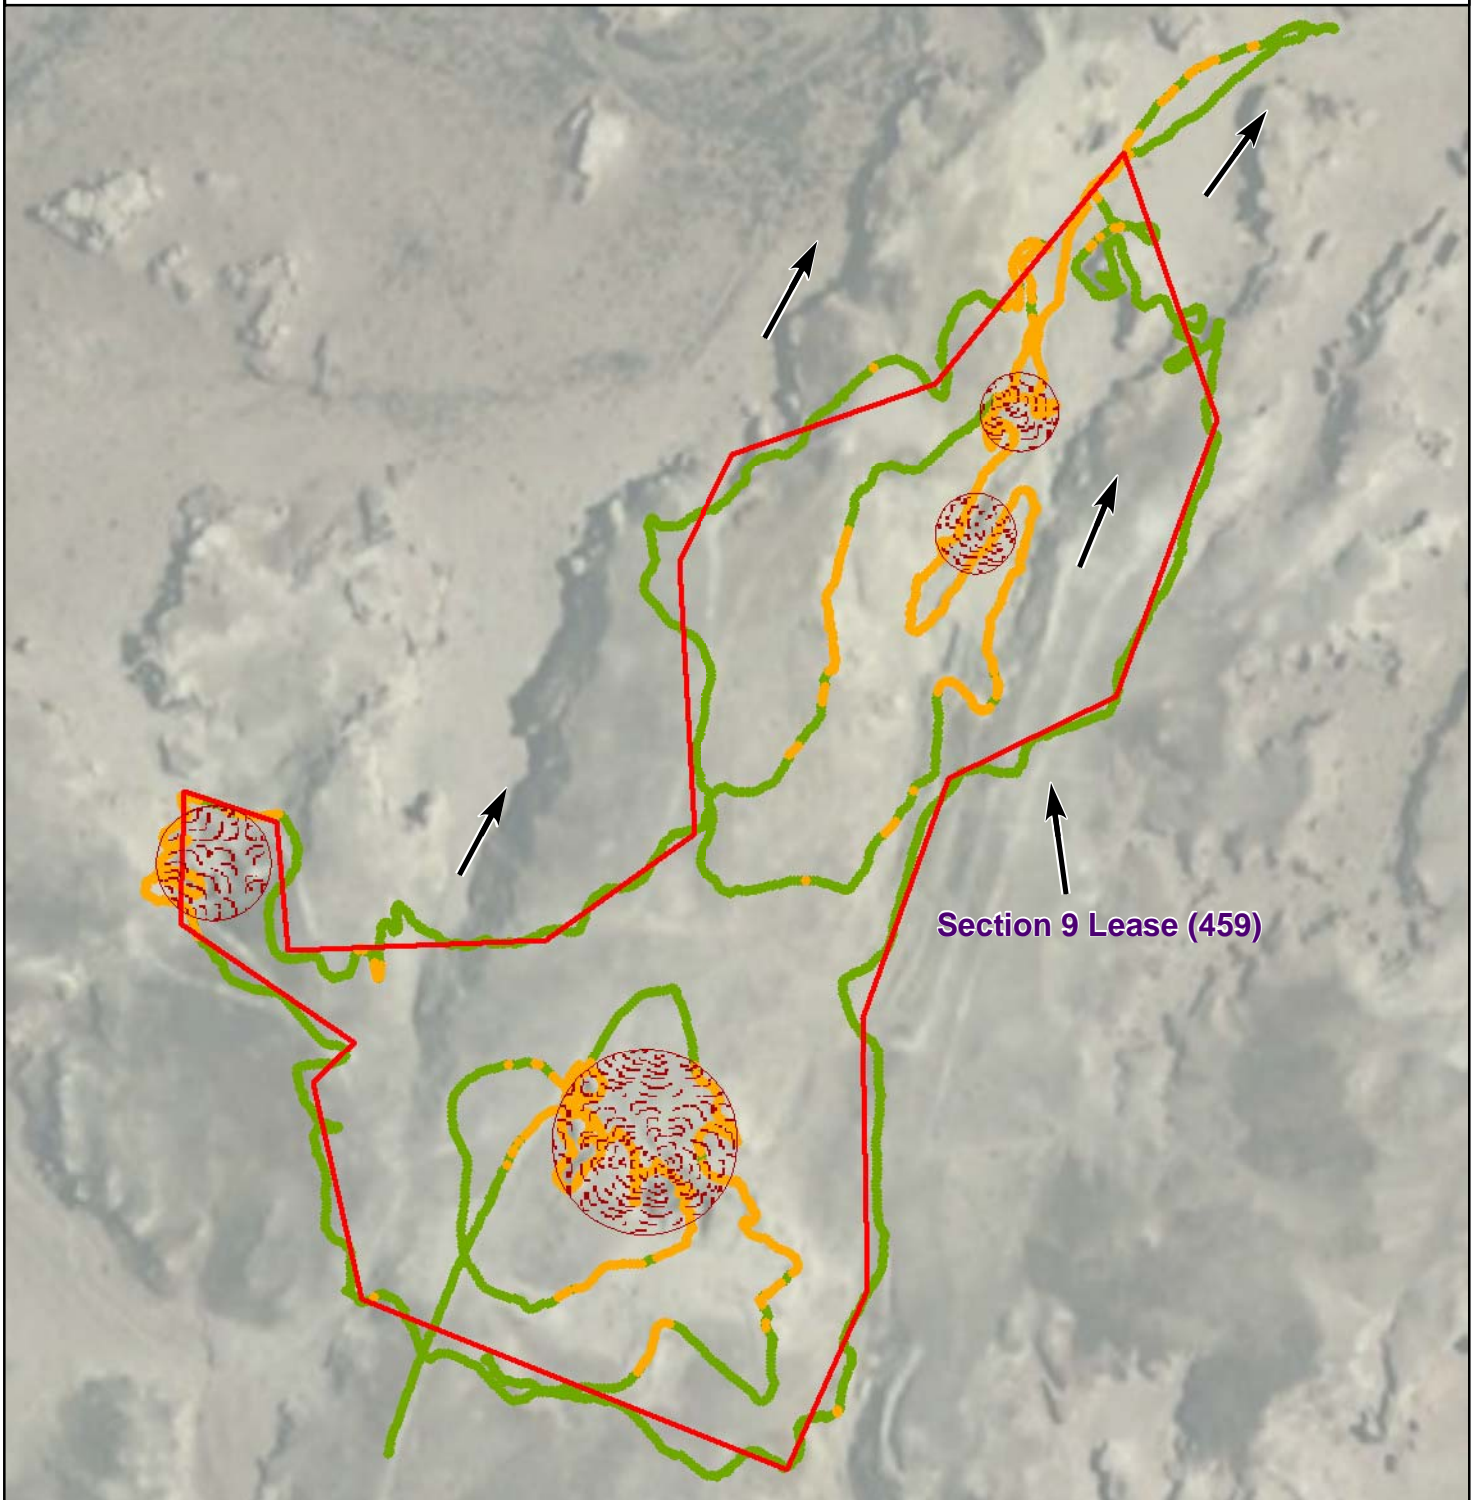
**Figure 7 - Gamma Radiation Measurements, Above Two Times Background
Section 9 Lease (459)
Coconino County, Arizona**

Gamma survey conducted 11/2010
Measured as counts per minute (cpm)

A total of 4,040 gamma radiation measurements were collected from the mine site, ranging from 10,775 cpm to 879,666 cpm. The measurements collected from the waste rock area were found at maximum levels ranging from approximately 60,000 cpm to 875,000 cpm, in the pit area ranging from approximately 30,000 cpm and the top to approximately 100,000 cpm at the bottom. The measurements are represented in Figures 1, 2, 7, and 8.

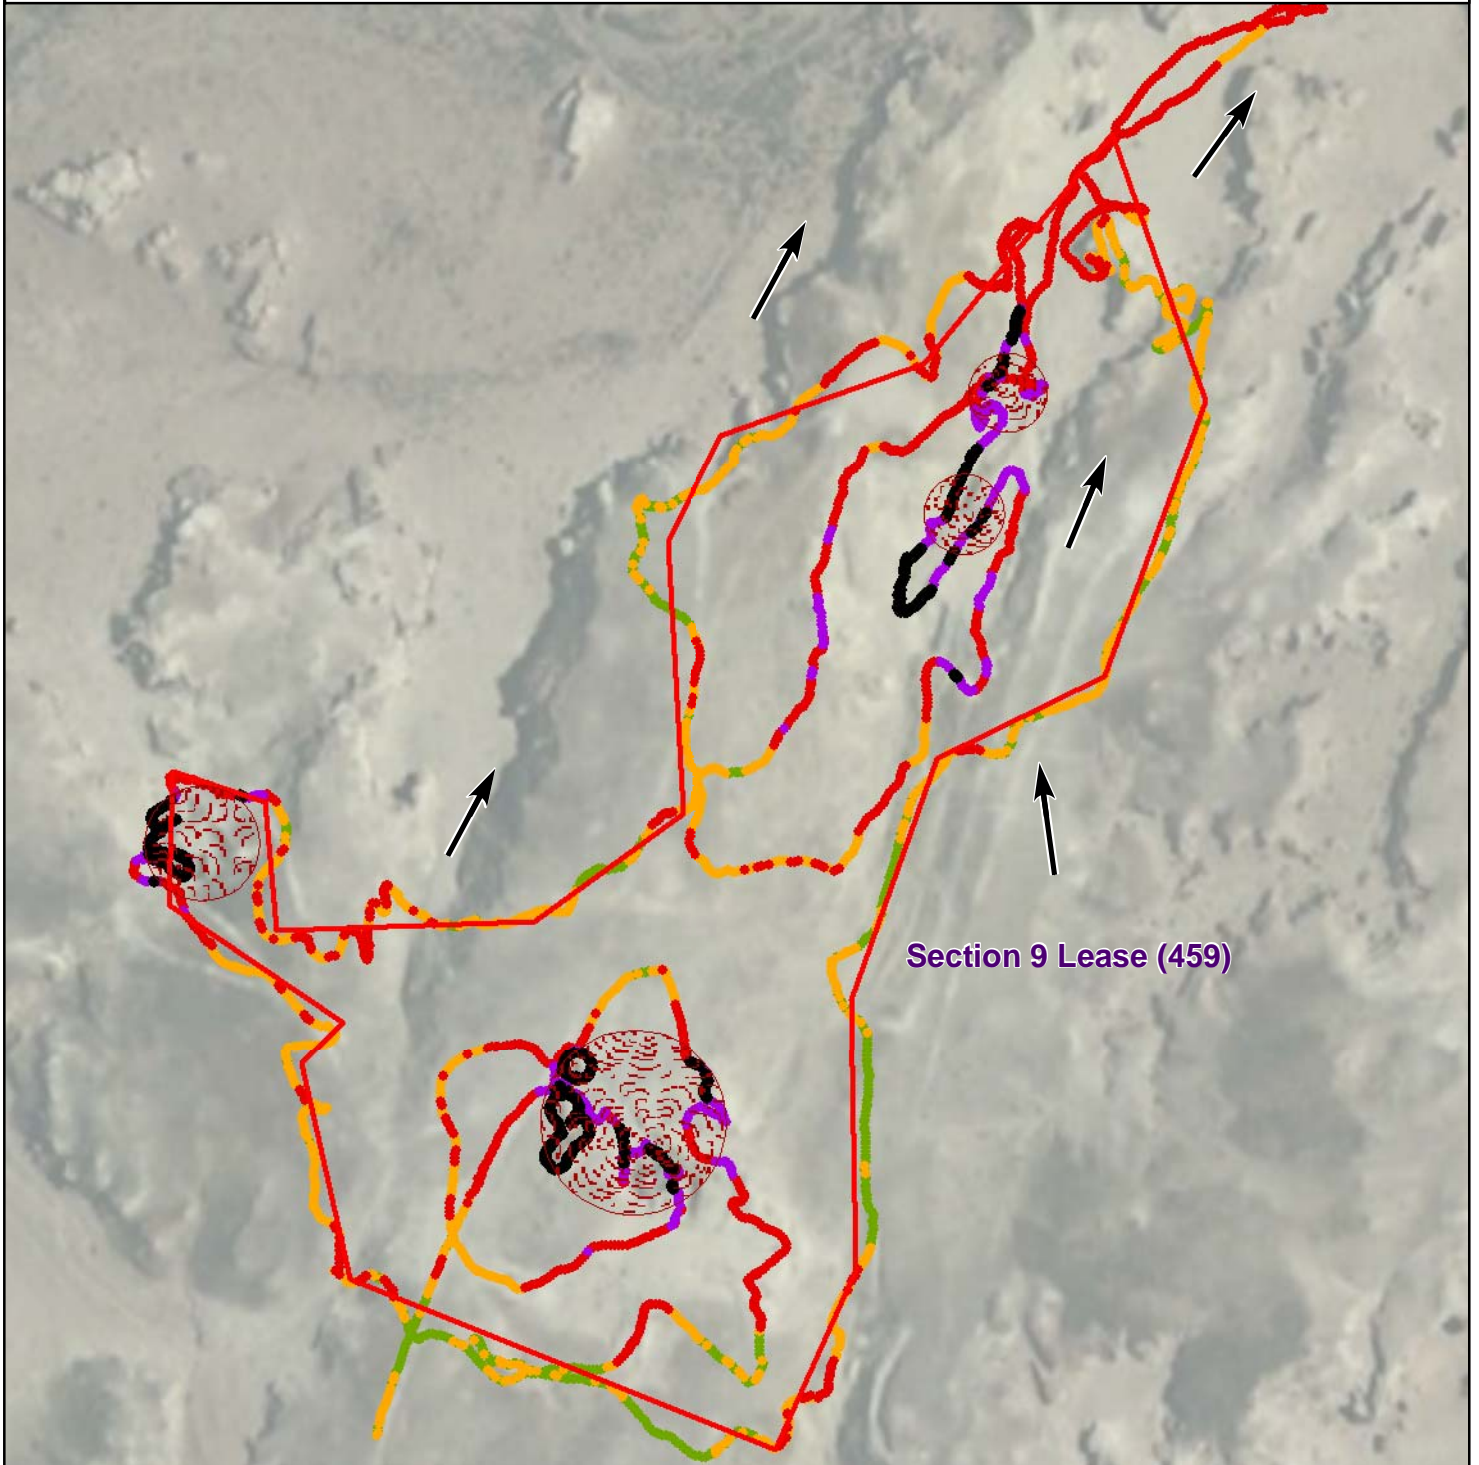
**Figure 8 - Gamma Radiation Measurements
Section 9 Lease (459)
Coconino County, Arizona**

Gamma survey conducted 11/2010
Measured as counts per minute (cpm)
