Navajo Abandoned Uranium Mine

Site Screen Report

Mesa IV 1/2 Mine and Simpson 181 Site

March 2010

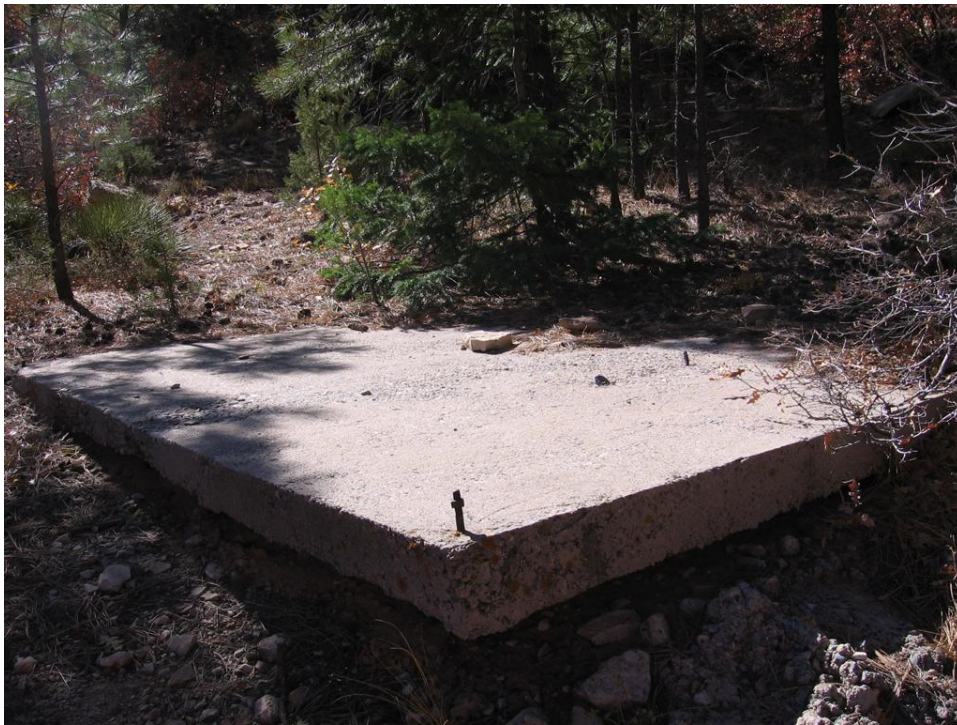
Photo 2. Concrete Pad

Concrete pad

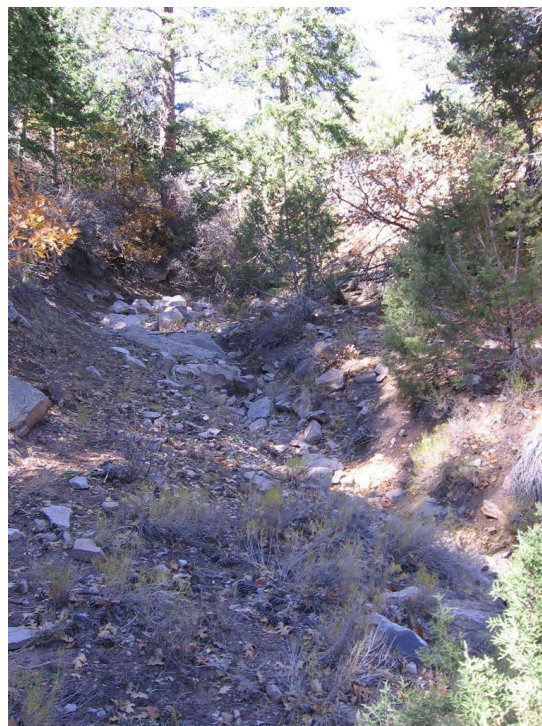
Photo 4. Drainage below concrete pad

A total of 3,121 gamma radiation measurements were collected from the mine site, ranging from 10,545 cpm to 39,029 cpm. Measurements in the vicinity of the concrete pad were found at levels in up to 17,000 cpm, and in the drainage coming off the concrete pad at approximately 30,000 cpm. The measurements are represented in Figures 1 and 2.
