# Navajo Abandoned Uranium Mine

## Site Screen Report

### Carson AUM Site

**August 2010**

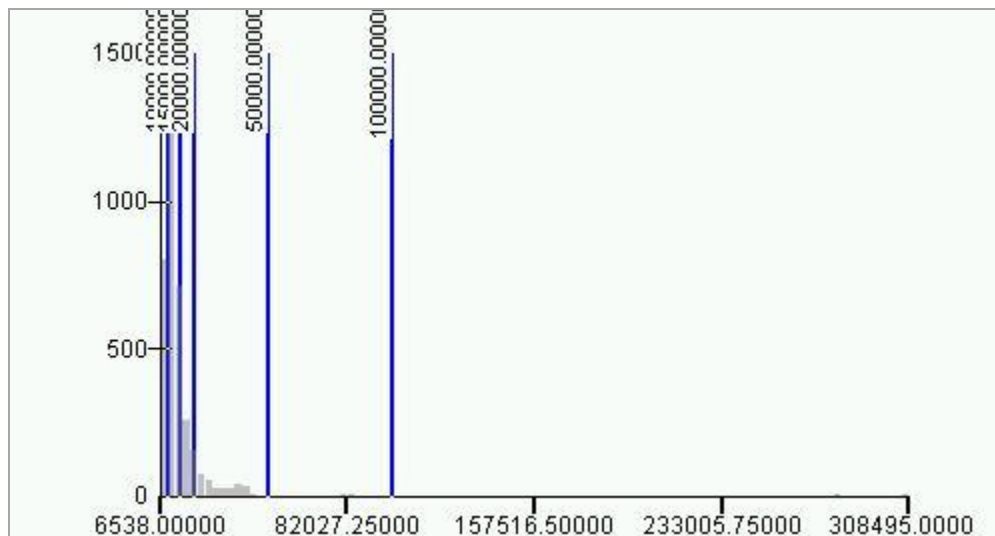
The following chart and statistics were generated by ESRI ArcGIS 9.3.1, and show the general distribution of the site gamma radiation measurements. The horizontal X axis represents the gamma radiation reading levels in cpm (lowest levels to the left). The vertical Y axis represents the frequency of each gamma radiation level.

Count:	3669
Minimum:	6538.00000
Maximum:	308495.00000
Sum:	63967055.00000
Mean:	17434.46579
Median:	11828.00000
Standard Deviation:	29250.56356

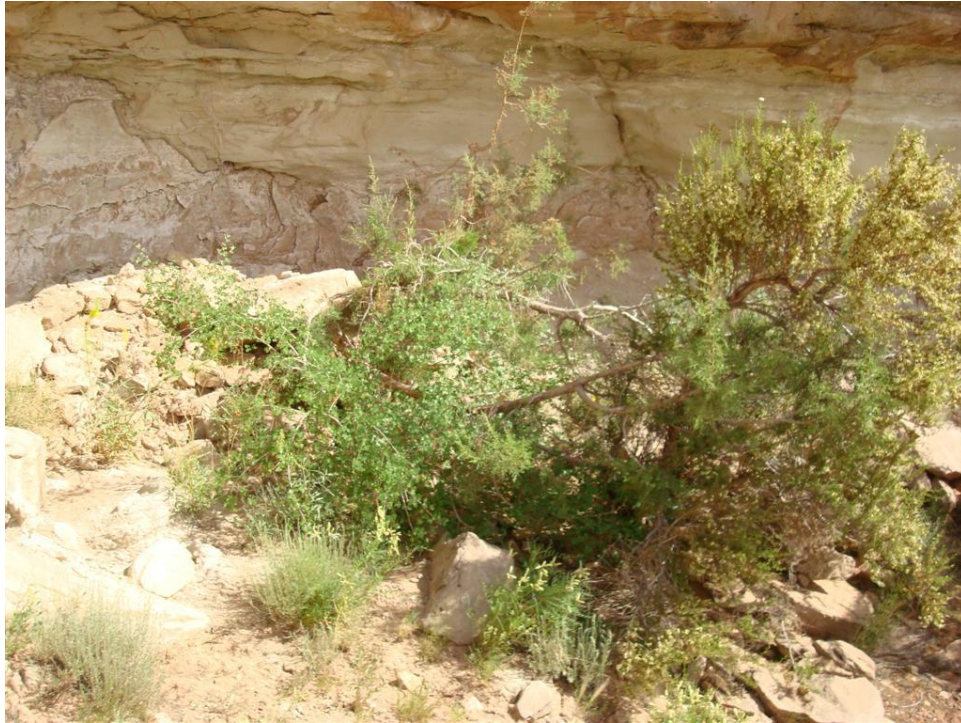
A total of 3,669 gamma radiation measurements were collected from the mine site, ranging from 6,538 cpm to 308,495 cpm. Measurements in the vicinity of the side wall were found at levels of approximately 300,000 cpm. The measurements are represented in Figures 1 and 2.

Photo 1. Carson mine site, wall area

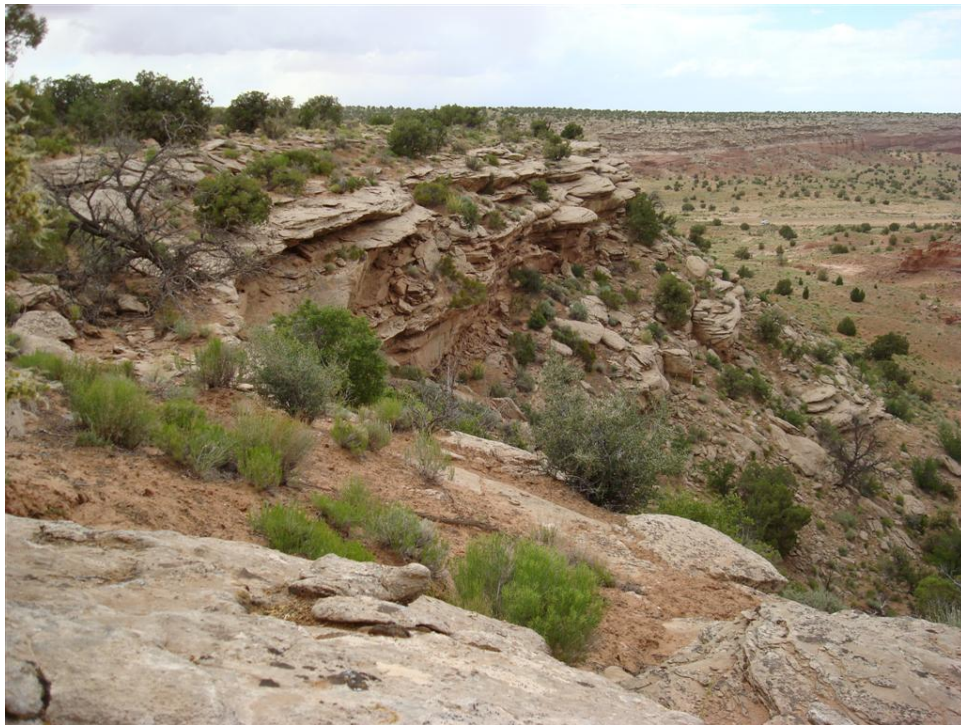
Photo 2. Carson mine site, down-slope area

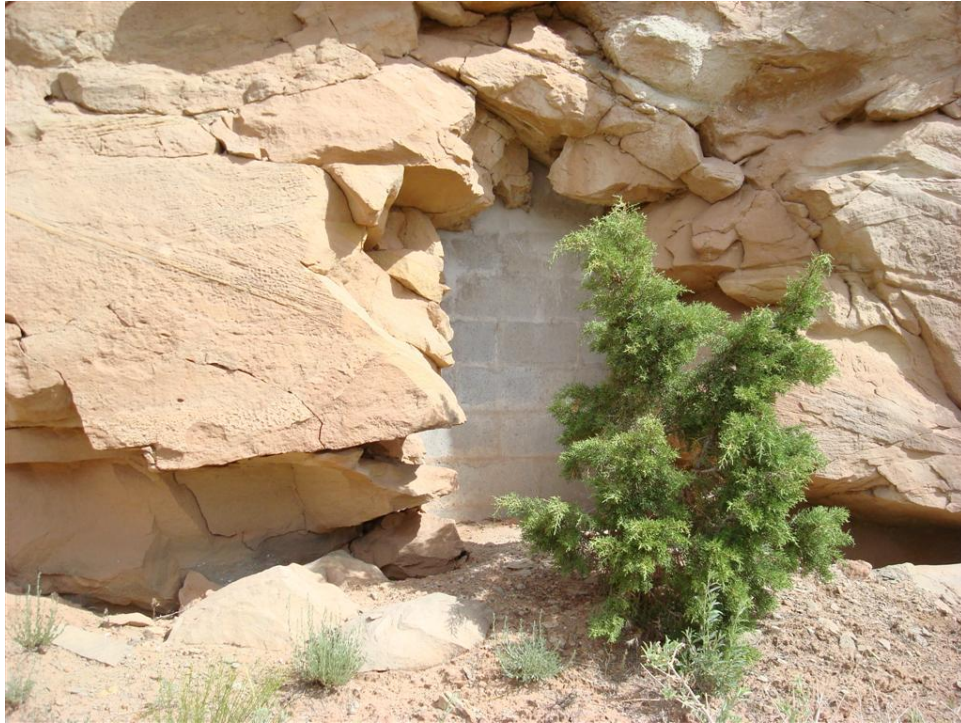
2 adits: adit 1 at base of lowermost resistant layer; adit 2 slightly north (100 ft) of adit 1; both sealed with mortar and concrete

Photo 3. Carson mine site, adit 1

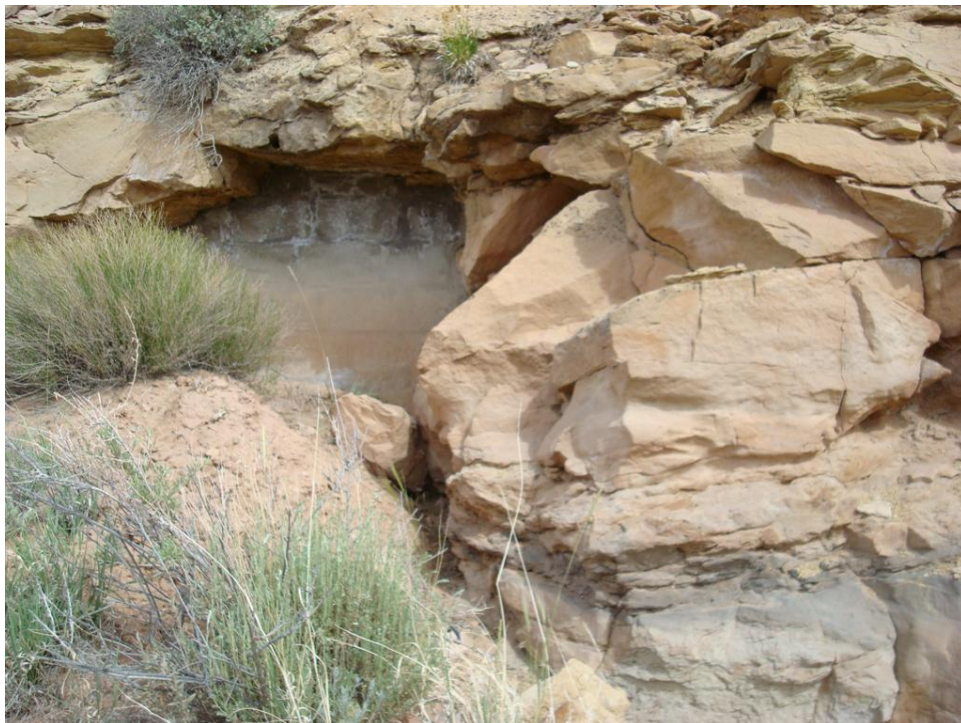
Photo 3. Carson mine site, adit 2

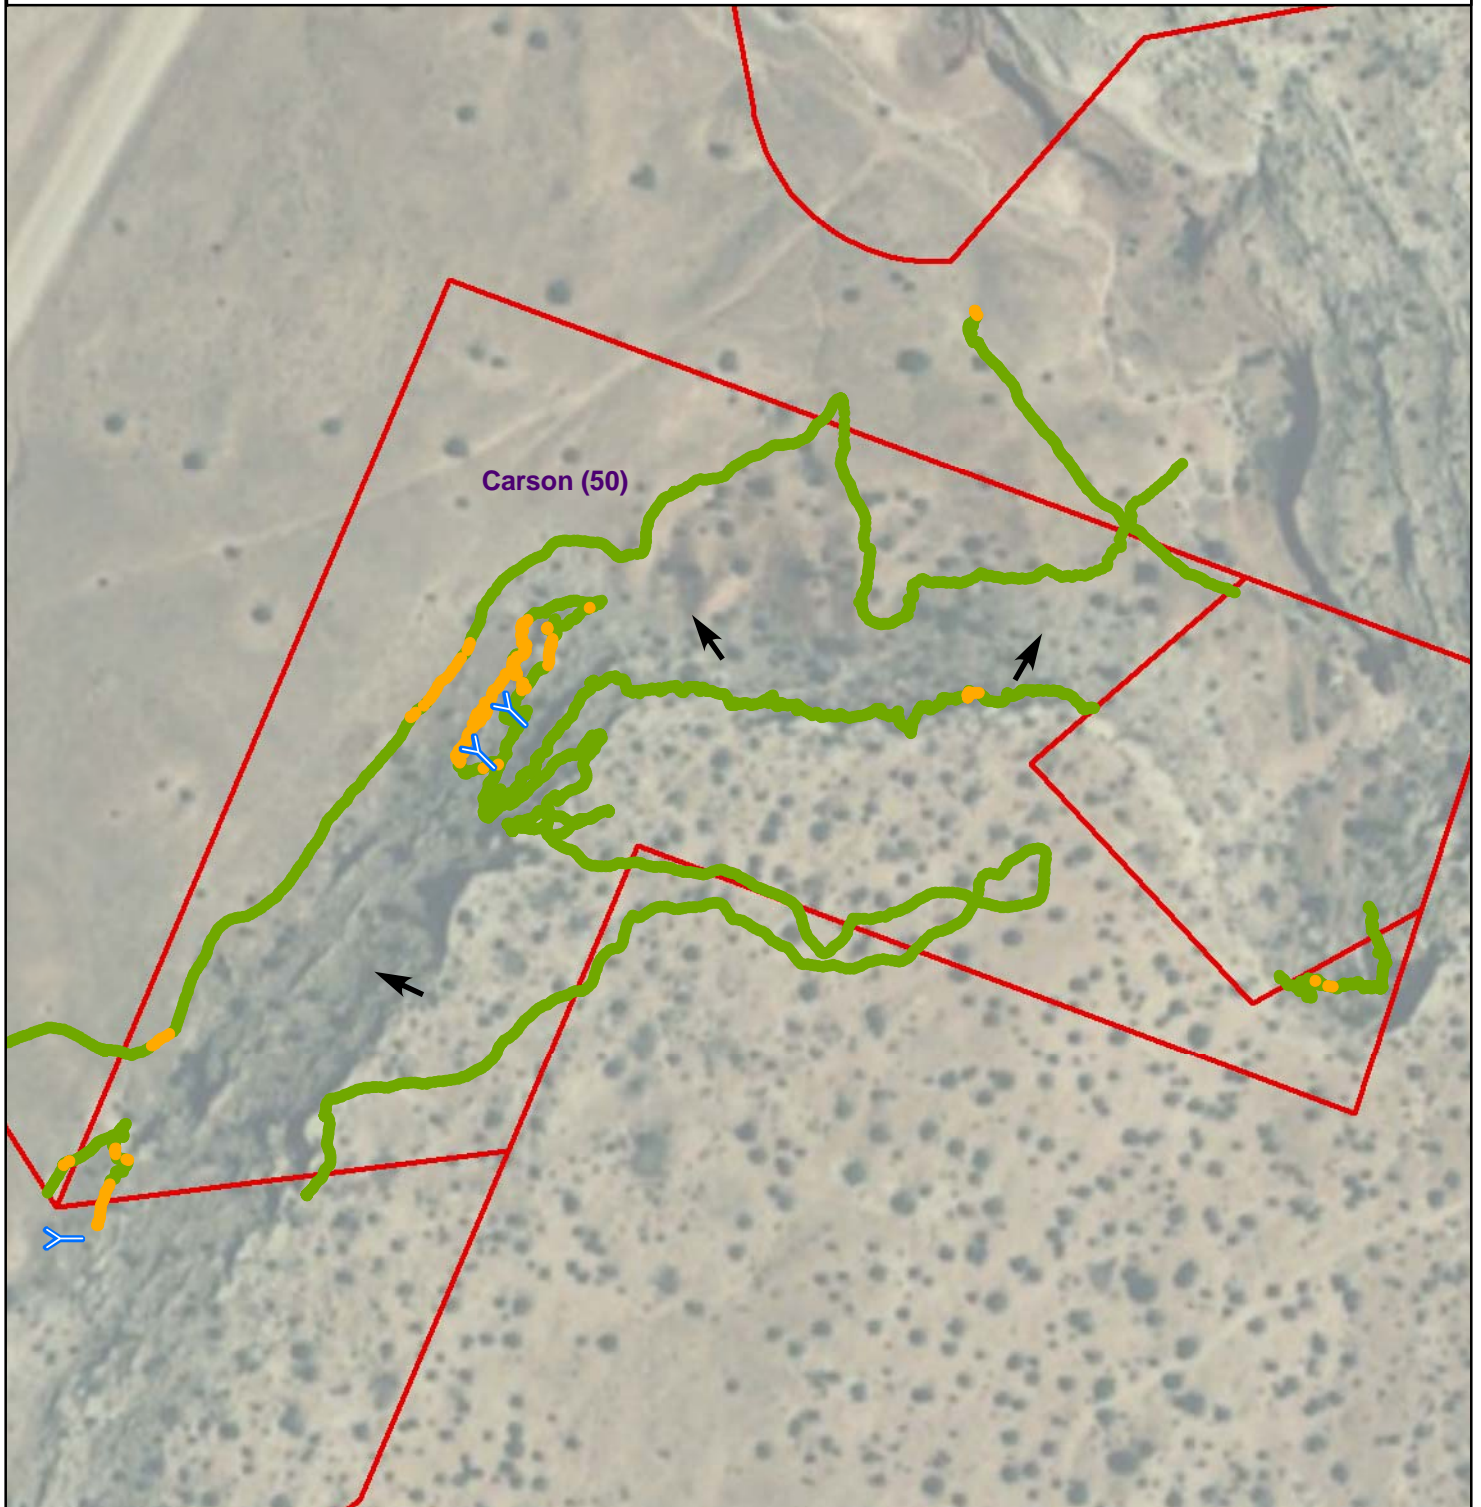
**Figure 1 - Gamma Radiation Measurements, Above Two Times Background  
Carson (50)  
Sweetwater / Teec Nos Pos Chapter, Navajo Nation**

Gamma survey conducted 06/2010  
Measured as counts per minute (cpm)

Average background = 9,634 cpm

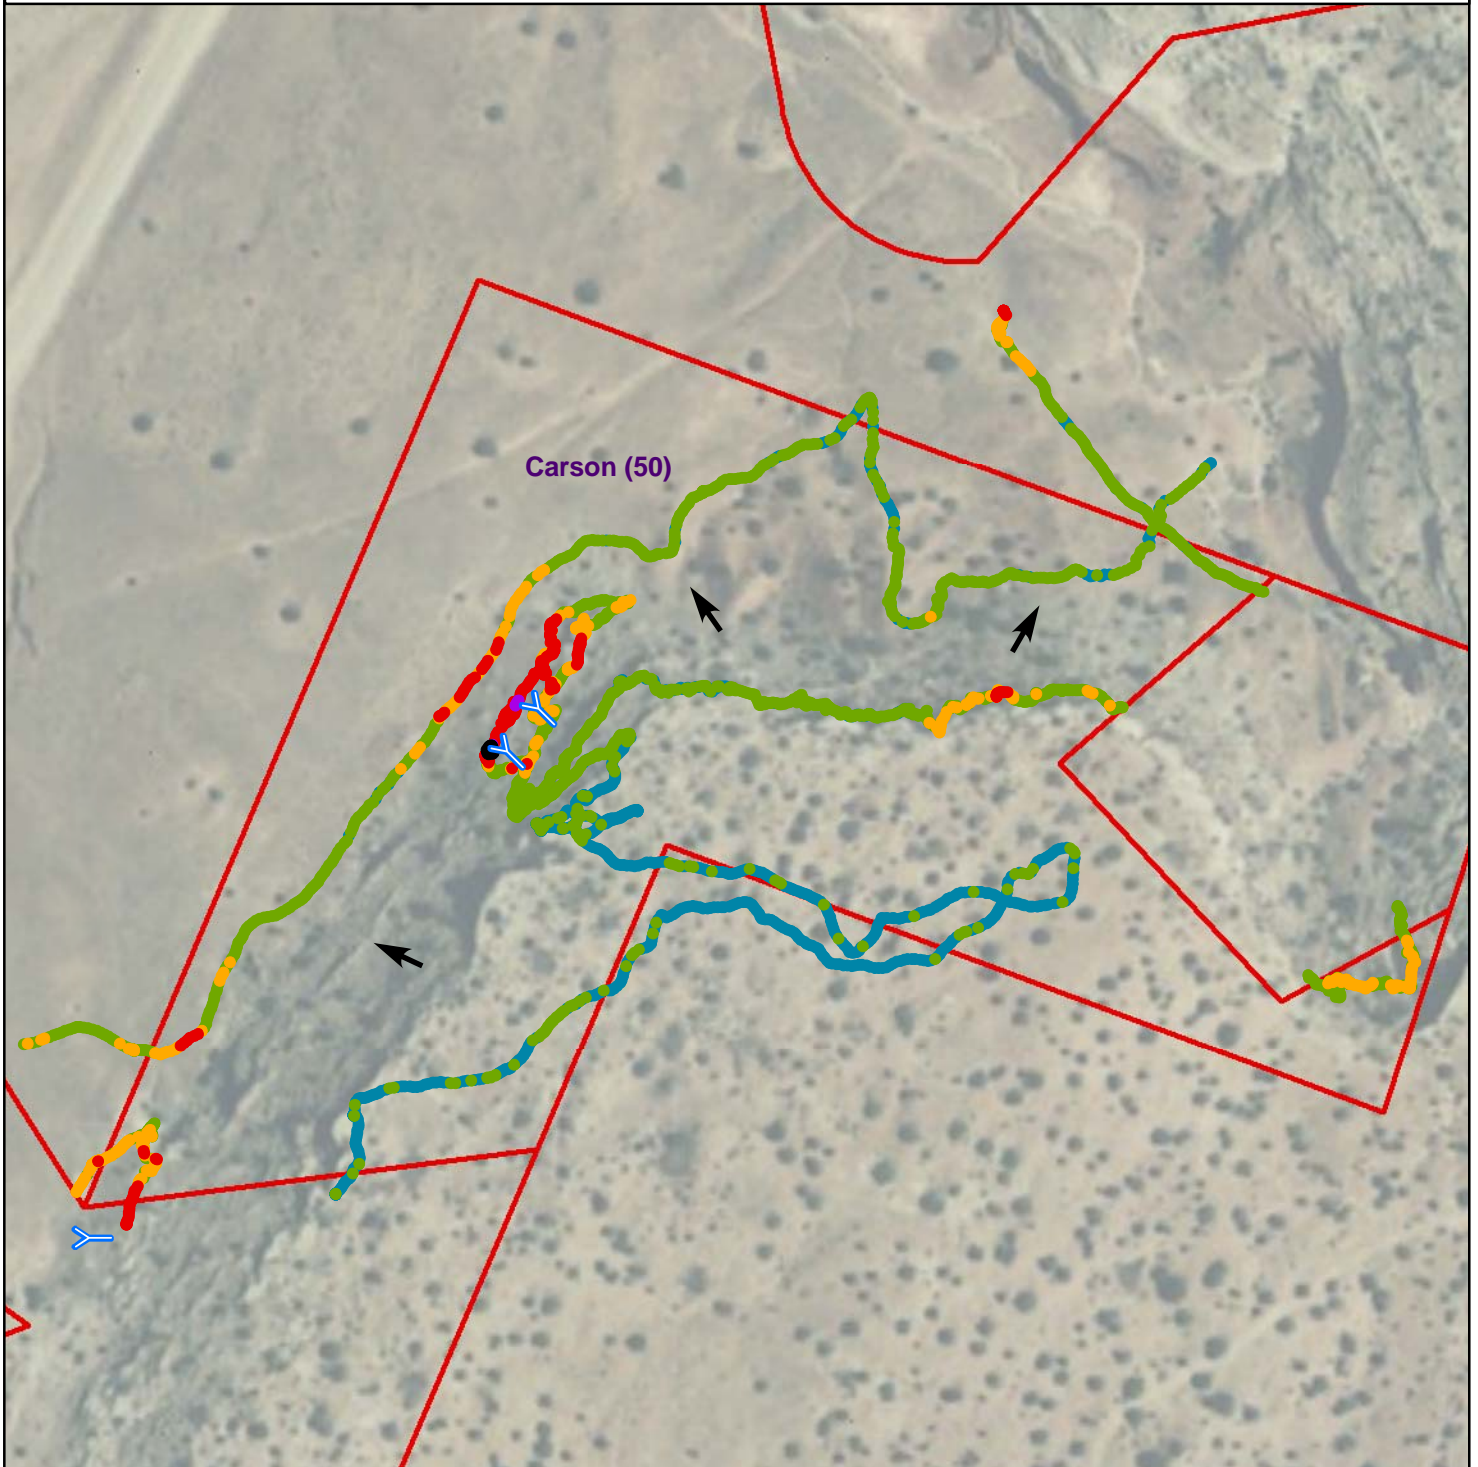
**Figure 2 - Gamma Radiation Measurements  
Carson (50)  
Sweetwater / Teec Nos Pos Chapter, Navajo Nation**

Gamma survey conducted 06/2010  
Measured as counts per minute (cpm)

Average background 9,634 cpm
