# Navajo Abandoned Uranium Mine

## Site Screen Report

### Frank No. 2 AUM Site

**March 2010**

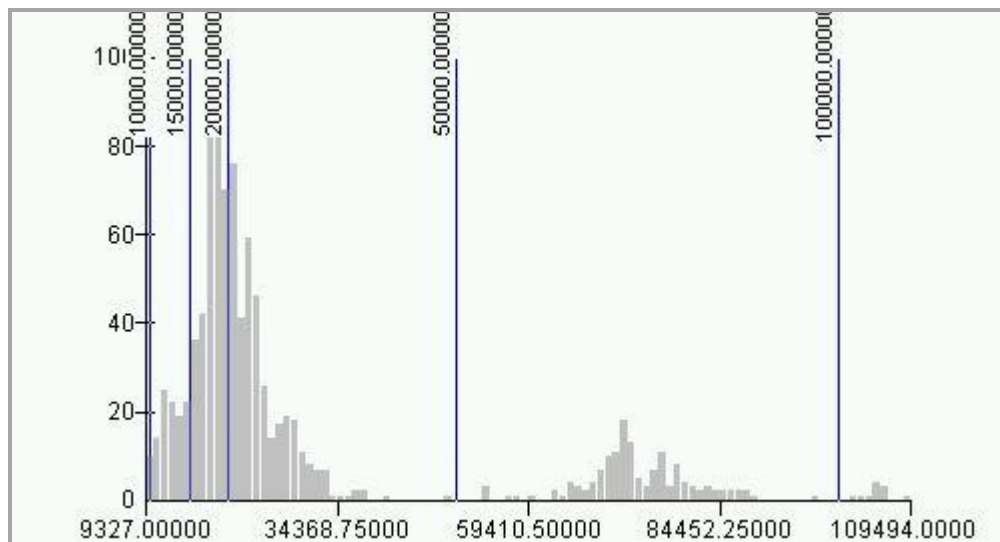
The following chart and statistics were generated by ESRI ArcGIS 9.3.1, and show the general distribution of the site gamma radiation measurements. The horizontal X axis represents the gamma radiation reading levels in cpm (lowest levels to the left). The vertical Y axis represents the frequency of each gamma radiation level.

Count:	943
Minimum:	9327.00000
Maximum:	109494.00000
Sum:	27669883.00000
Mean:	29342.39979
Median:	20882.00000
Standard Deviation:	21452.44076

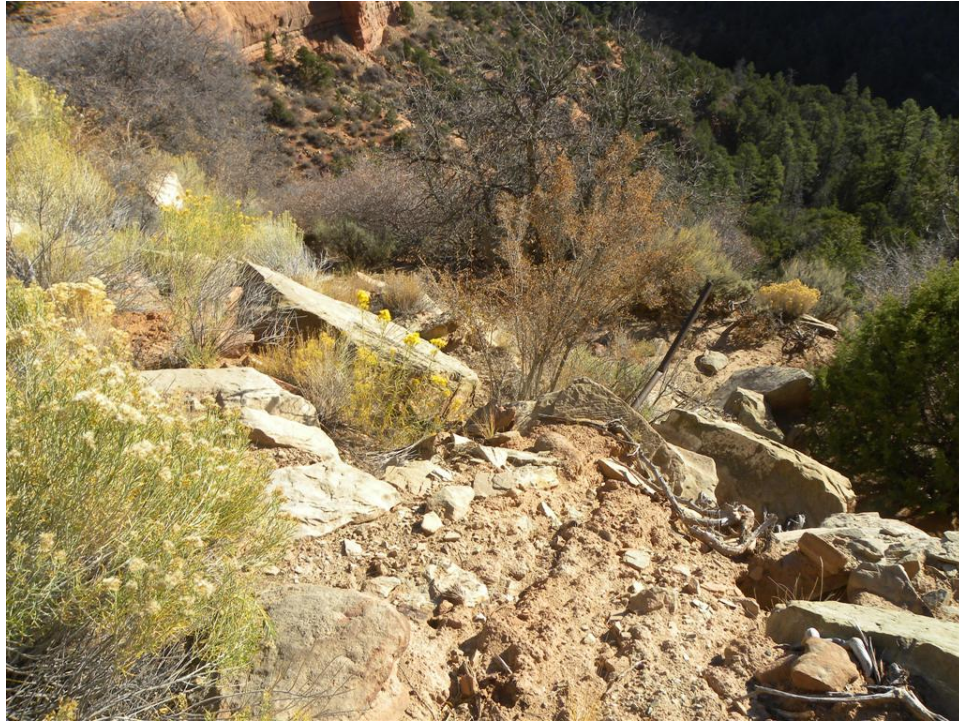
Photo 1. Down slope area

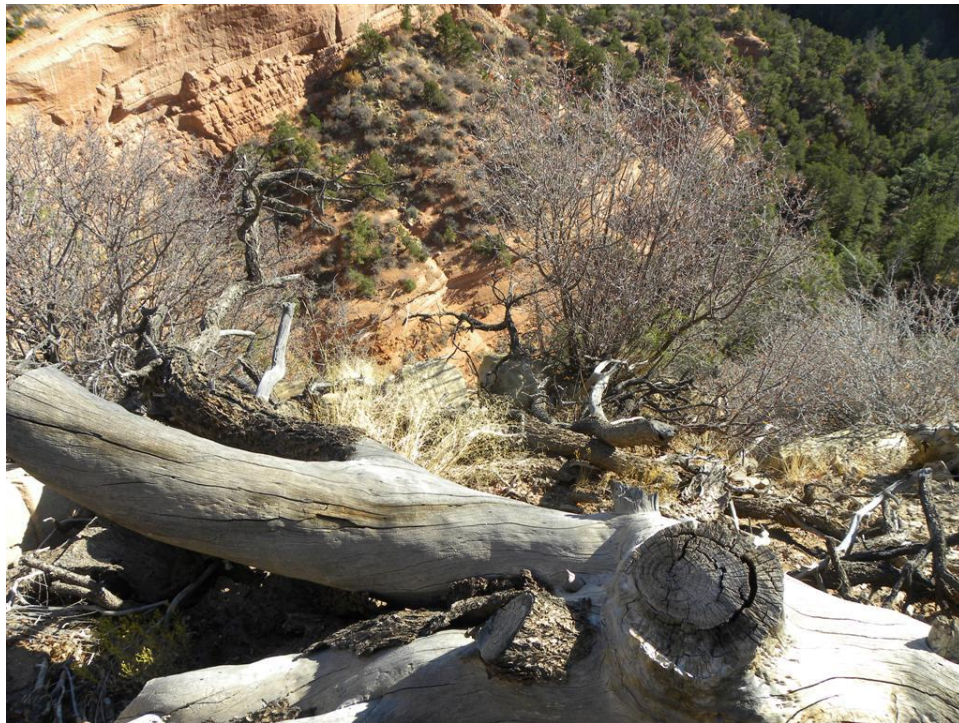
Photo 2. Cliff area

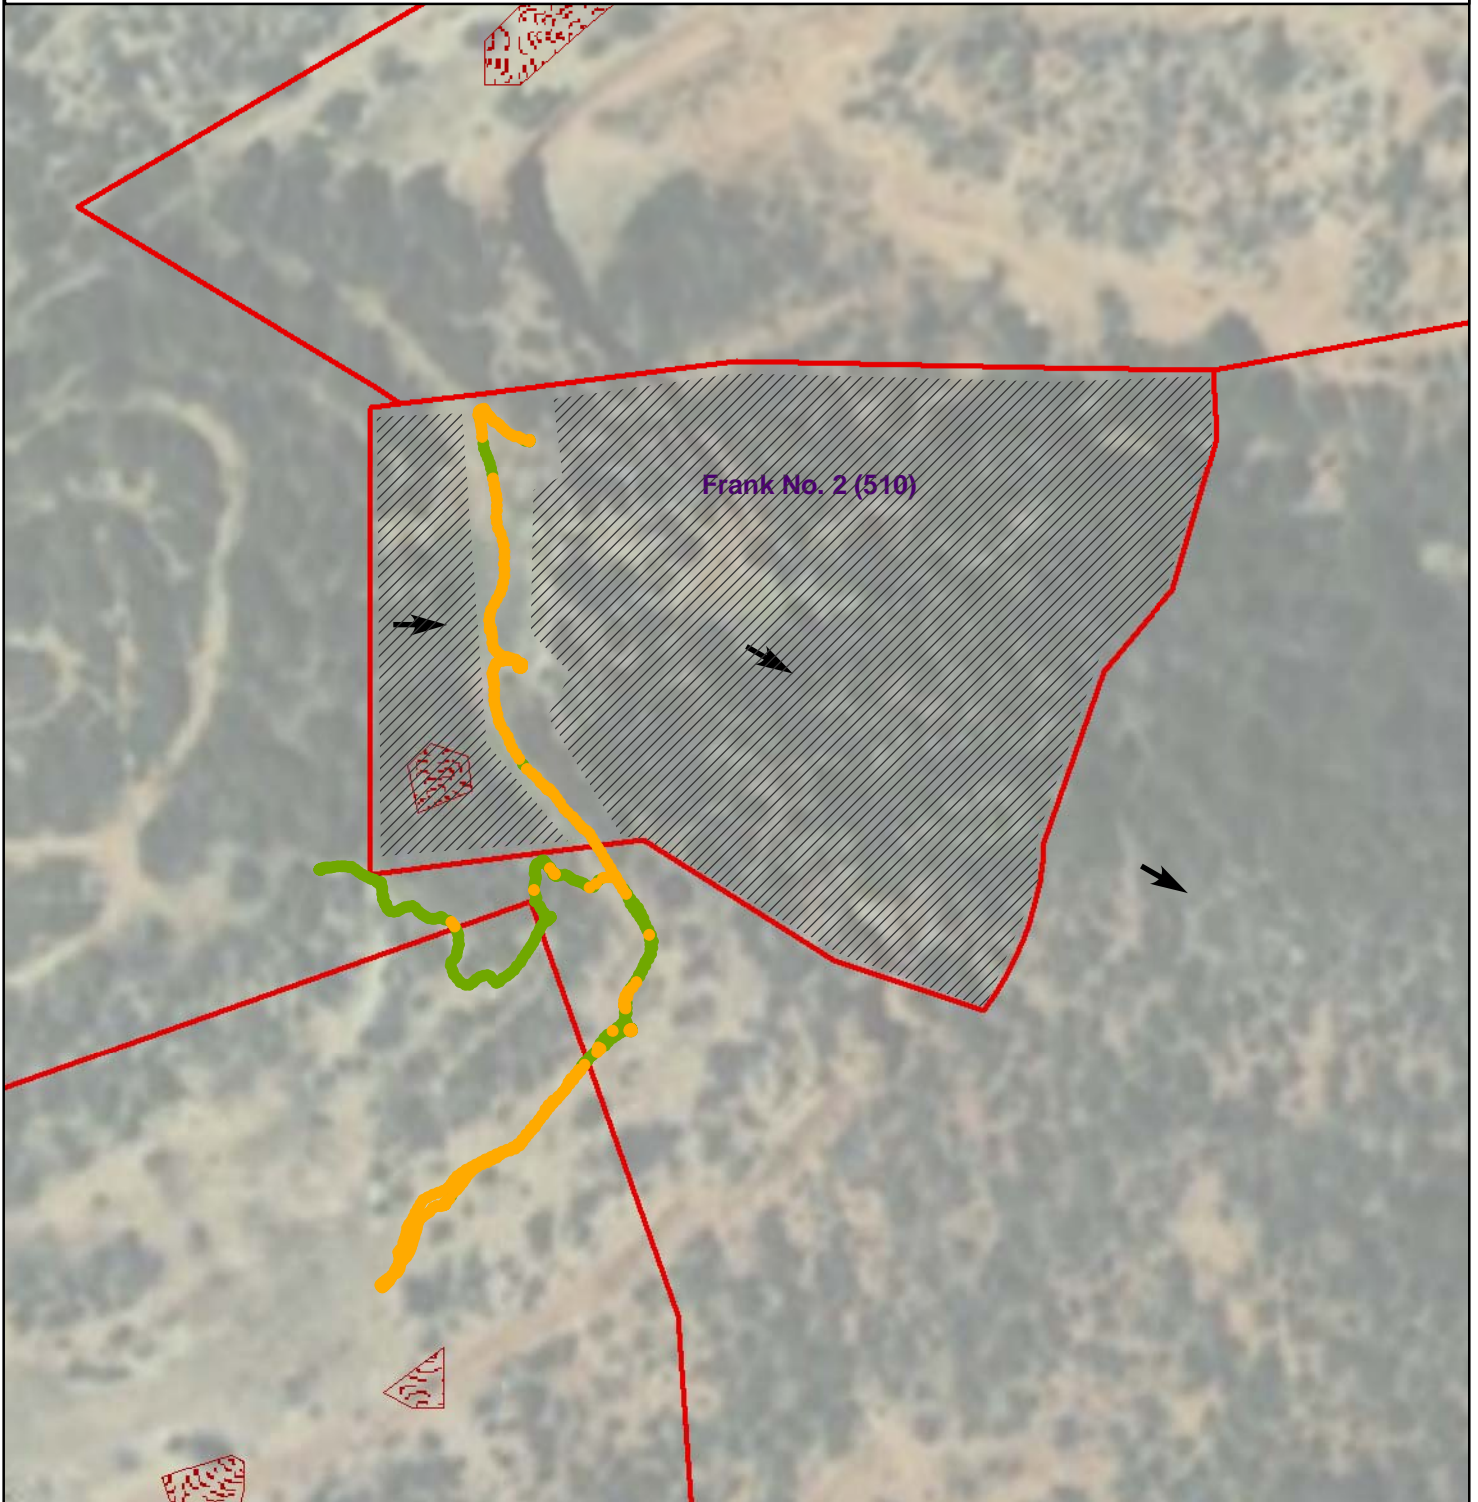
**Figure 1 - Gamma Radiation Measurements, Above Two Times Background  
Frank No. 2 (510)  
Cove Chapter, Navajo Nation, Arizona**

A total of 943 gamma radiation measurements were collected from the mine site, ranging from 9,327 cpm to 109,494 cpm. Measurements in the vicinity of the waste debris were found at levels ranging from 80,000 – 100,000 cpm. The measurements are represented in Figures 1 and 2.

Gamma survey conducted 10/2009  
Measured as counts per minute (cpm)

Average background = 9,717 cpm

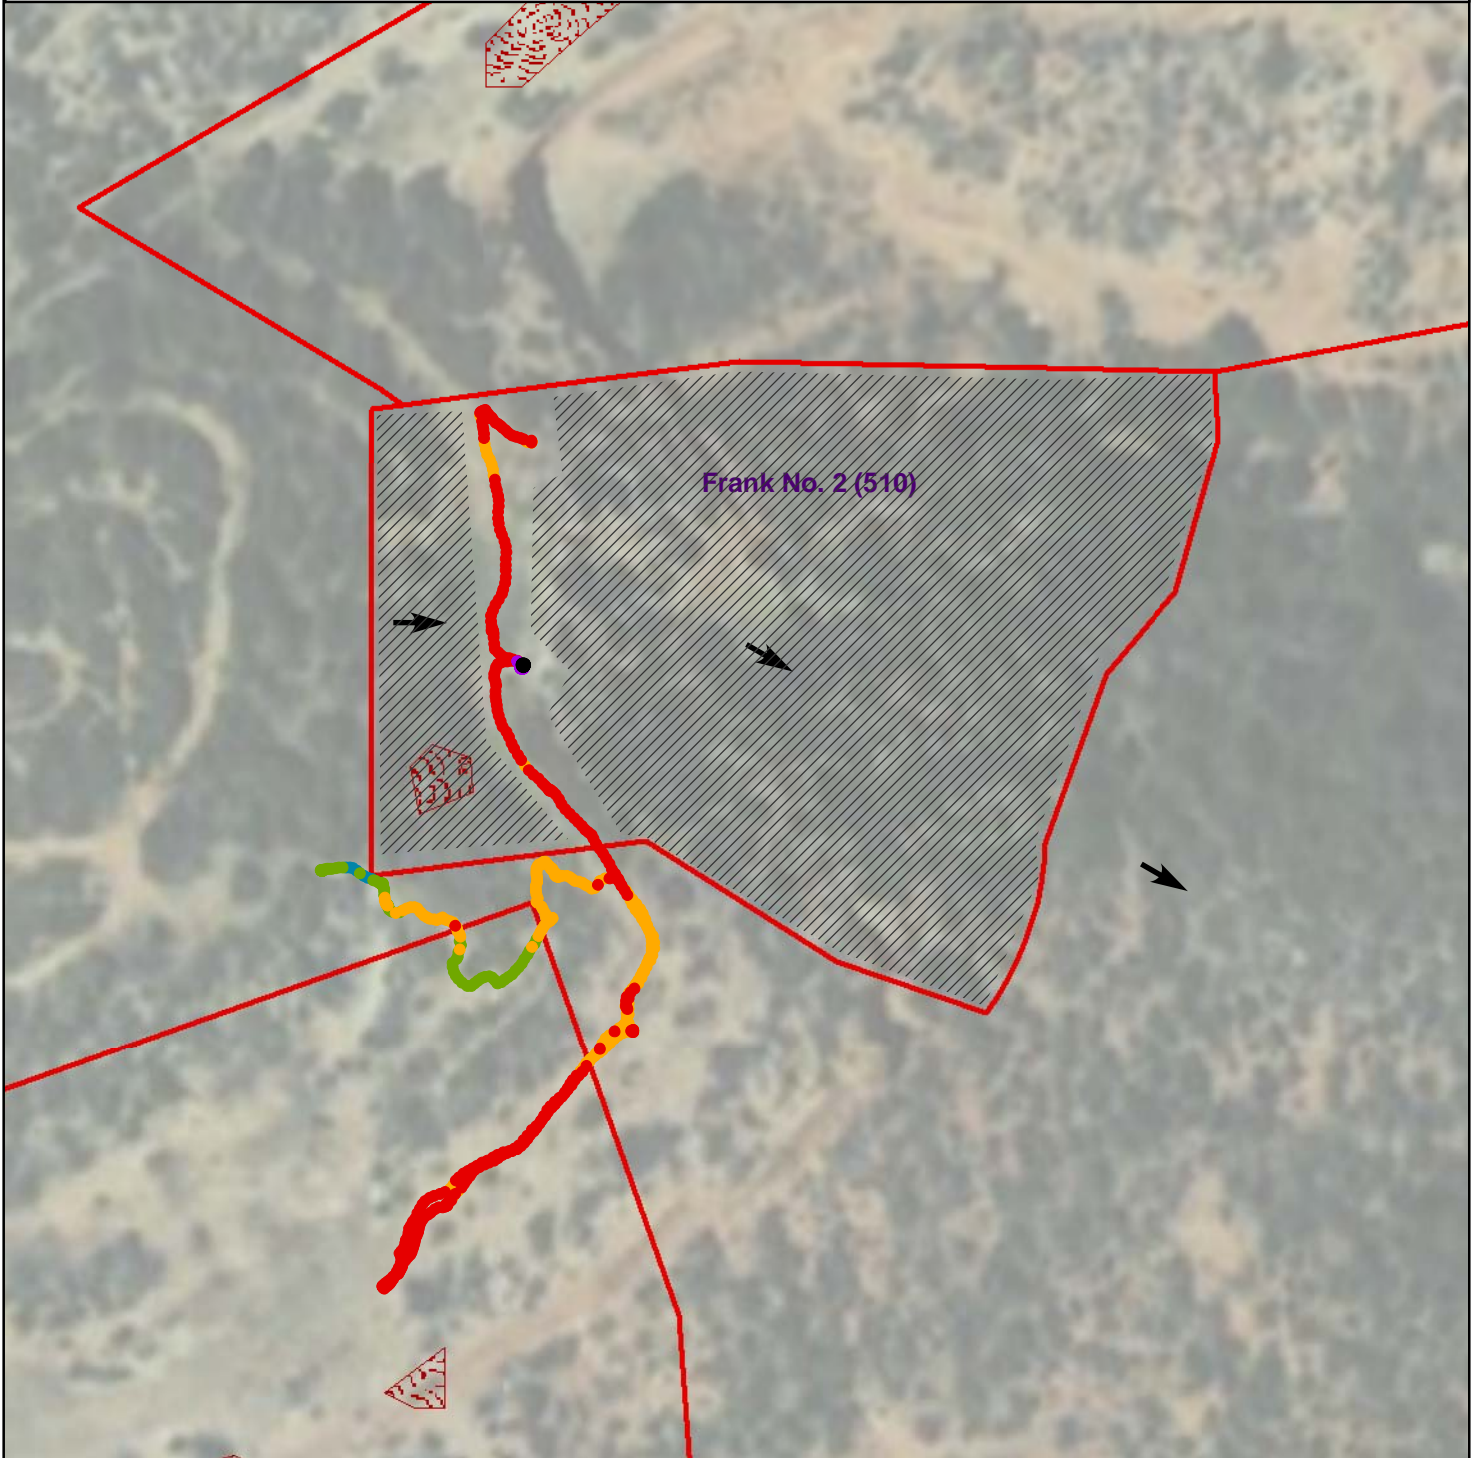
**Figure 2 - Gamma Radiation Measurements  
Frank No. 2 (510)  
Cove Chapter, Navajo Nation, Arizona**

**Gamma survey conducted 10/2009  
Measured as counts per minute (cpm)**

**Average background = 9,717 cpm**
