Navajo Abandoned Uranium Mine

Site Screen Report

Mine Name: Firelight No. 6
Mine ID: 513

Weston Solutions, Inc.

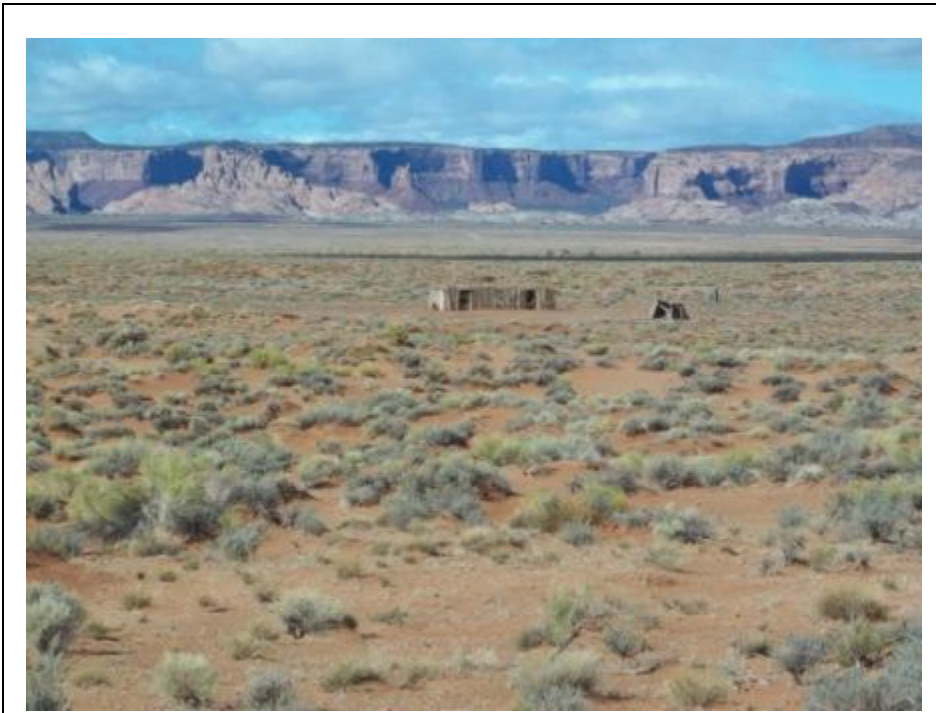
200 feet to 0.25 mile: 750 ft NW - Hogan and long wooden shed

Photo 2	Mine Site #513 - Structures
----------------	-----------------------------
