Navajo Abandoned Uranium Mine

Site Screen Report

Mine Name: Big Four No. 2
Mine ID: 519

April 2012

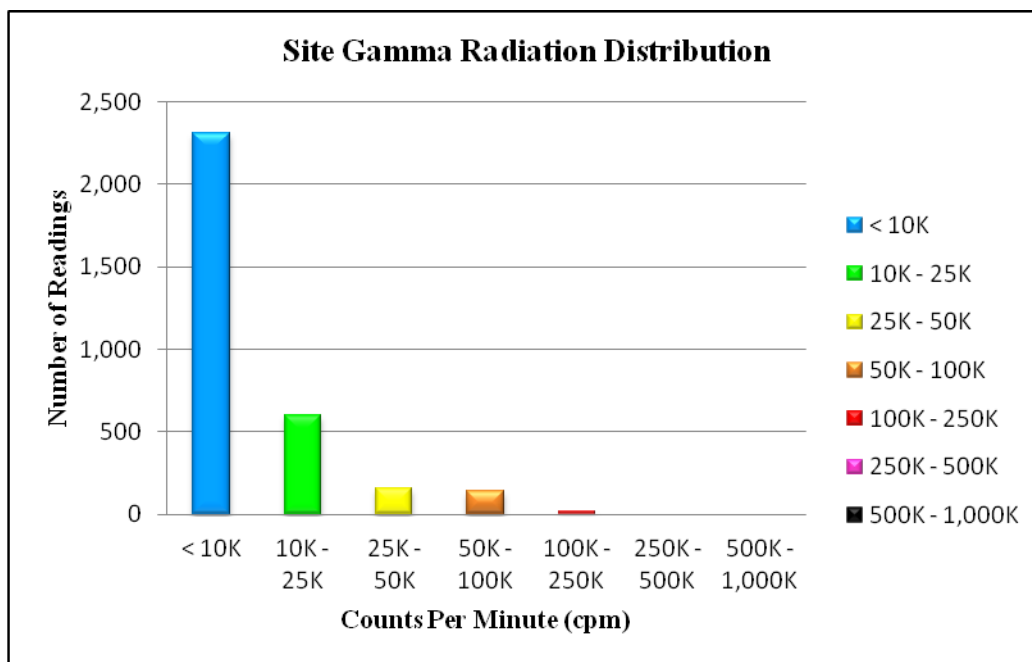
Distribution Chart and Statistics:

Site Gamma Radiation Statistics	
Number of Readings	3,228
Minimum (cpm)	5,386
Maximum (cpm)	150,653
Mean (cpm)	13,901
Median (cpm)	8,581
Standard Deviation	16,487

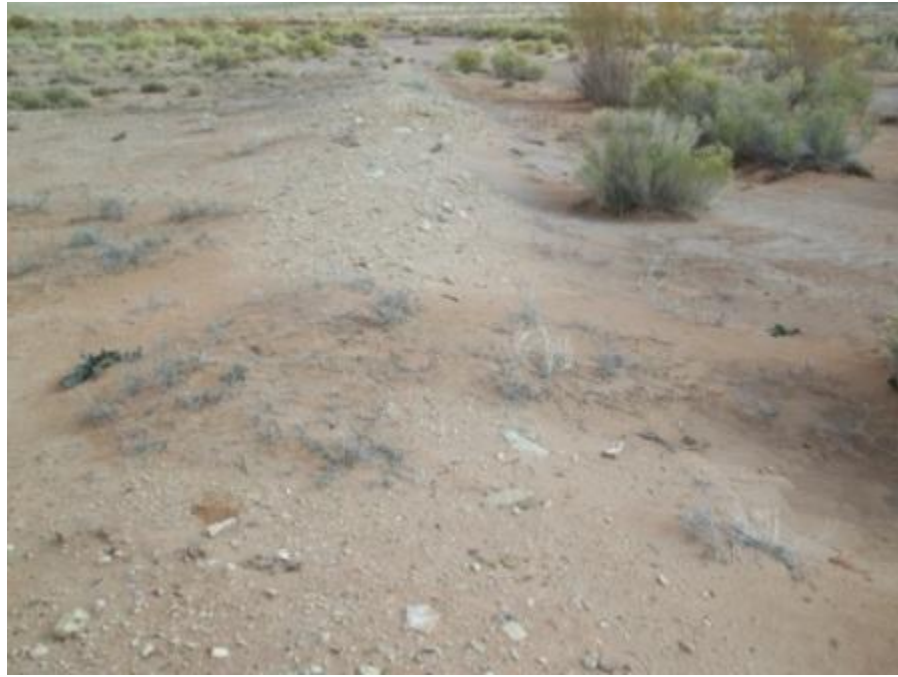
Photo 1

Standpipe in the northern part of the site; berm along the wash that has been cut by a meander

Mine Site #519 – Bermed area

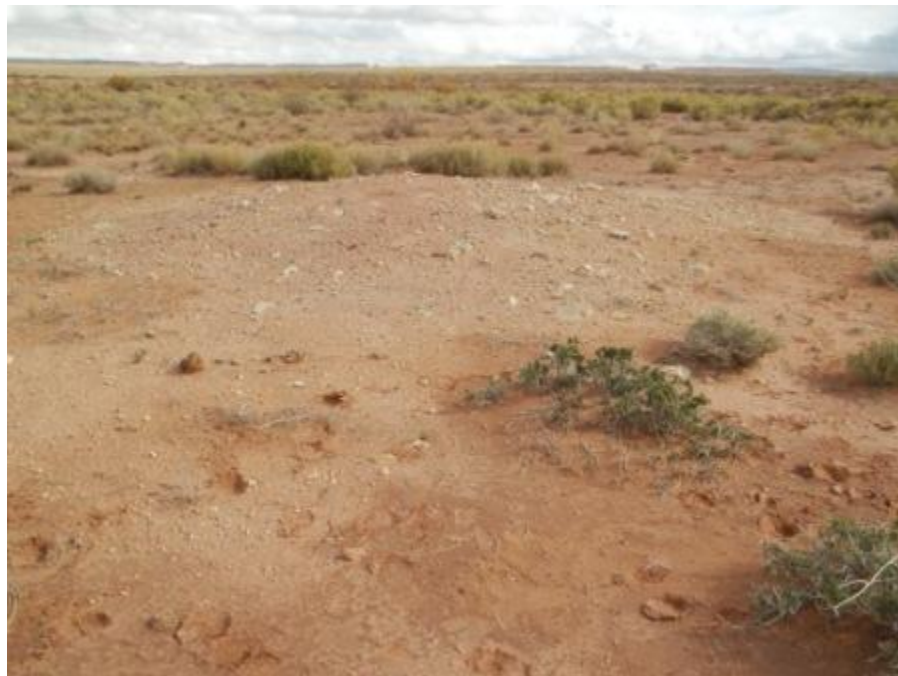
Photo 4

A total of 3,228 gamma radiation measurements were collected from the mine site, ranging from 5,386 cpm to 150,653 cpm. Maximum levels of approximately 150,000 cpm were found in the vicinity of the waste rock. The measurements are represented in Figures 1 and 2.

2 waste piles, each approximately 50' x 20'

Mine Site #519 – Waste rock

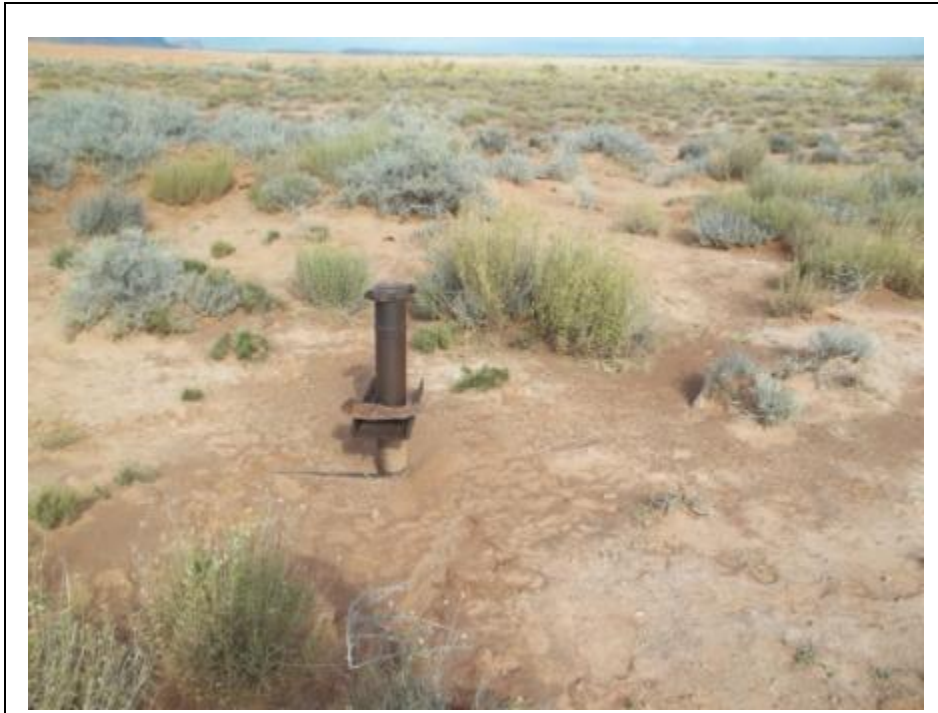
Photo 5

0 to 0.25 miles: Onsite - Well (519)

Mine Site #519 - Well

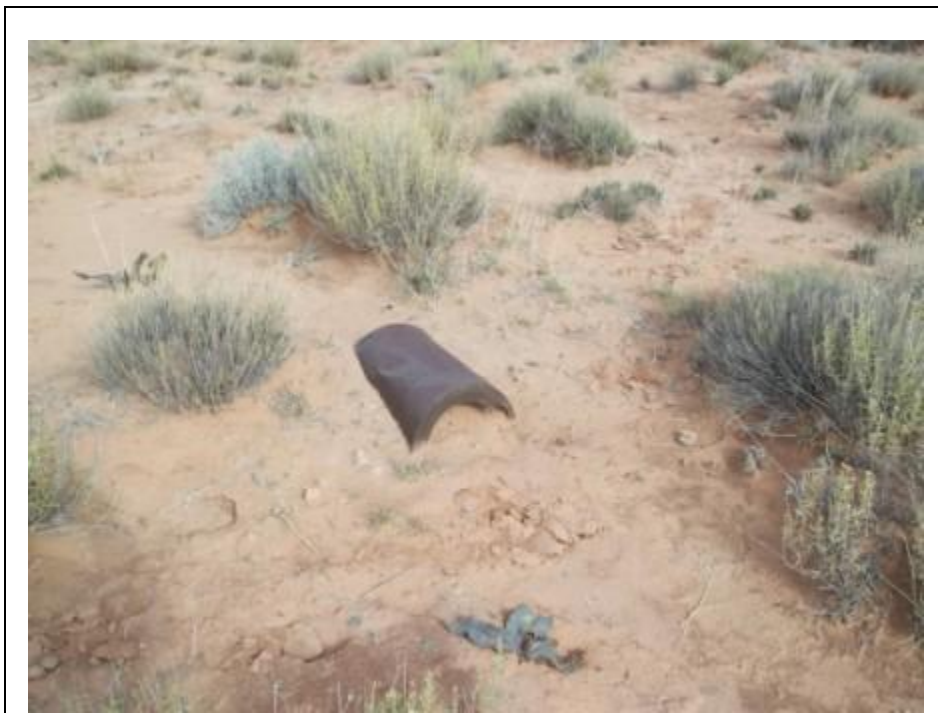
Photo 6

Mine Site #519 – Mining debris

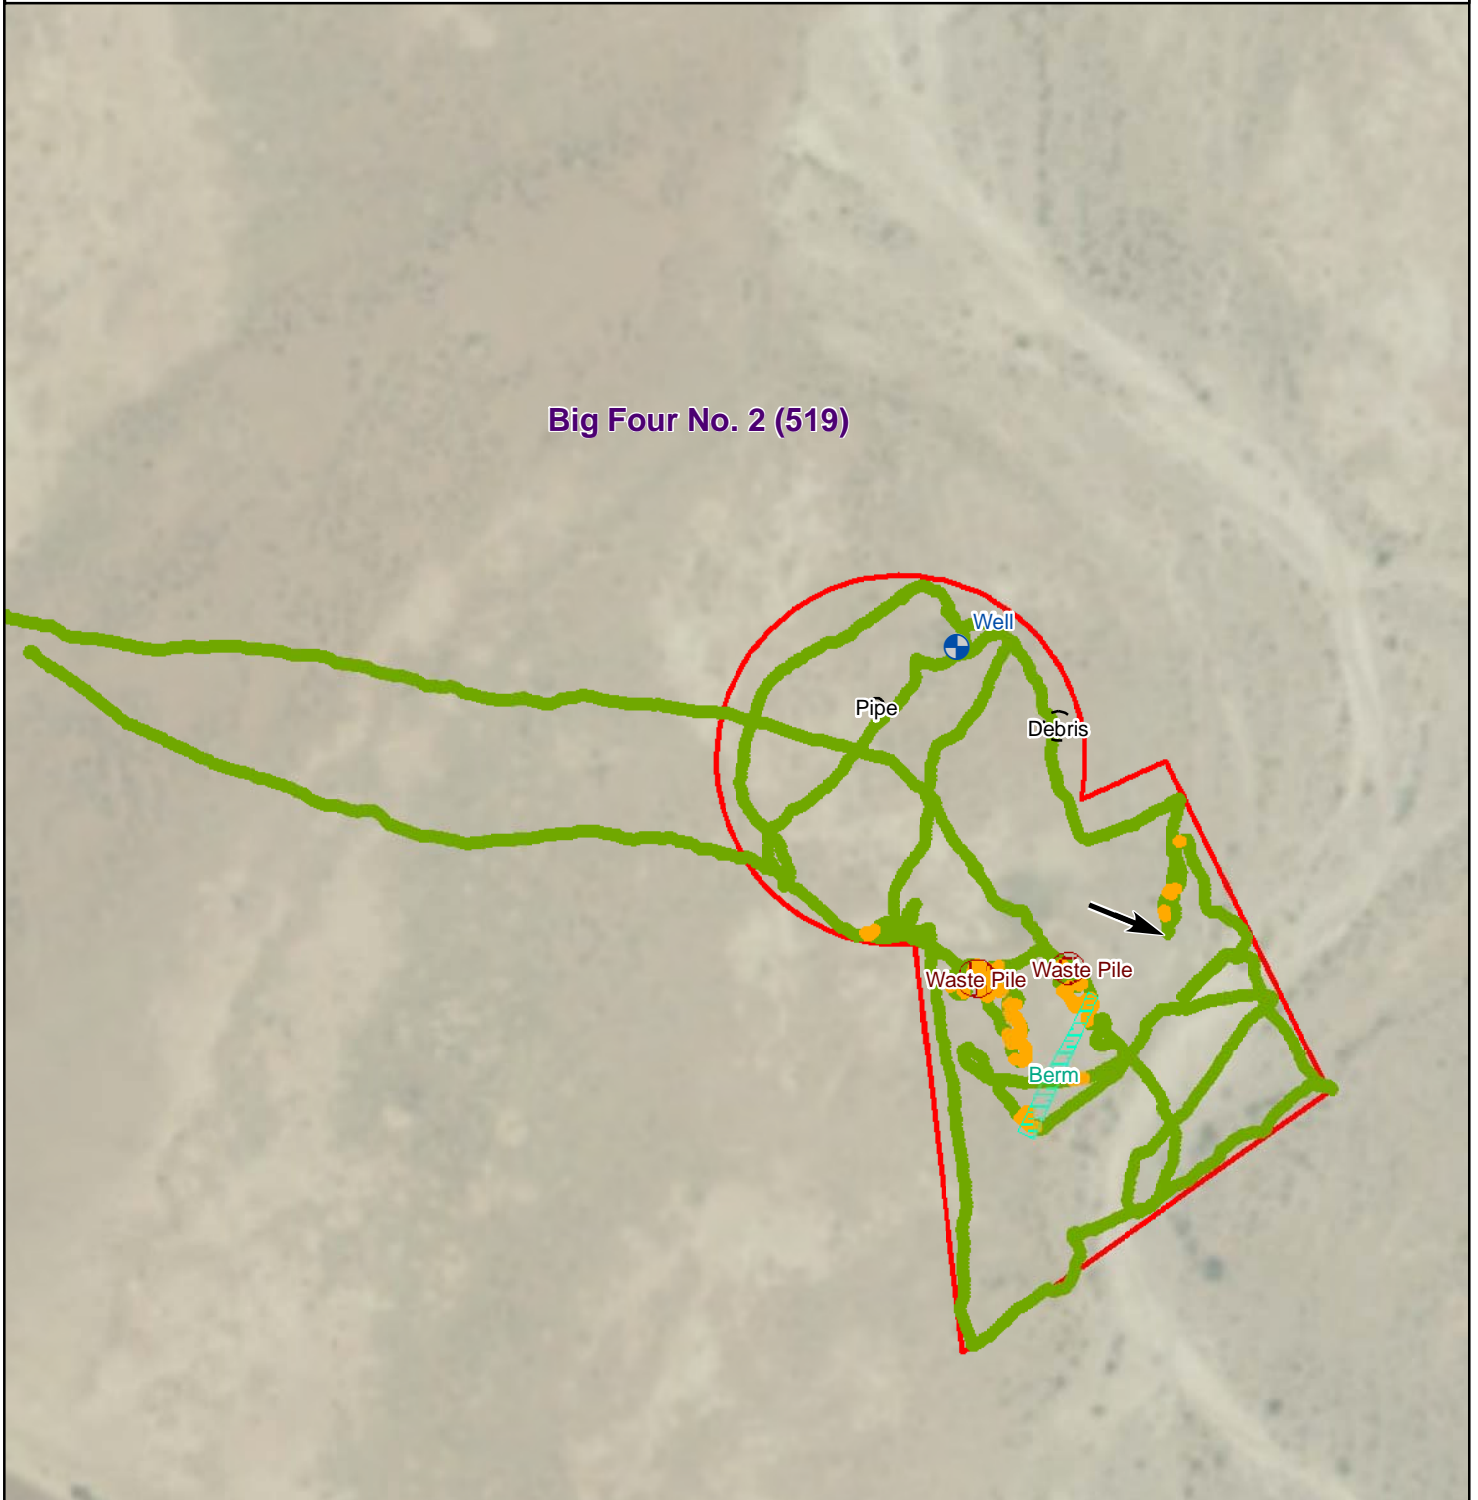
**Figure 1 - Gamma Radiation Measurements, Above Two Times Background
Big Four No. 2 (519)
Oljato Chapter, Navajo Nation**

Measured as counts per minute (cpm)

Average background 6,902 cpm

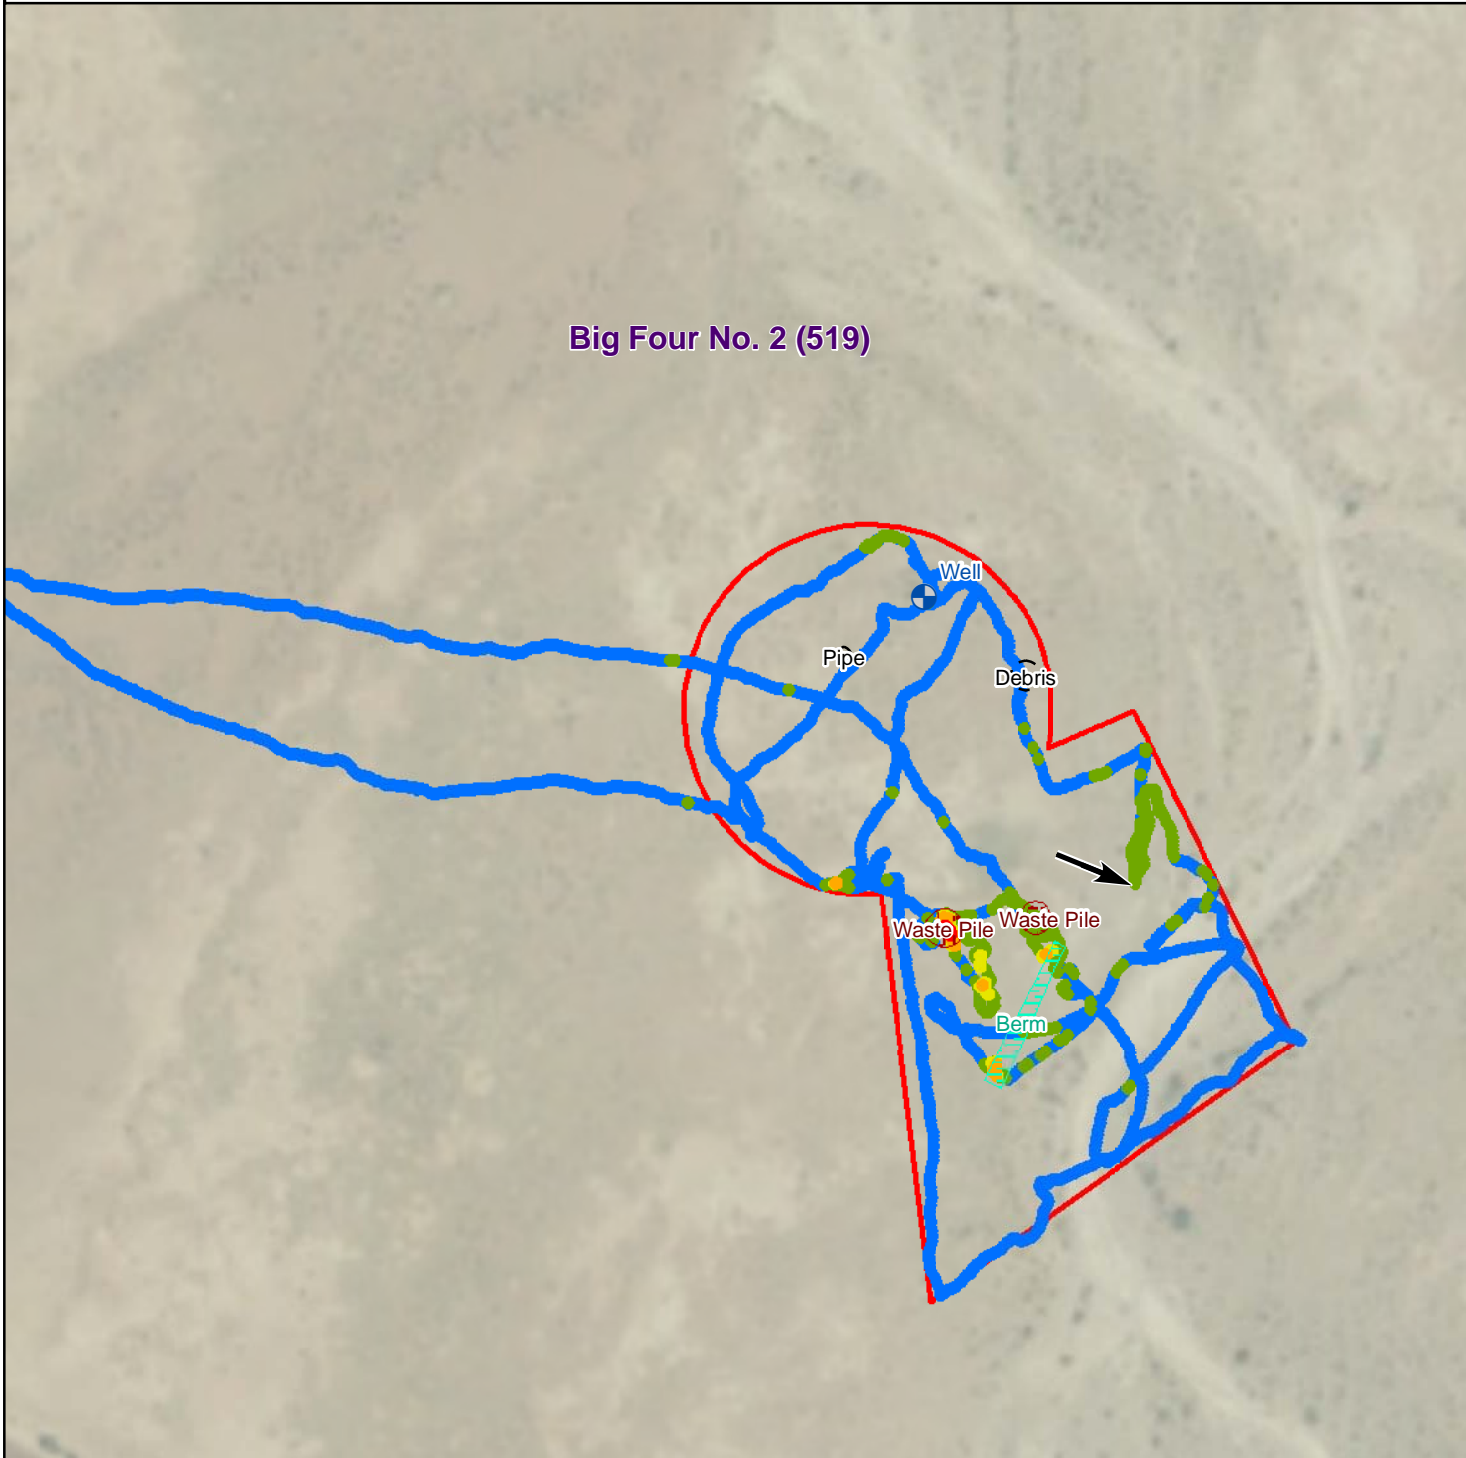
**Figure 2 - Gamma Radiation Measurements
Big Four No. 2 (519)
Ojato Chapter, Navajo Nation**

- 0 - 10,000 cpm
- 10,000 - 25,000 cpm
- 25,000 - 50,000 cpm
- 50,000 - 100,000 cpm
- 100,000 - 250,000 cpm
- 250,000 - 500,000 cpm
- 500,000 - 1,000,000 cpm

Average background 6,902 cpm
