# Navajo Abandoned Uranium Mine

## Site Screen Report

**Mine Name: June**

**Mine ID: 534**

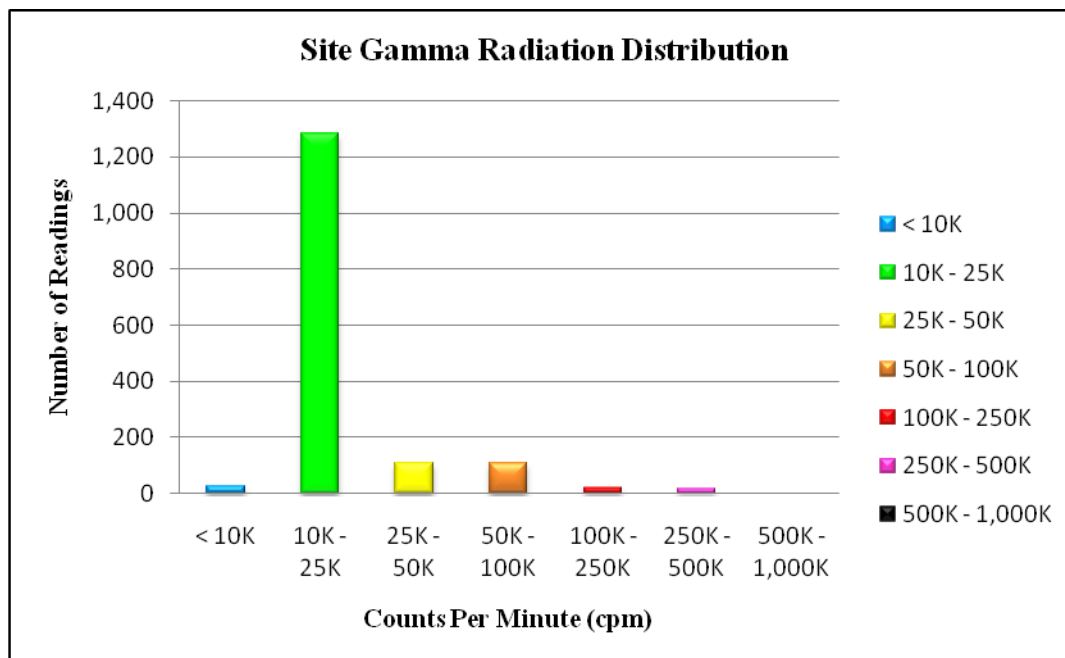
**Distribution Chart and Statistics:**

<b>Site Gamma Radiation Statistics</b>	
Number of Readings	1,567
Minimum (cpm)	8,512
Maximum (cpm)	330,435
Mean (cpm)	24,440
Median (cpm)	15,271
Standard Deviation	35,743

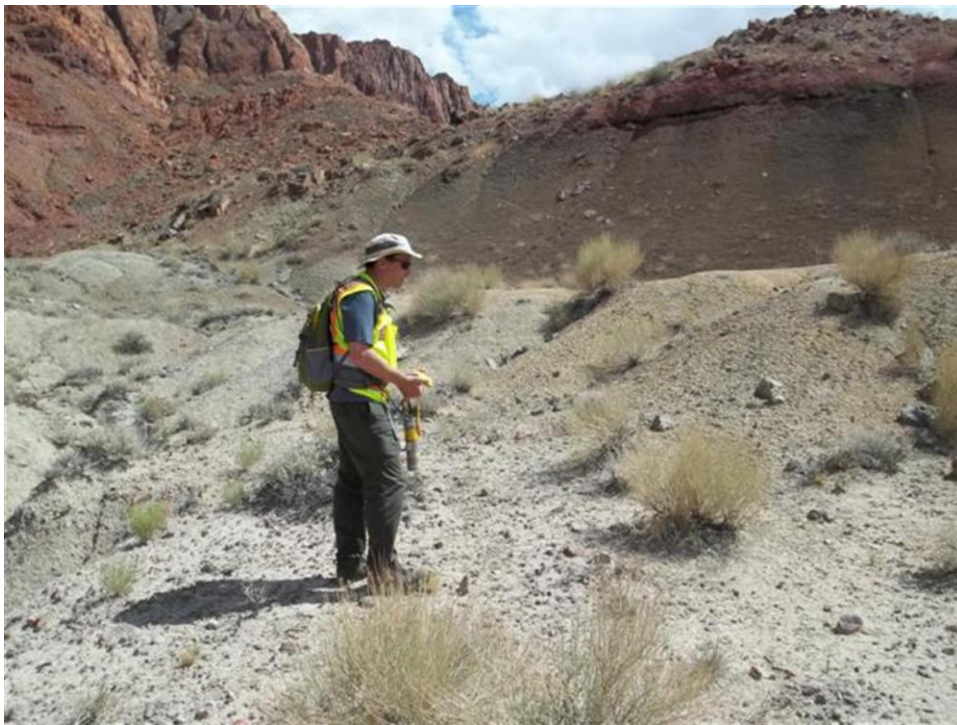
**Photo 2:** Mine Site #534; Elevated readings

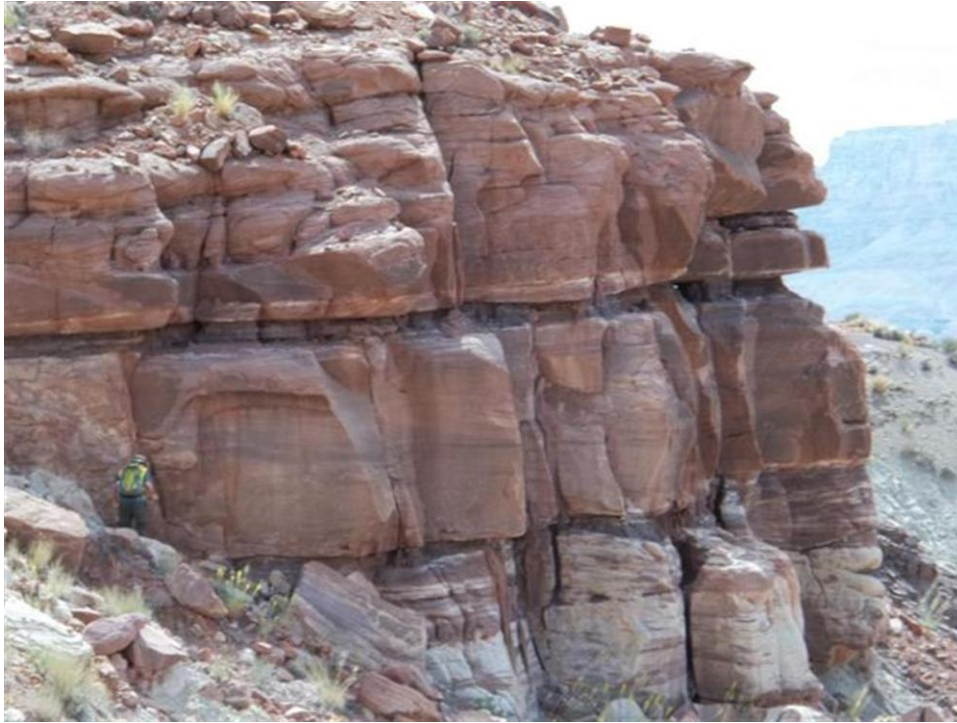
**Photo 3:** Mine Site #534; Cliff area

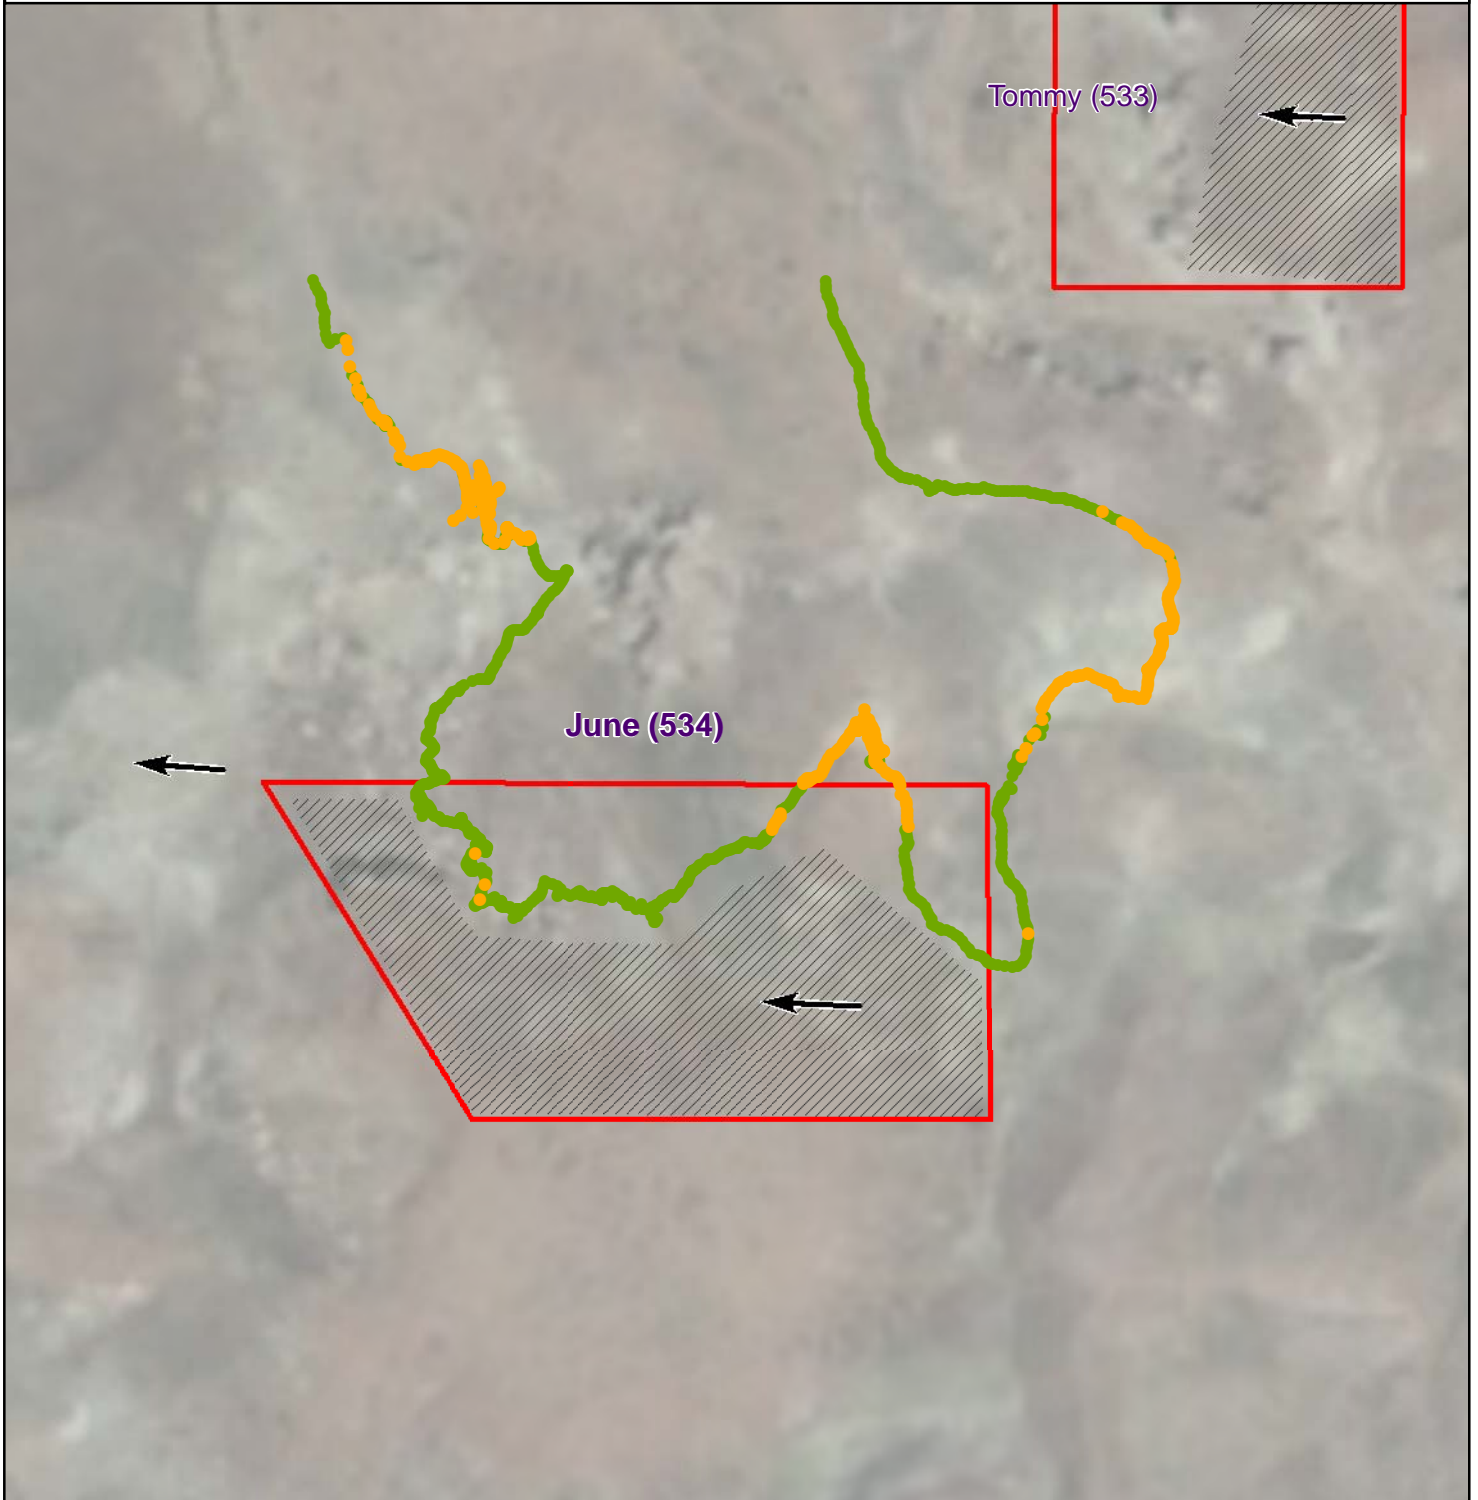
**Figure 1 - Gamma Radiation Measurements, Above Two Times Background  
June (534)  
Bodaway / Gap Chapter, Navajo Nation**

Average background 8,979 cpm

A total of 1,567 gamma radiation measurements were collected from the mine site, ranging from 8,512 cpm to 330,435 cpm. The measurements are represented in Figures 1 and 2.

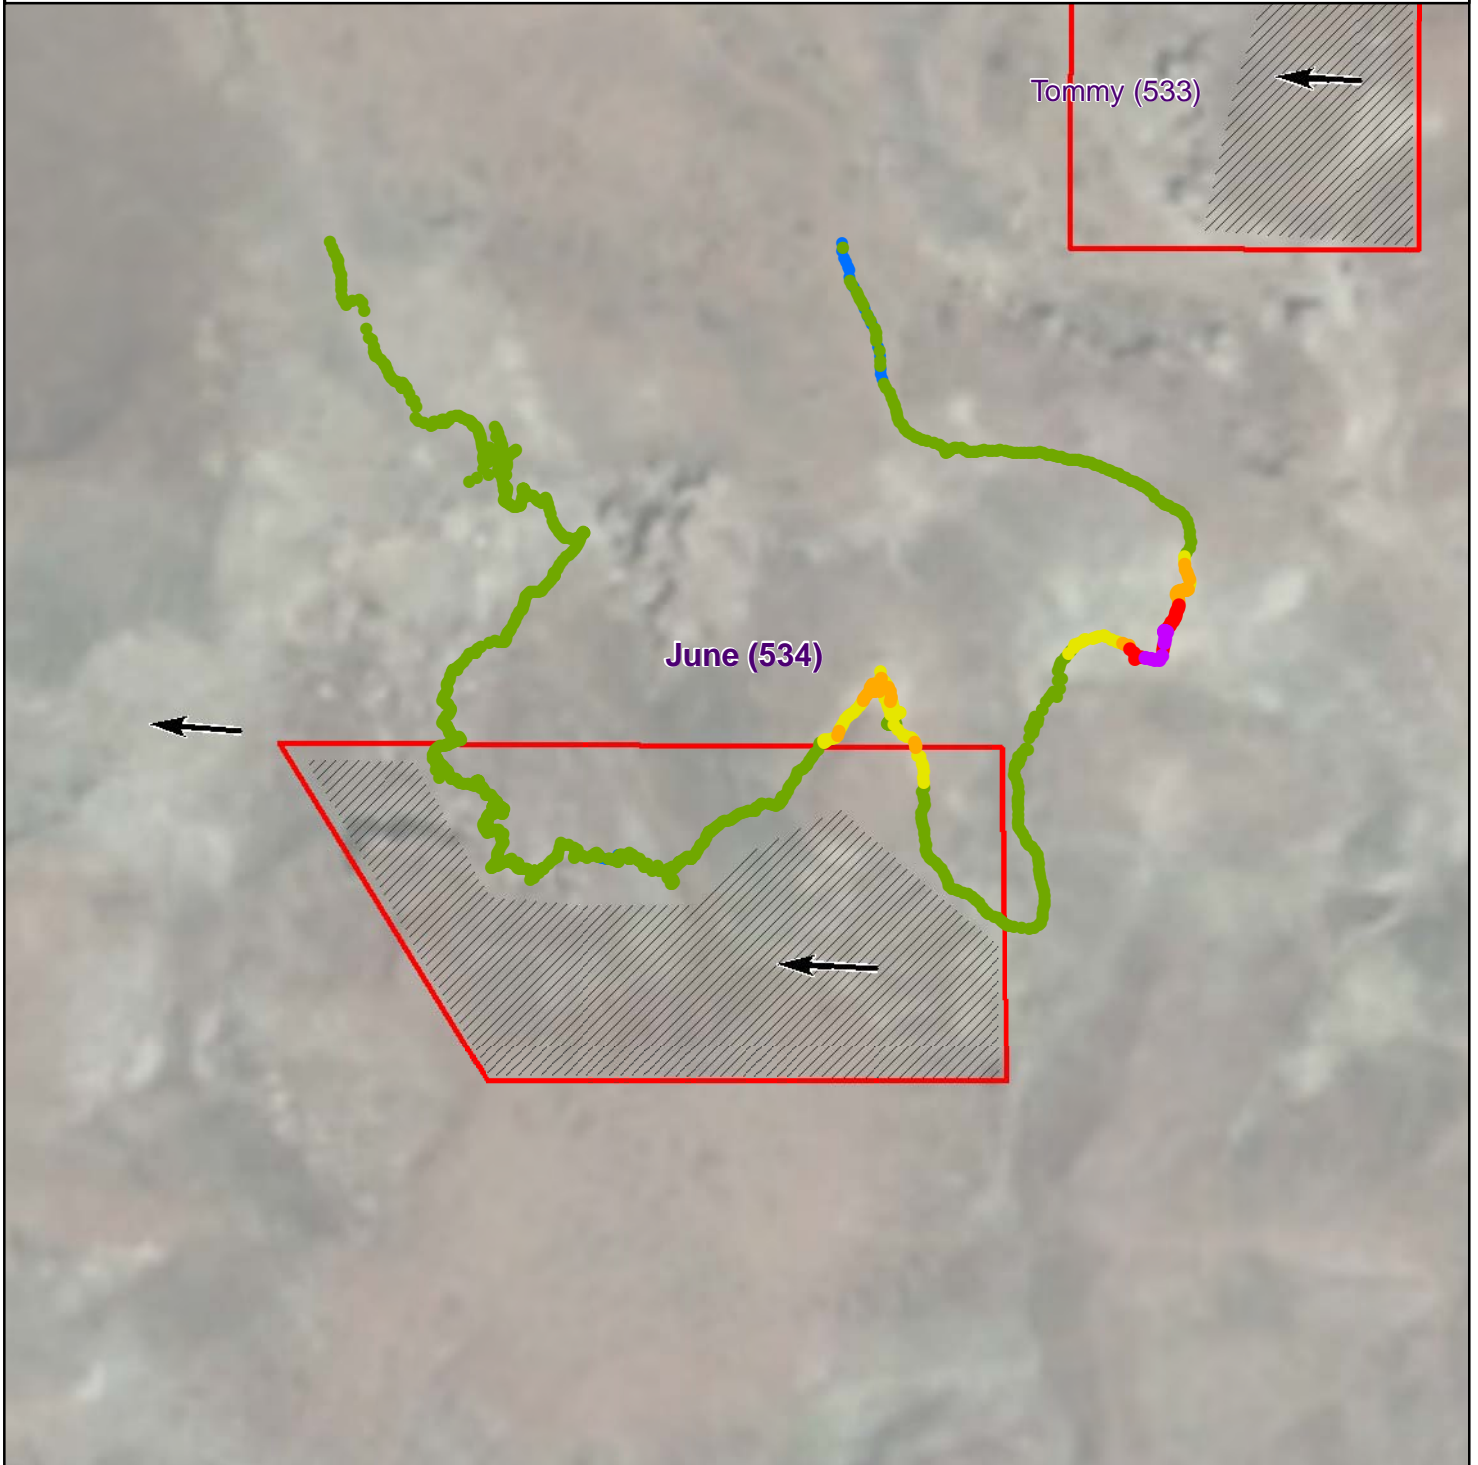
**Figure 2 - Gamma Radiation Measurements  
June (534)  
Bodaway / Gap Chapter, Navajo Nation**

Average background 8,979 cpm
