# **Navajo Abandoned Uranium Mine**

## **Site Screen Report**

### **Adolf Maloney No. 2 AUM Site**

**January 2011**

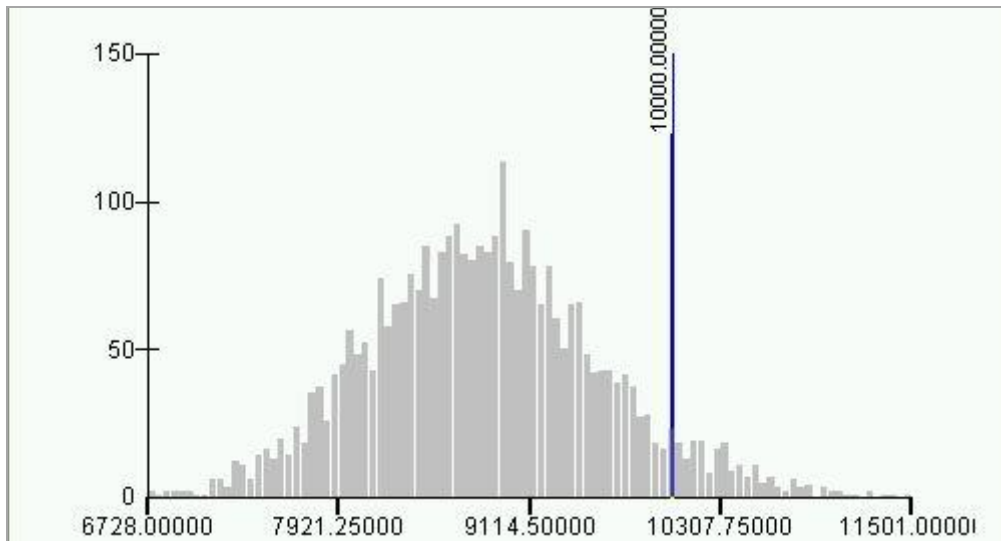
The following chart and statistics were generated by ESRI ArcGIS 9.3.1, and show the general distribution of the site gamma radiation measurements. The horizontal X axis represents the gamma radiation reading levels in cpm (lowest levels to the left). The vertical Y axis represents the frequency of each gamma radiation level.

Count:	3212
Minimum:	6728.00000
Maximum:	11501.00000
Sum:	28372246.00000
Mean:	8833.20237
Median:	8815.00000
Standard Deviation:	724.63665

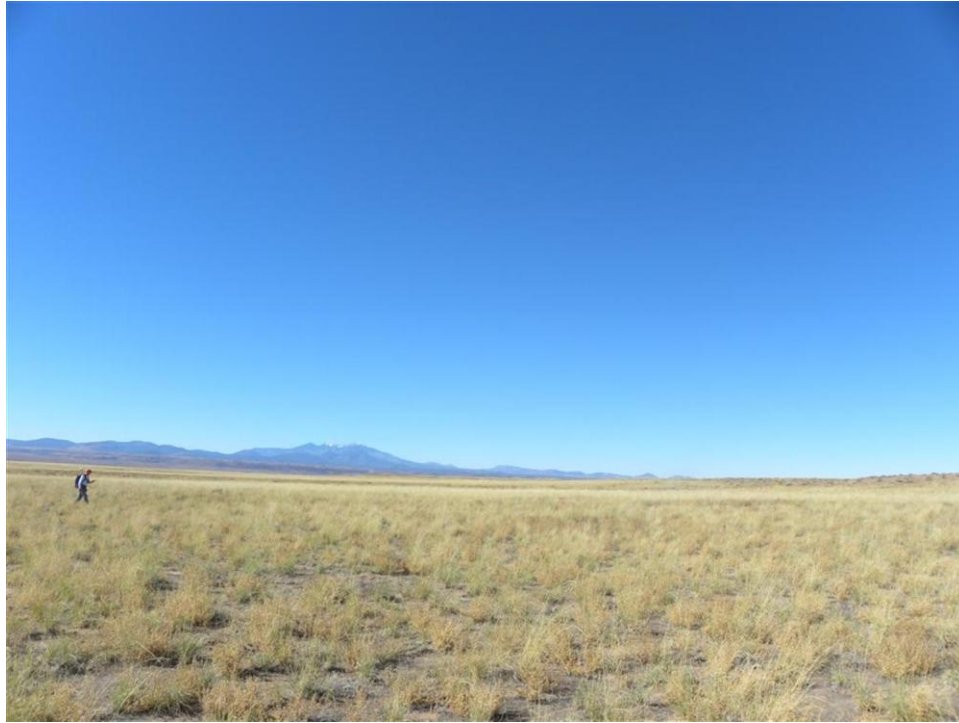
Photo 1. Adolf Maloney mine site

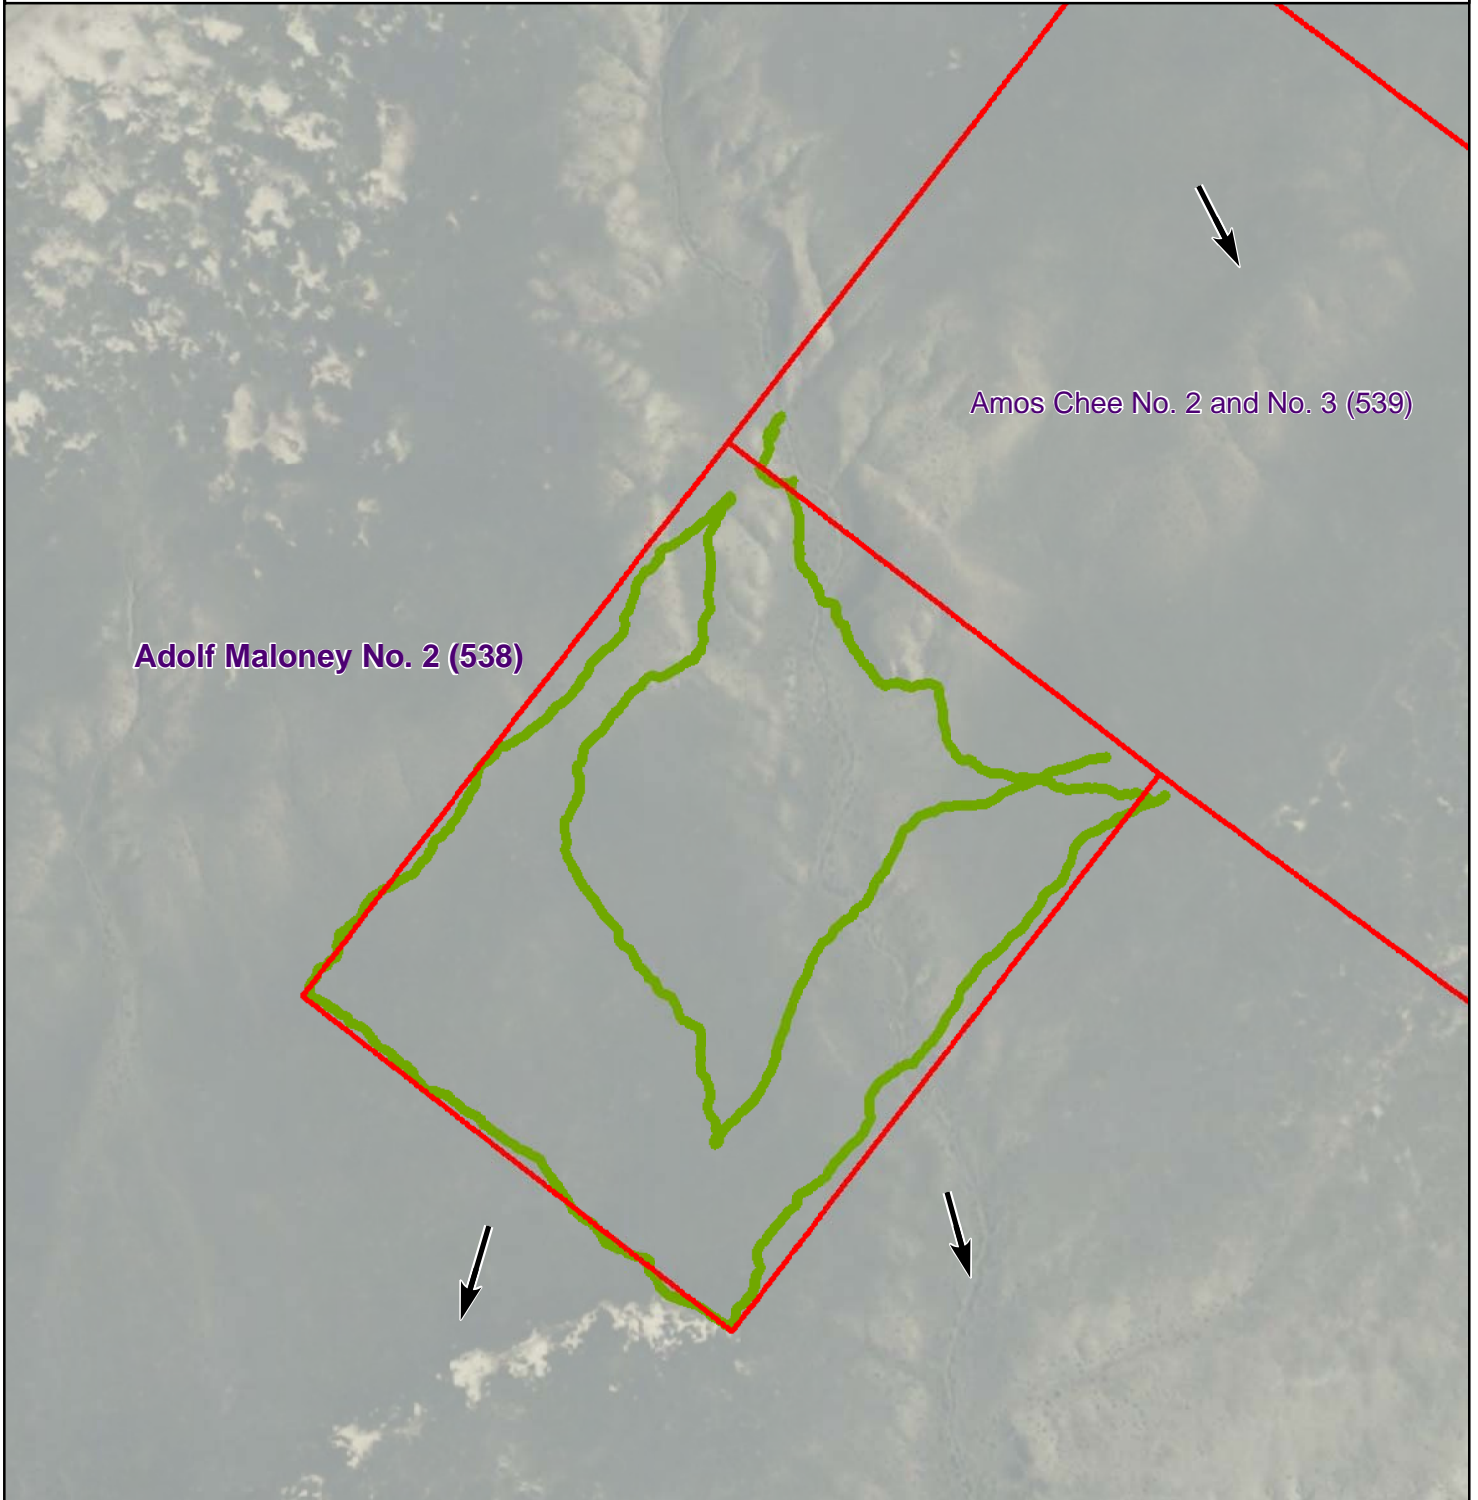
**Figure 1 - Gamma Radiation Measurements, Above Two Times Background  
Adolf Maloney No. 2 (538)  
Leupp Chapter, Navajo Nation**

Gamma survey conducted 11/2010  
Measured as counts per minute (cpm)

Average background 9,212 cpm

A total of 3,212 gamma radiation measurements were collected from the mine site, ranging from 6,728 cpm to 11,501 cpm. The measurements are represented in Figures 1 and 2.

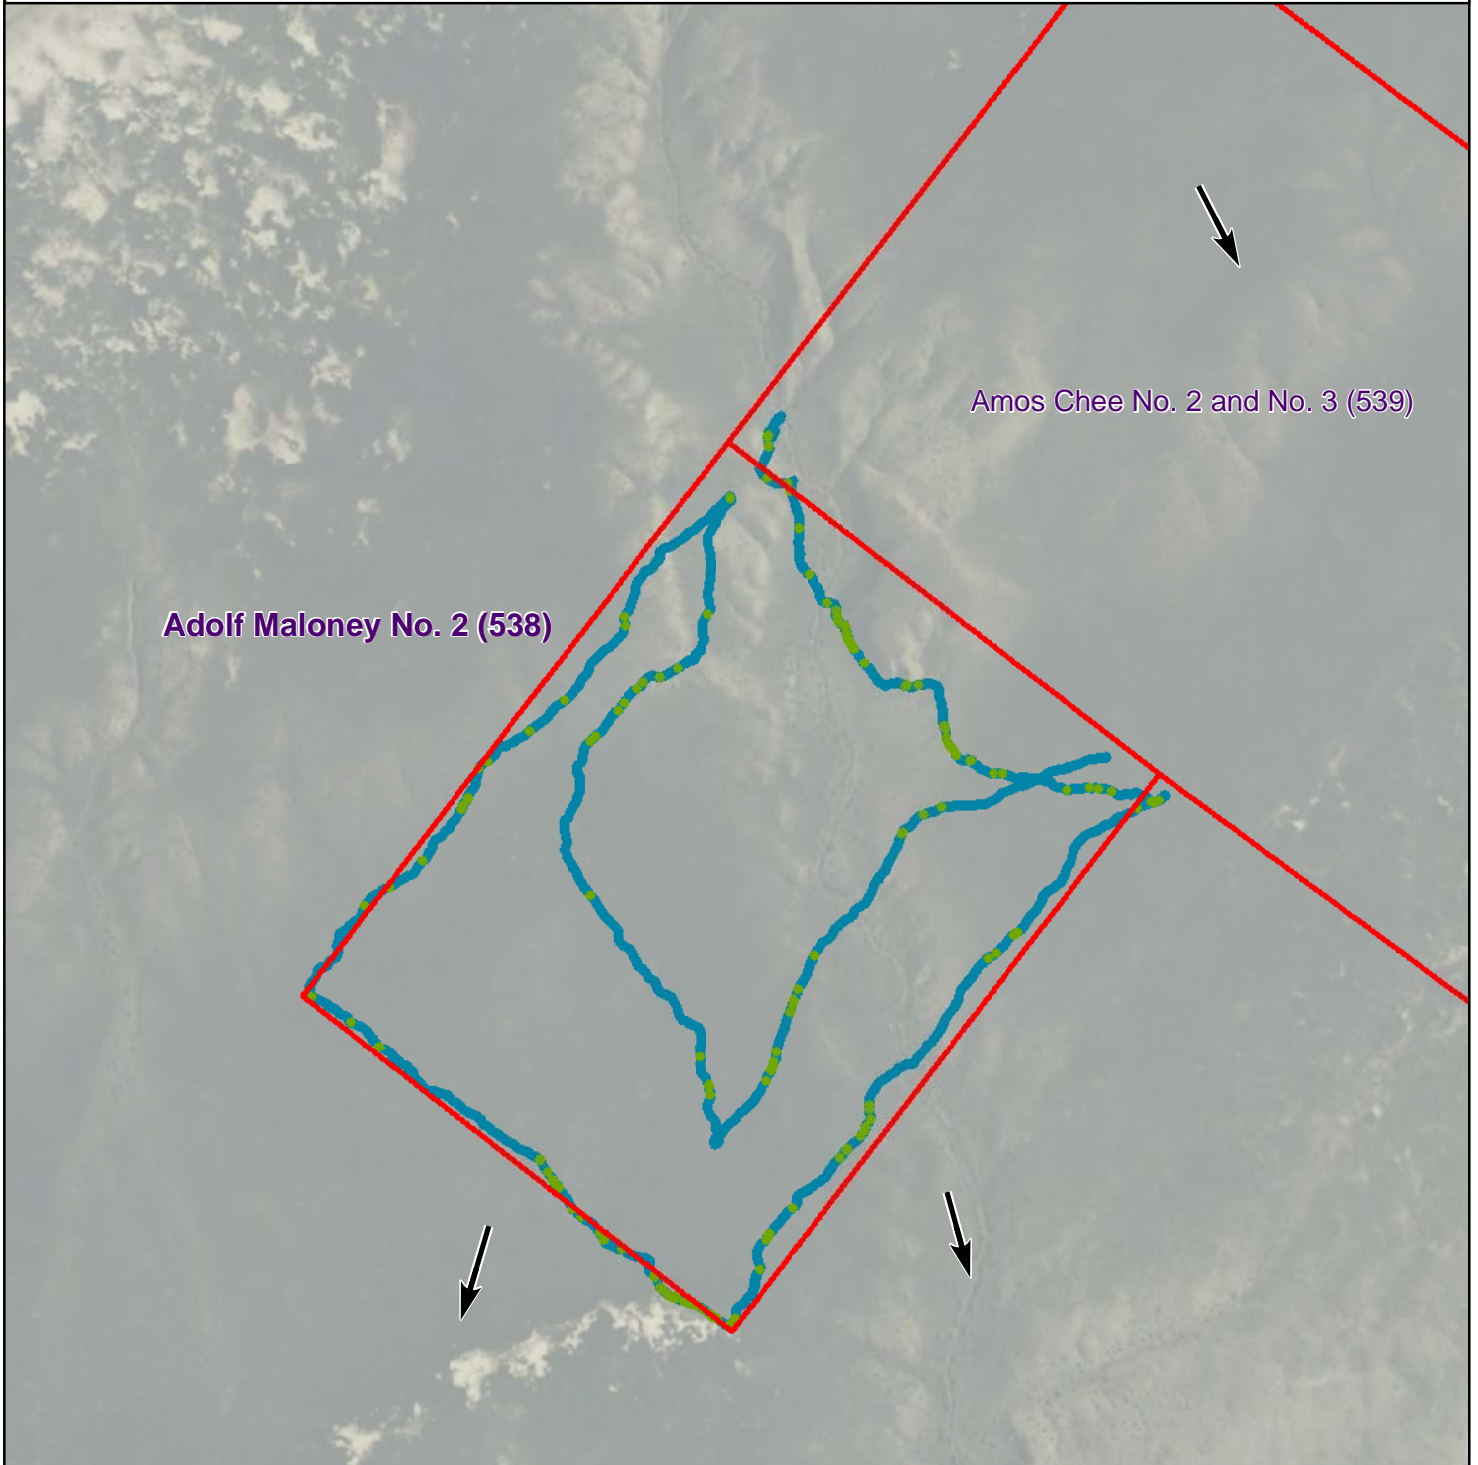
**Figure 2 - Gamma Radiation Measurements  
Adolf Maloney No. 2 (538)  
Leupp Chapter, Navajo Nation**

**Gamma survey conducted 11/2010  
Measured as counts per minute (cpm)**

**Average background 9,212 cpm**
