# Navajo Abandoned Uranium Mine

## Site Screen Report

### Mesa IV, Mine No. 2 AUM Site

**March 2010**

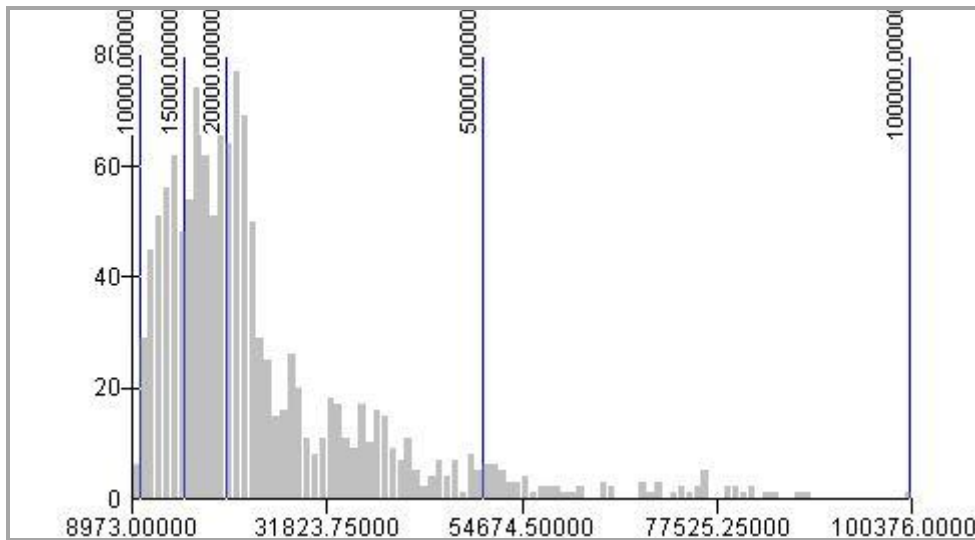
The following chart and statistics were generated by ESRI ArcGIS 9.3.1, and show the general distribution of the site gamma radiation measurements. The horizontal X axis represents the gamma radiation reading levels in cpm (lowest levels to the left). The vertical Y axis represents the frequency of each gamma radiation level.

Count:	1287
Minimum:	8973.00000
Maximum:	100376.00000
Sum:	31107264.00000
Mean:	24170.36830
Median:	20372.00000
Standard Deviation:	13346.50641

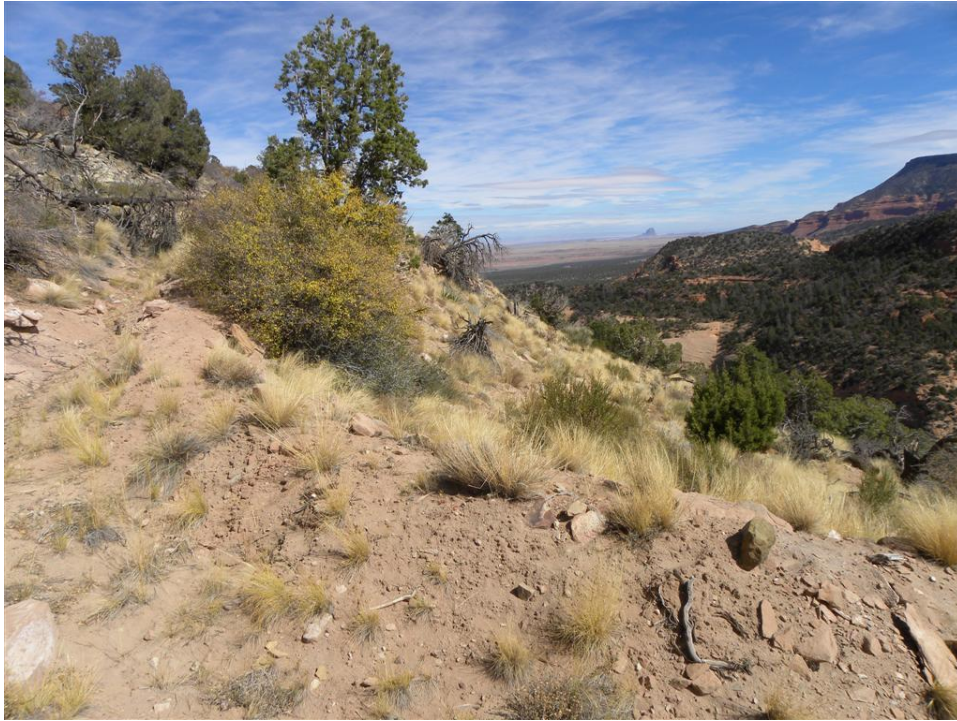
Photo 1. Mine site

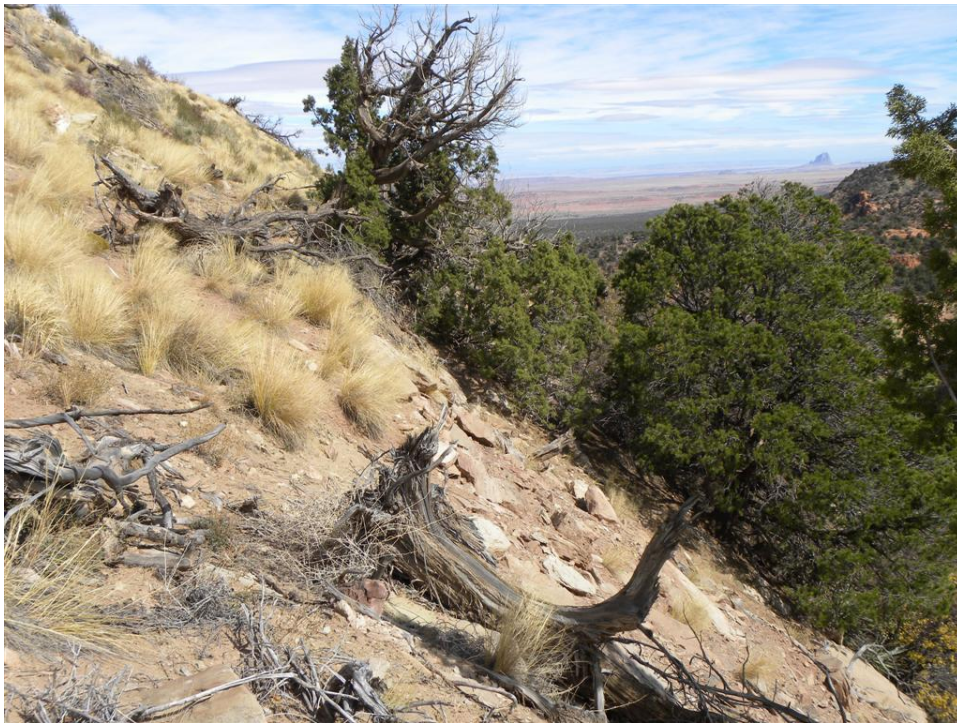
Photo 2. Slope area

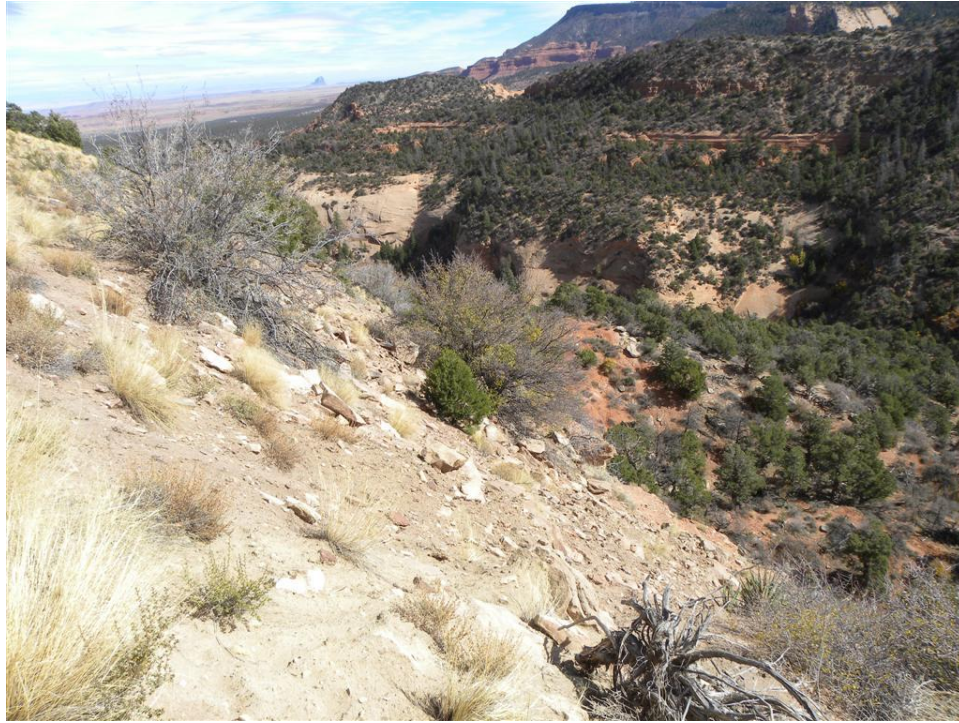
Waste rock throughout east portion of site, with a total estimated volume of 1,500 yd<sup>3</sup>

Photo 3. Slope area and waste debris

Unreclaimed waste pile

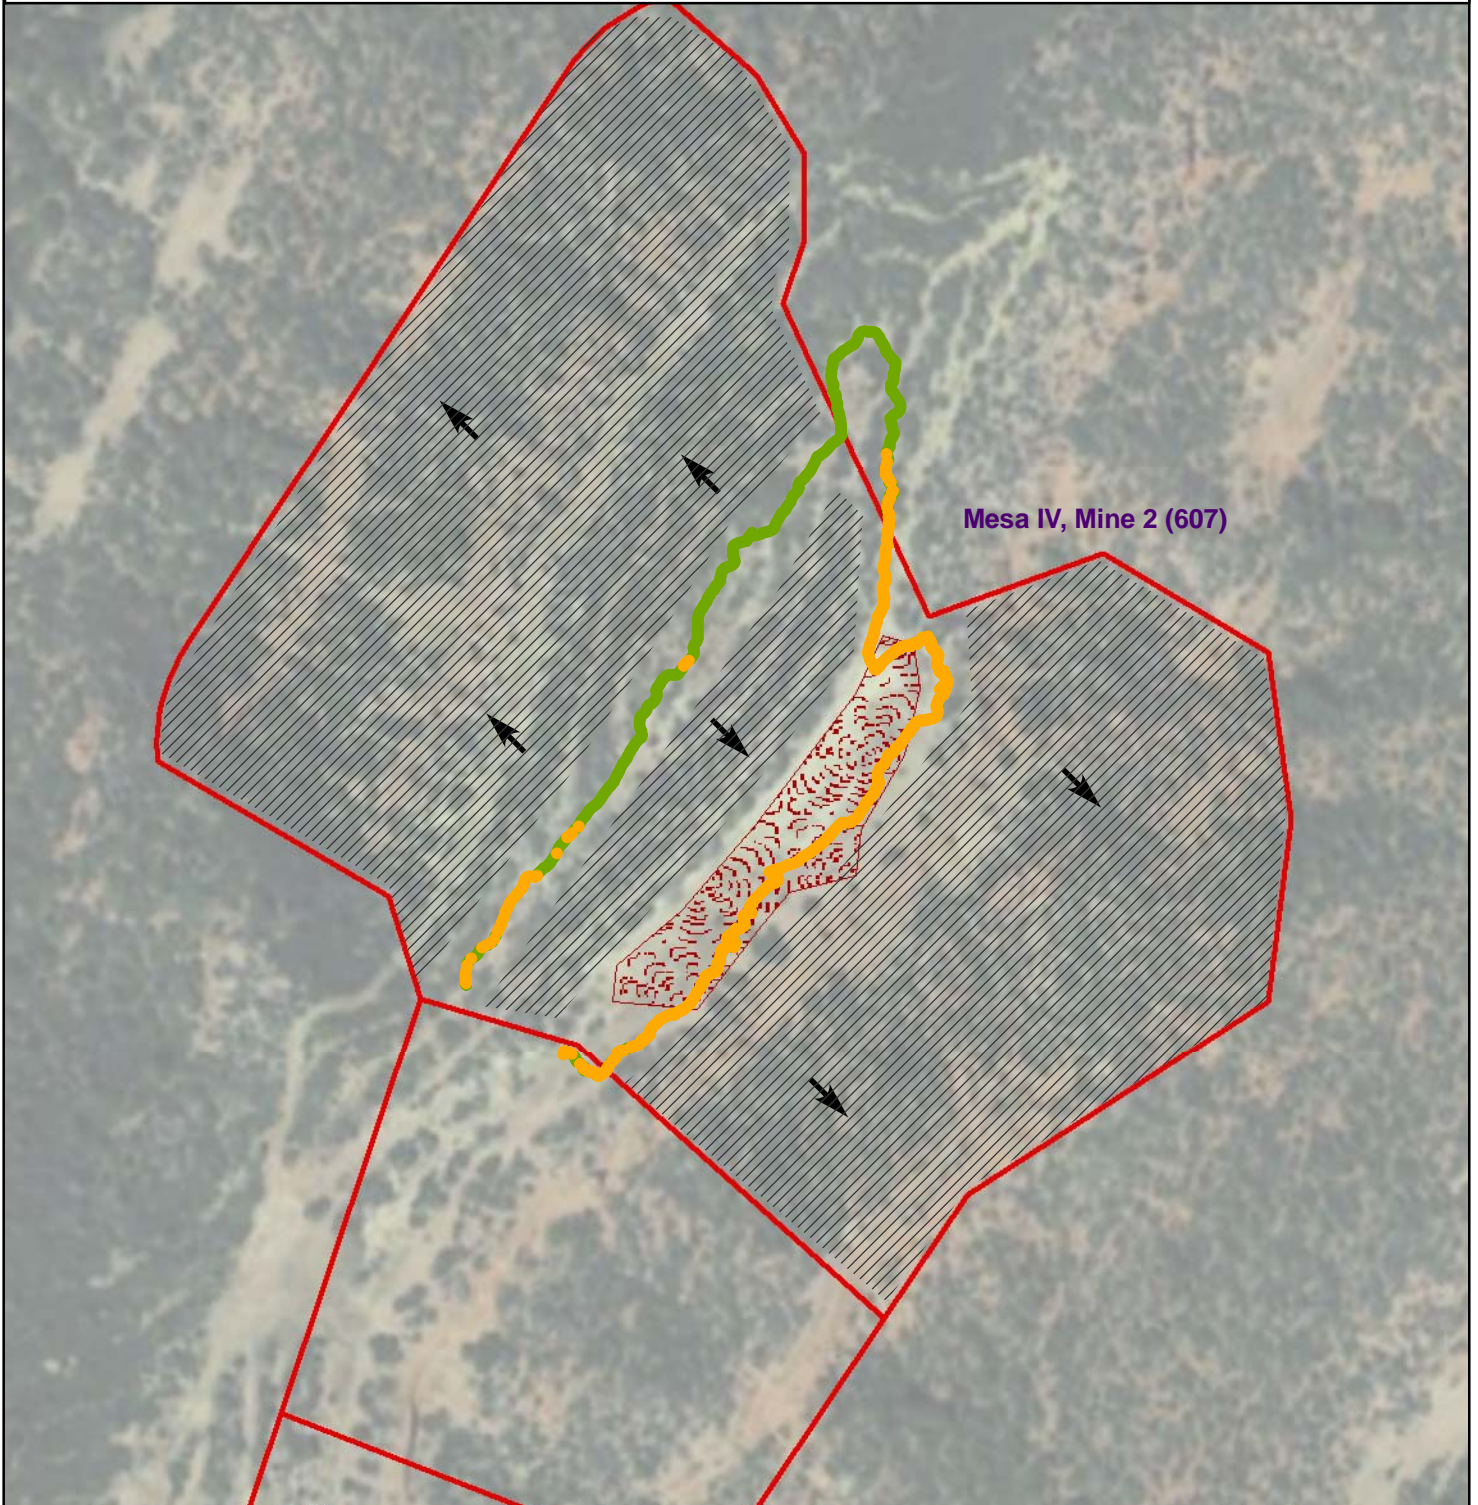
A total of 1,287 gamma radiation measurements were collected from the mine site, ranging from 8,973 cpm to 100,376 cpm. Measurements in the vicinity of the waste debris were found at levels in up to 100,000 cpm. The measurements are represented in Figures 1 and 2.

**Figure 1 - Gamma Radiation Measurements, Above Two Times Background  
Mesa IV, Mine 2 (607)  
Cove Chapter, Navajo Nation, Arizona**

Gamma survey conducted 10/2009  
Measured as counts per minute (cpm)

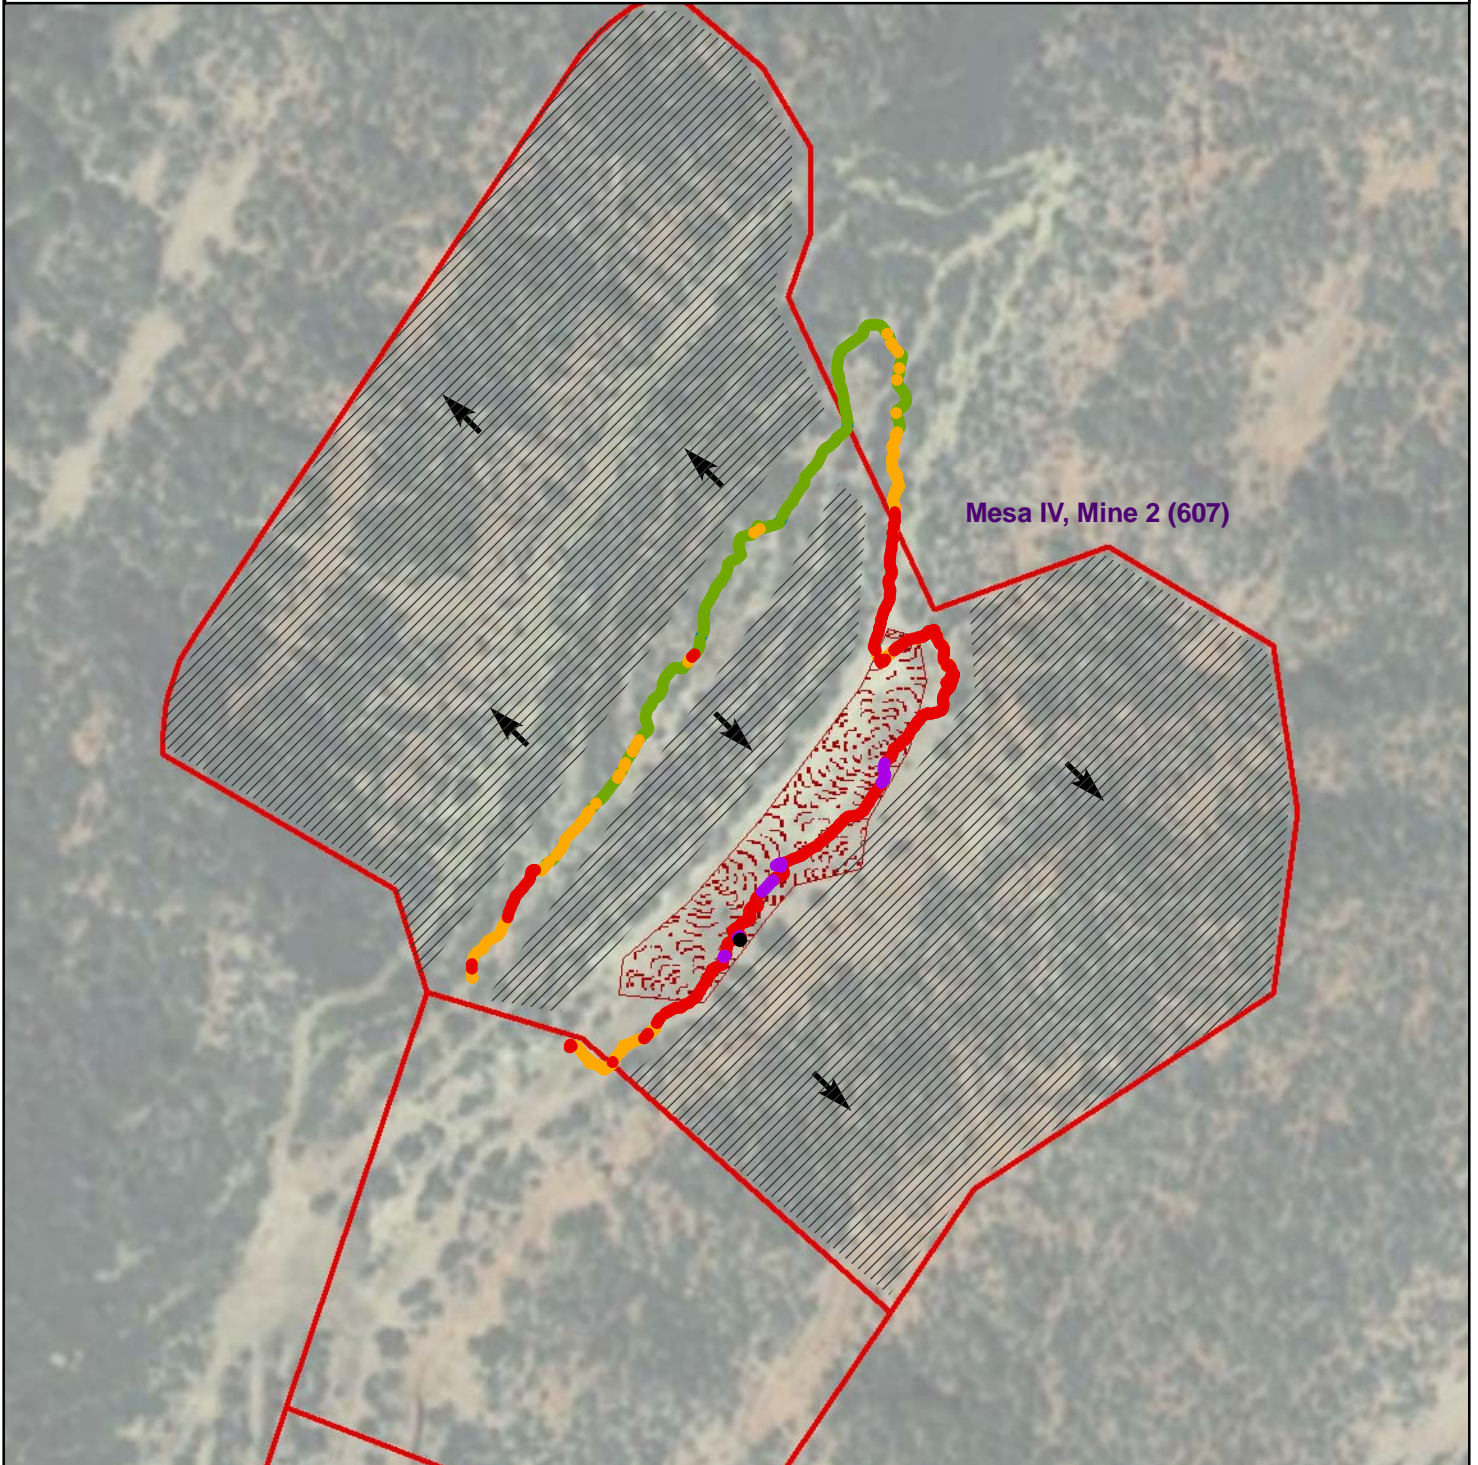
**Figure 2 - Gamma Radiation Measurements  
Mesa IV, Mine 2 (607)  
Cove Chapter, Navajo Nation, Arizona**

**Gamma survey conducted 10/2009  
Measured as counts per minute (cpm)**
