# Navajo Abandoned Uranium Mine

## Site Screen Report

### **NA-0505B AUM Site**

**August 2010**

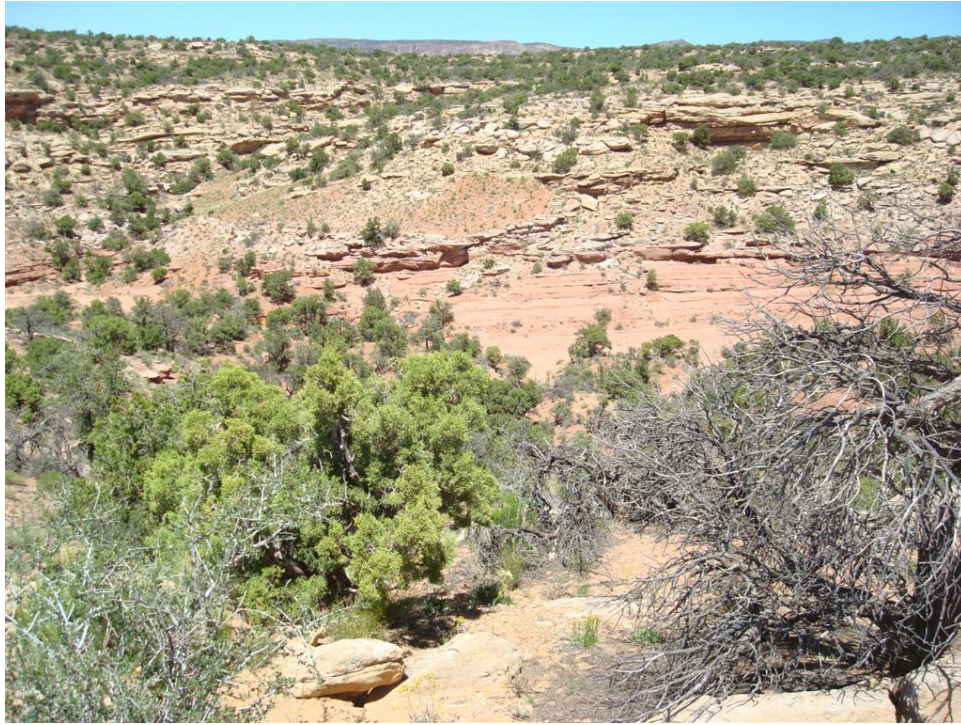
Small excavation pit

Photo 1. NA-0505B site

Small excavation pit; unreclaimed waste rock

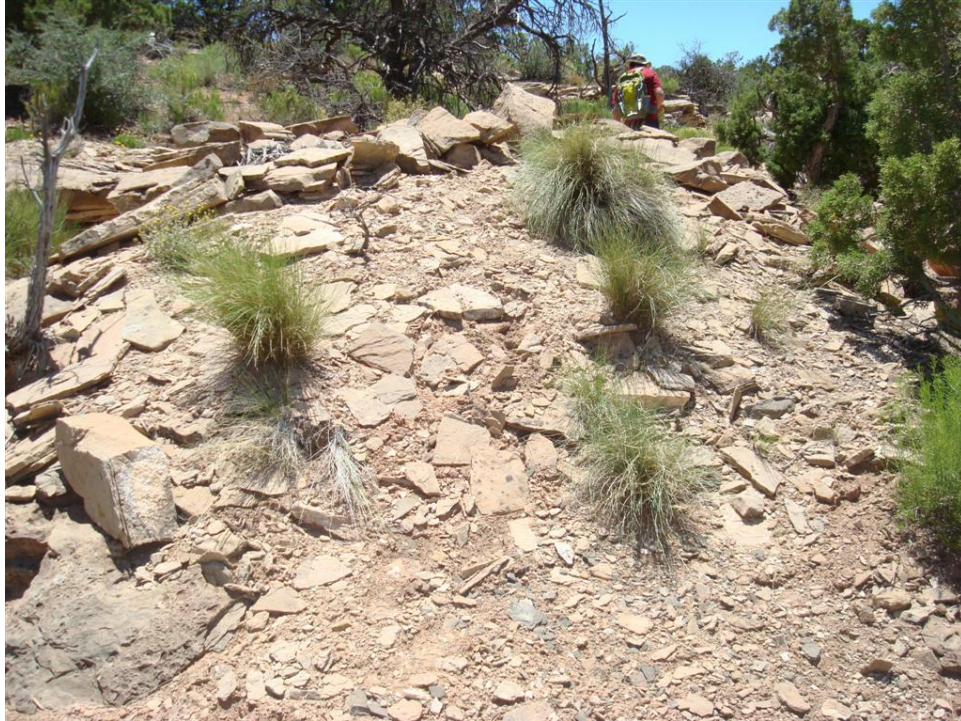
Waste pile associated with excavation pit, approximately 40 yd<sup>3</sup>

Photo 2. NA-0505B site, waste rock
