# Navajo Abandoned Uranium Mine

## Site Screen Report

### Melvin Benally No. 1 AUM Site

**August 2010**

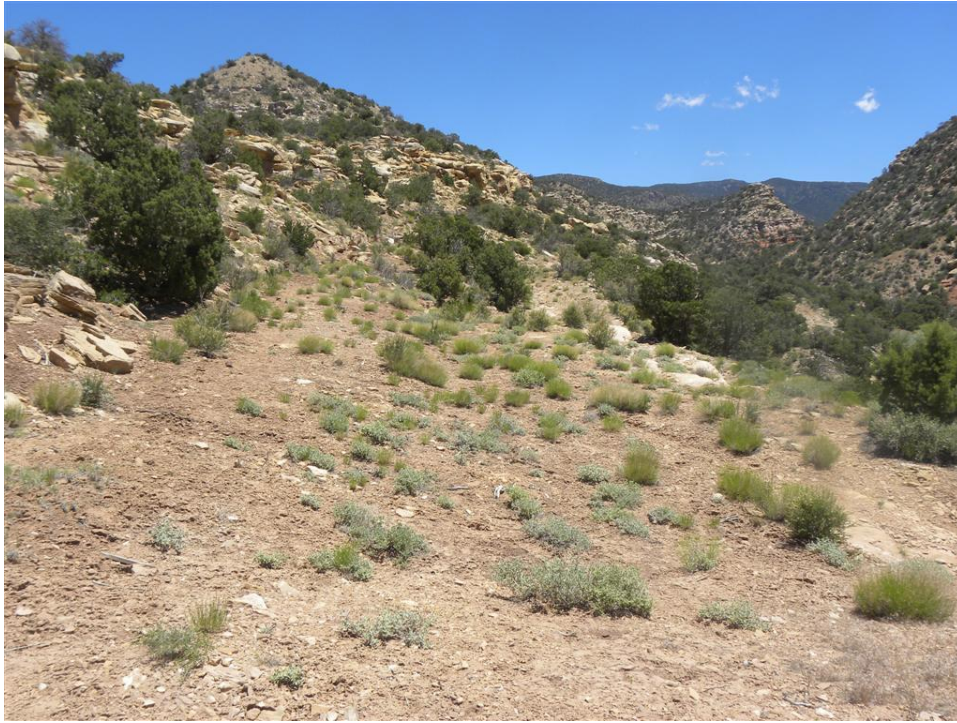
Photo 1. Melvin Benally No. 1 site

Possible excavation pit

Assorted mine workings evidence
