Navajo Abandoned Uranium Mine

Site Screen Report

Plot 2 AUM Site

Weston Solutions, Inc.

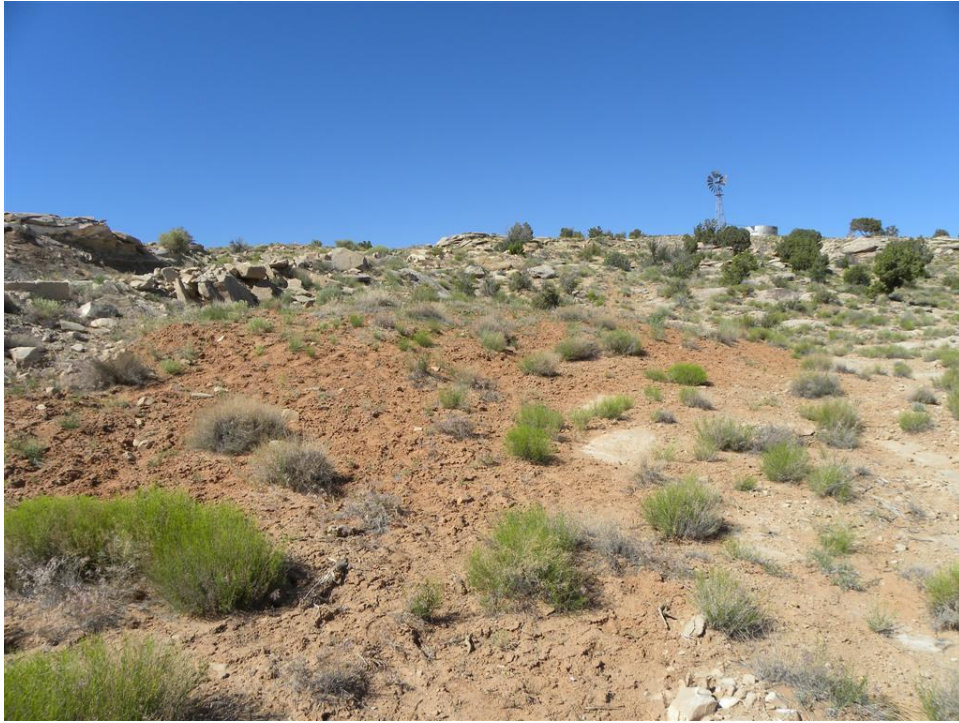
Drill hole in rock surrounded by some scattered rocks; vent hole in soil; reclamation cap along edge of road at sound end 35' x 20' x 2'; cap north of cap 1 20' x 14' x 1'; another cap at NW end of site 30' x 15' x 1'

Photo 3, Plot 2 site, cap area

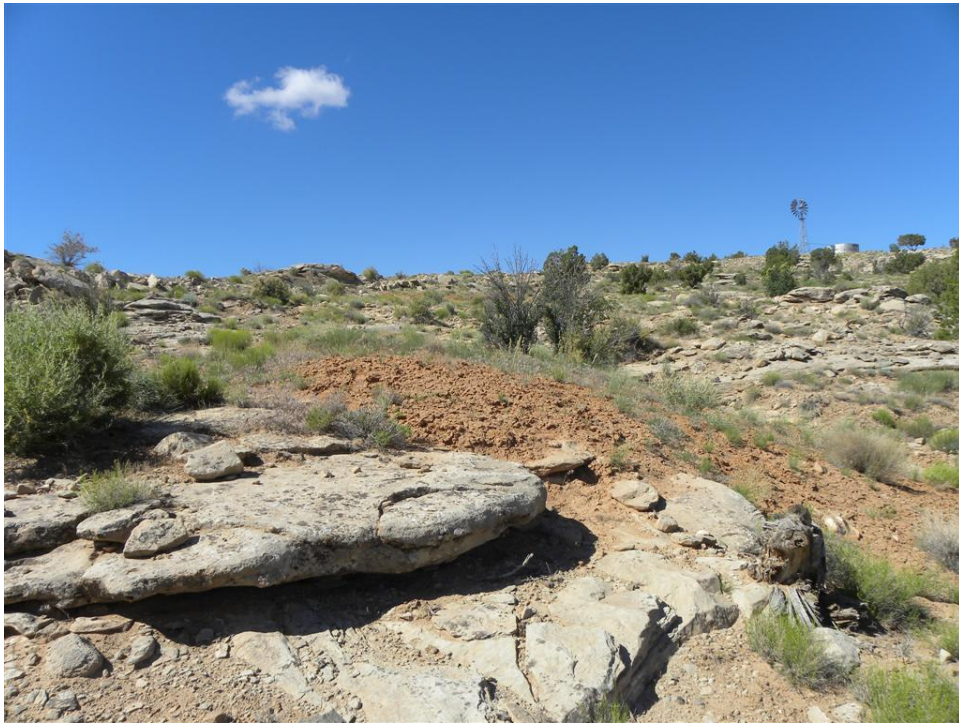
Photo 4, Plot 2 site, cap area

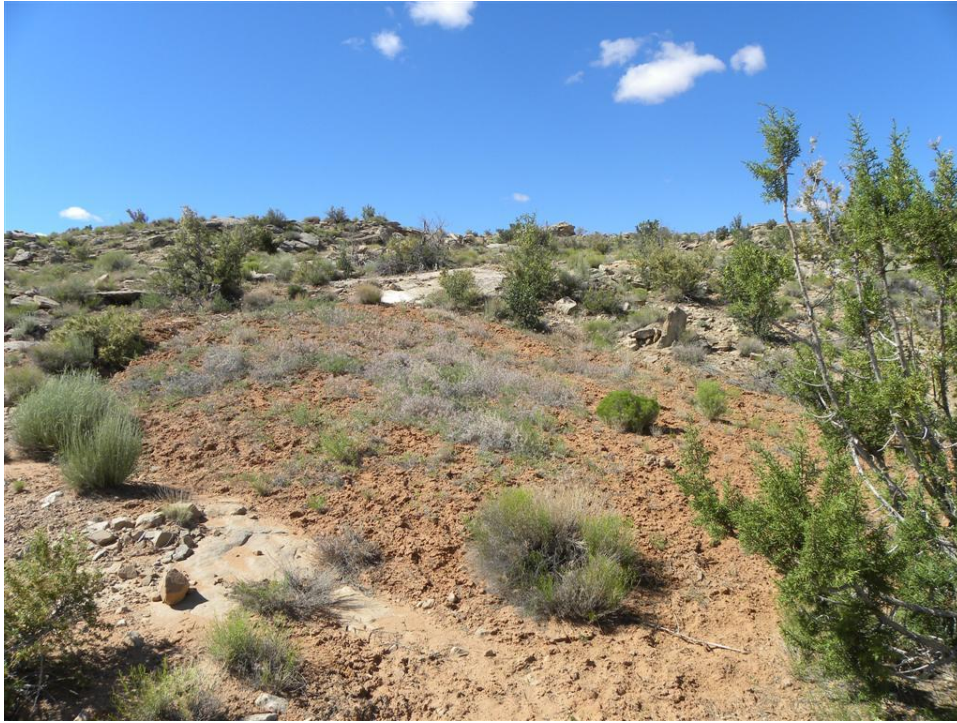
Photo 5, Plot 2 site, cap area

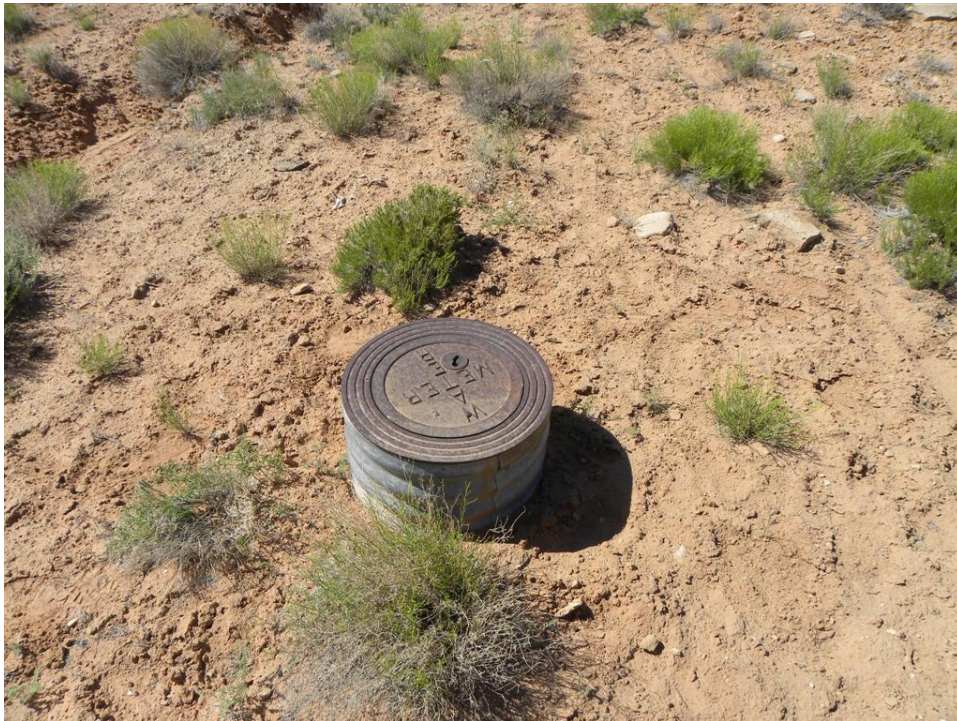
Photo 6, Plot 2 site, vent hole
