# Navajo Abandoned Uranium Mine

## Site Screen Report

## George Simpson 1 Incline AUM Site

**August 2010**

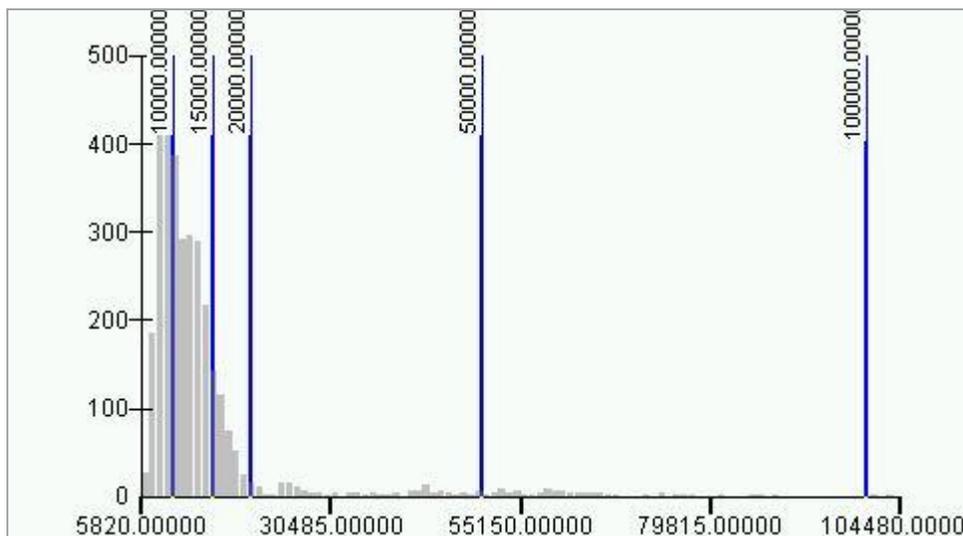
The following chart and statistics were generated by ESRI ArcGIS 9.3.1, and show the general distribution of the site gamma radiation measurements. The horizontal X axis represents the gamma radiation reading levels in cpm (lowest levels to the left). The vertical Y axis represents the frequency of each gamma radiation level.

Count:	3302
Minimum:	5820.00000
Maximum:	104480.00000
Sum:	48578832.00000
Mean:	14711.94185
Median:	11339.00000
Standard Deviation:	12438.75948

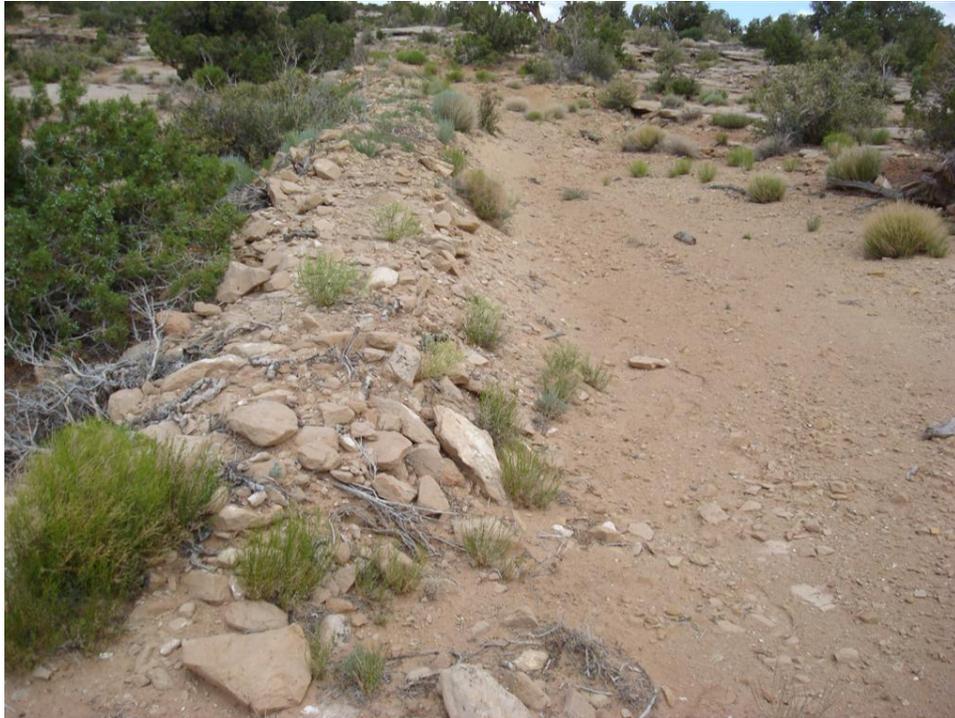
Diversion structure above adit leading towards underground workings; road from adit leads to possible excavation pit

Photo 5. George Simpson 1 Incline site, diversion

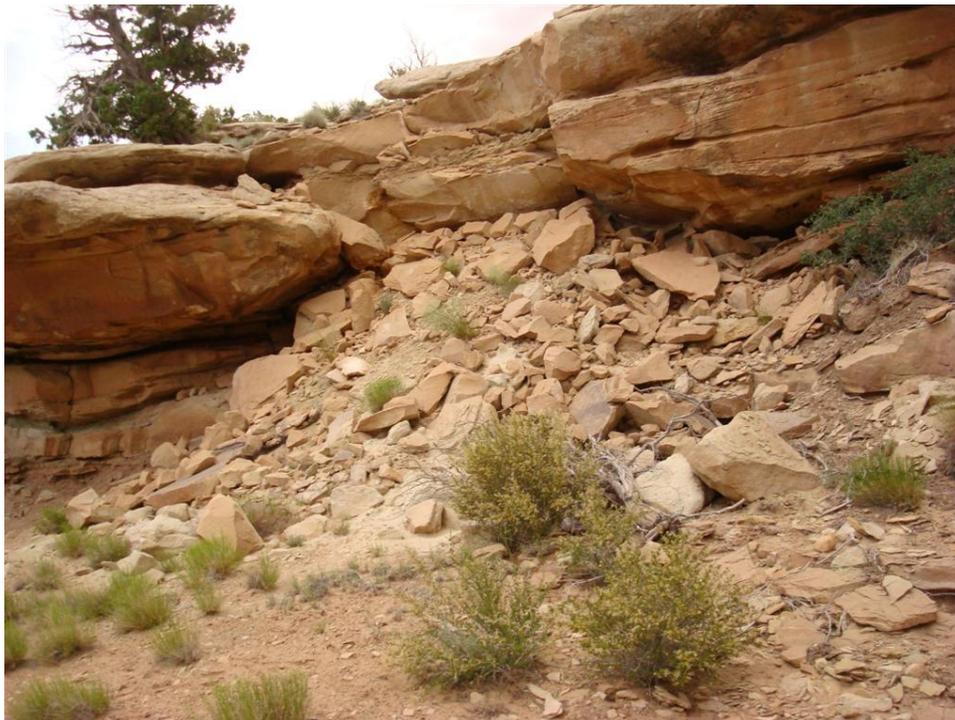
Adit in the south facing, backfilled

Backfilled adit; possible excavation pit

Photo 6. George Simpson 1 Incline site, backfilled adit

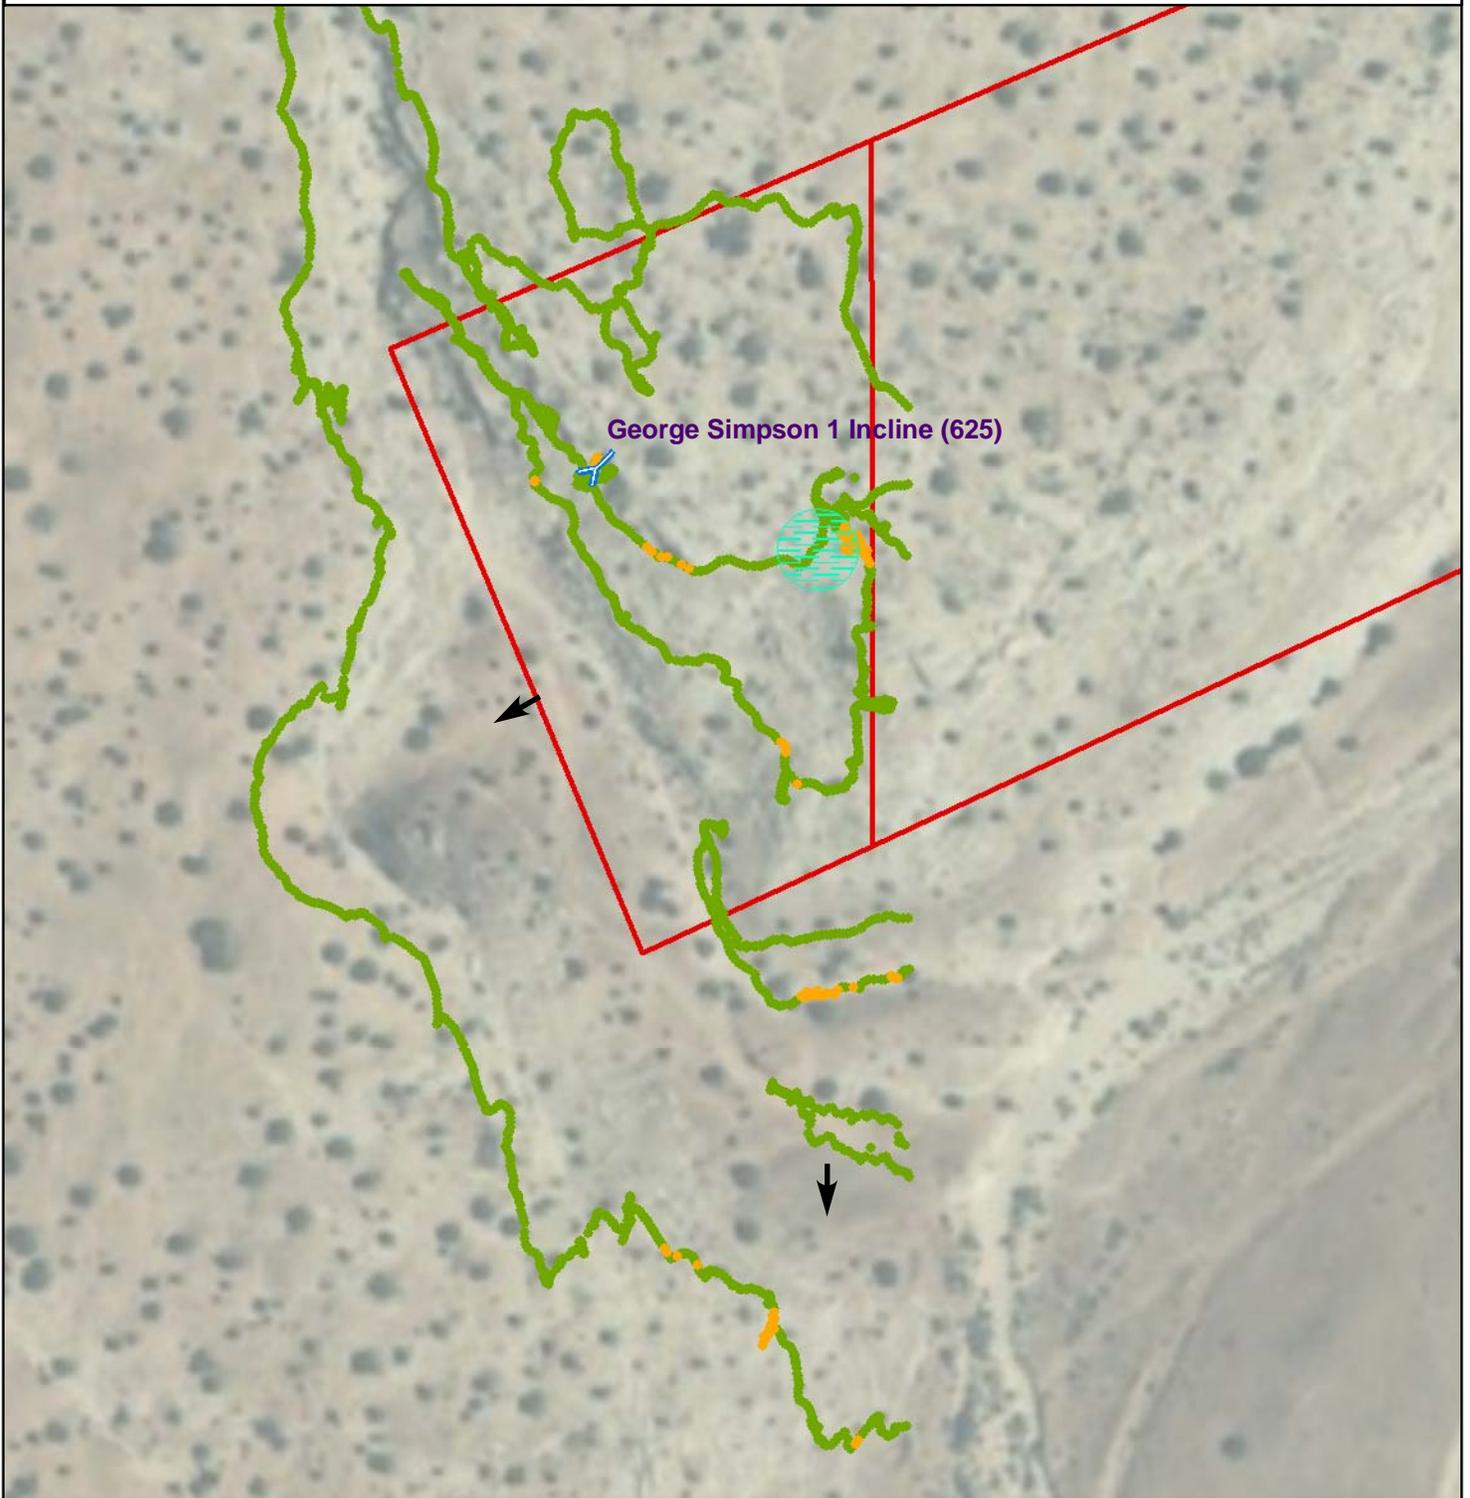
A total of 3,302 gamma radiation measurements were collected from the mine site, ranging from 5,820 cpm to 104,480 cpm. The measurements are represented in Figures 1 and 2.

**Figure 1 - Gamma Radiation Measurements, Above Two Times Background  
George Simpson 1 Incline (625)  
Sweetwater Chapter, Navajo Nation**

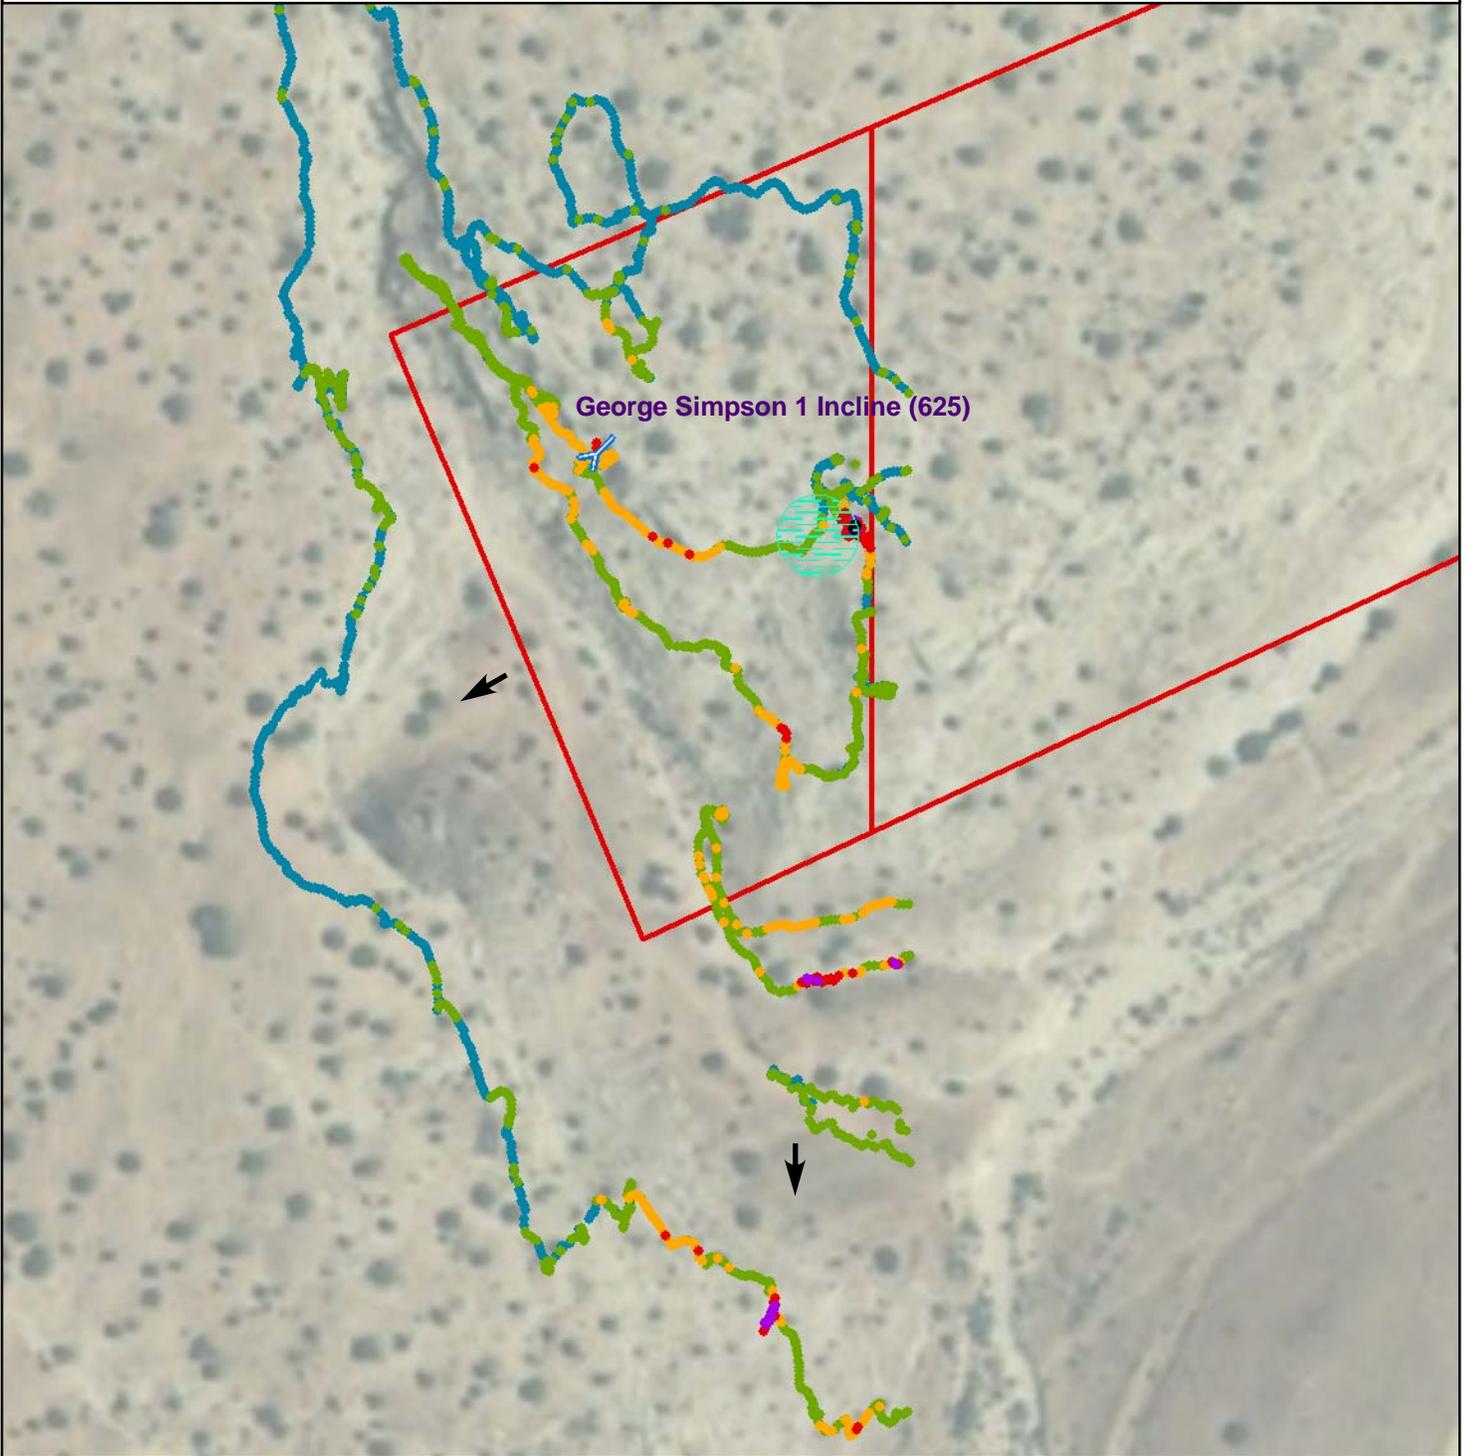
**Figure 2 - Gamma Radiation Measurements  
George Simpson 1 Incline (625)  
Sweetwater Chapter, Navajo Nation**
