# Navajo Abandoned Uranium Mine

## Site Screen Report

### Plot 13 AUM Site

#### Navajo AUM Northern Region

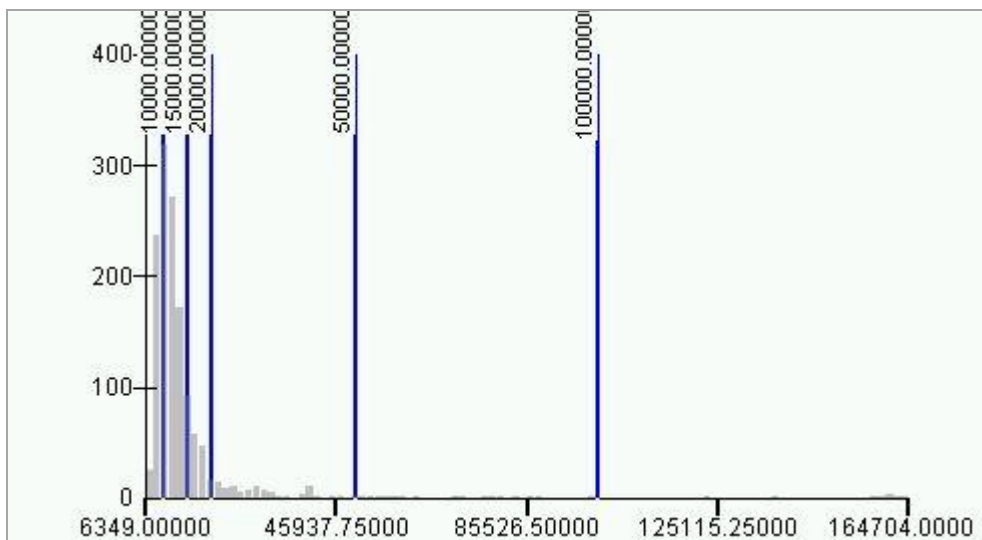
The following chart and statistics were generated by ESRI ArcGIS 9.3.1, and show the general distribution of the site gamma radiation measurements. The horizontal X axis represents the gamma radiation reading levels in cpm (lowest levels to the left). The vertical Y axis represents the frequency of each gamma radiation level.

Count:	1356
Minimum:	6349.00000
Maximum:	164704.00000
Sum:	20072613.00000
Mean:	14802.81195
Median:	11666.50000
Standard Deviation:	14479.47821

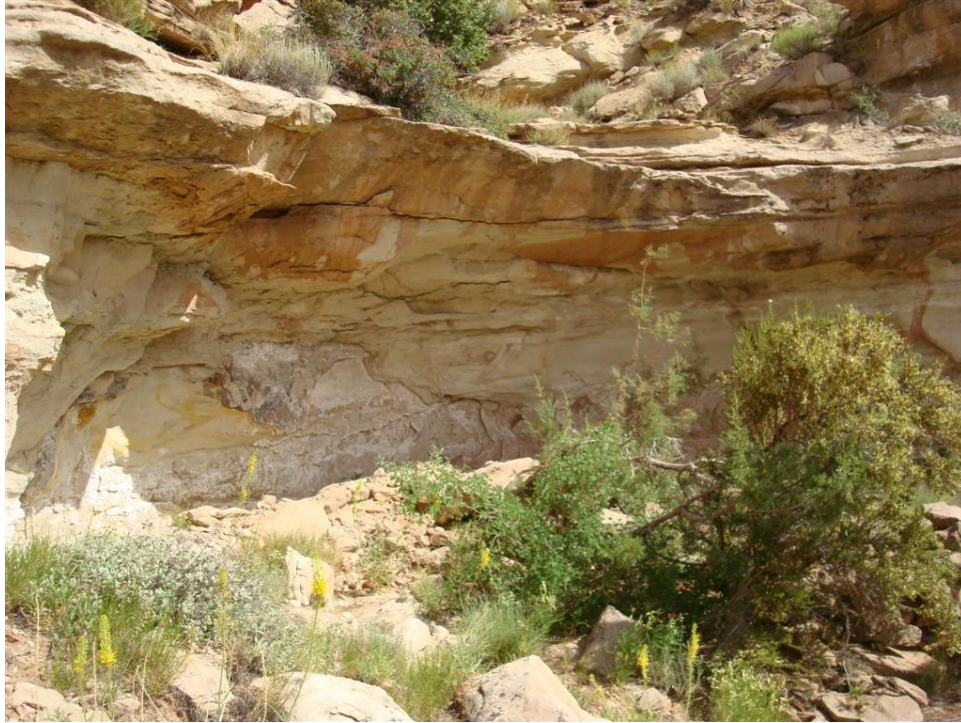
Photo 2. Plot 13 site, overhang

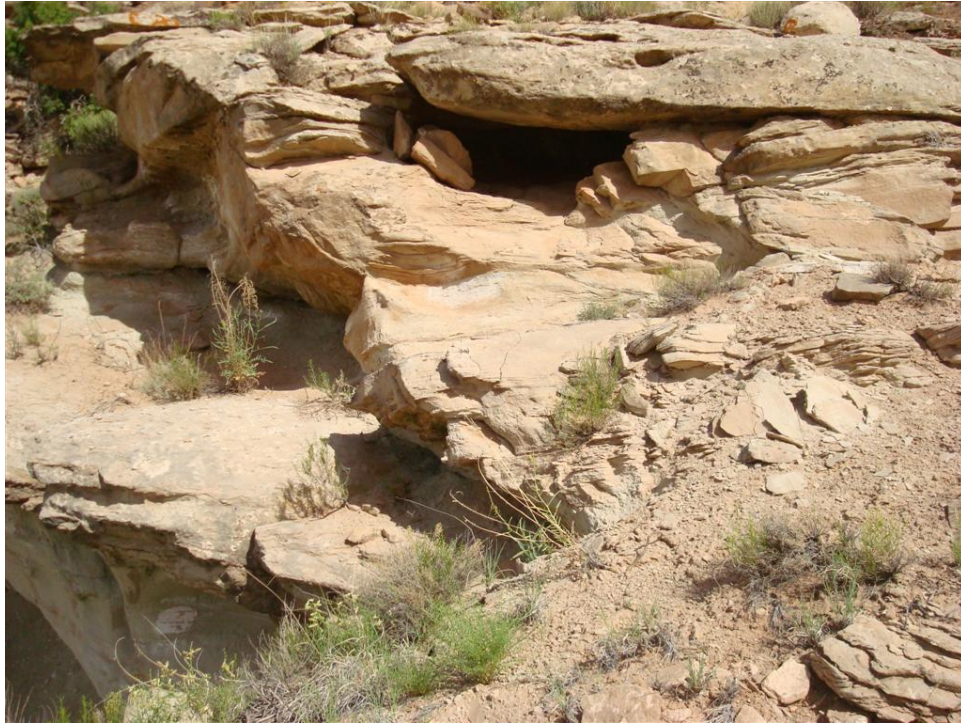
1 possible adit

Photo 3. Plot 13 site, possible adit

1 possible adit; excavations of fine material below lowest restraint ledge

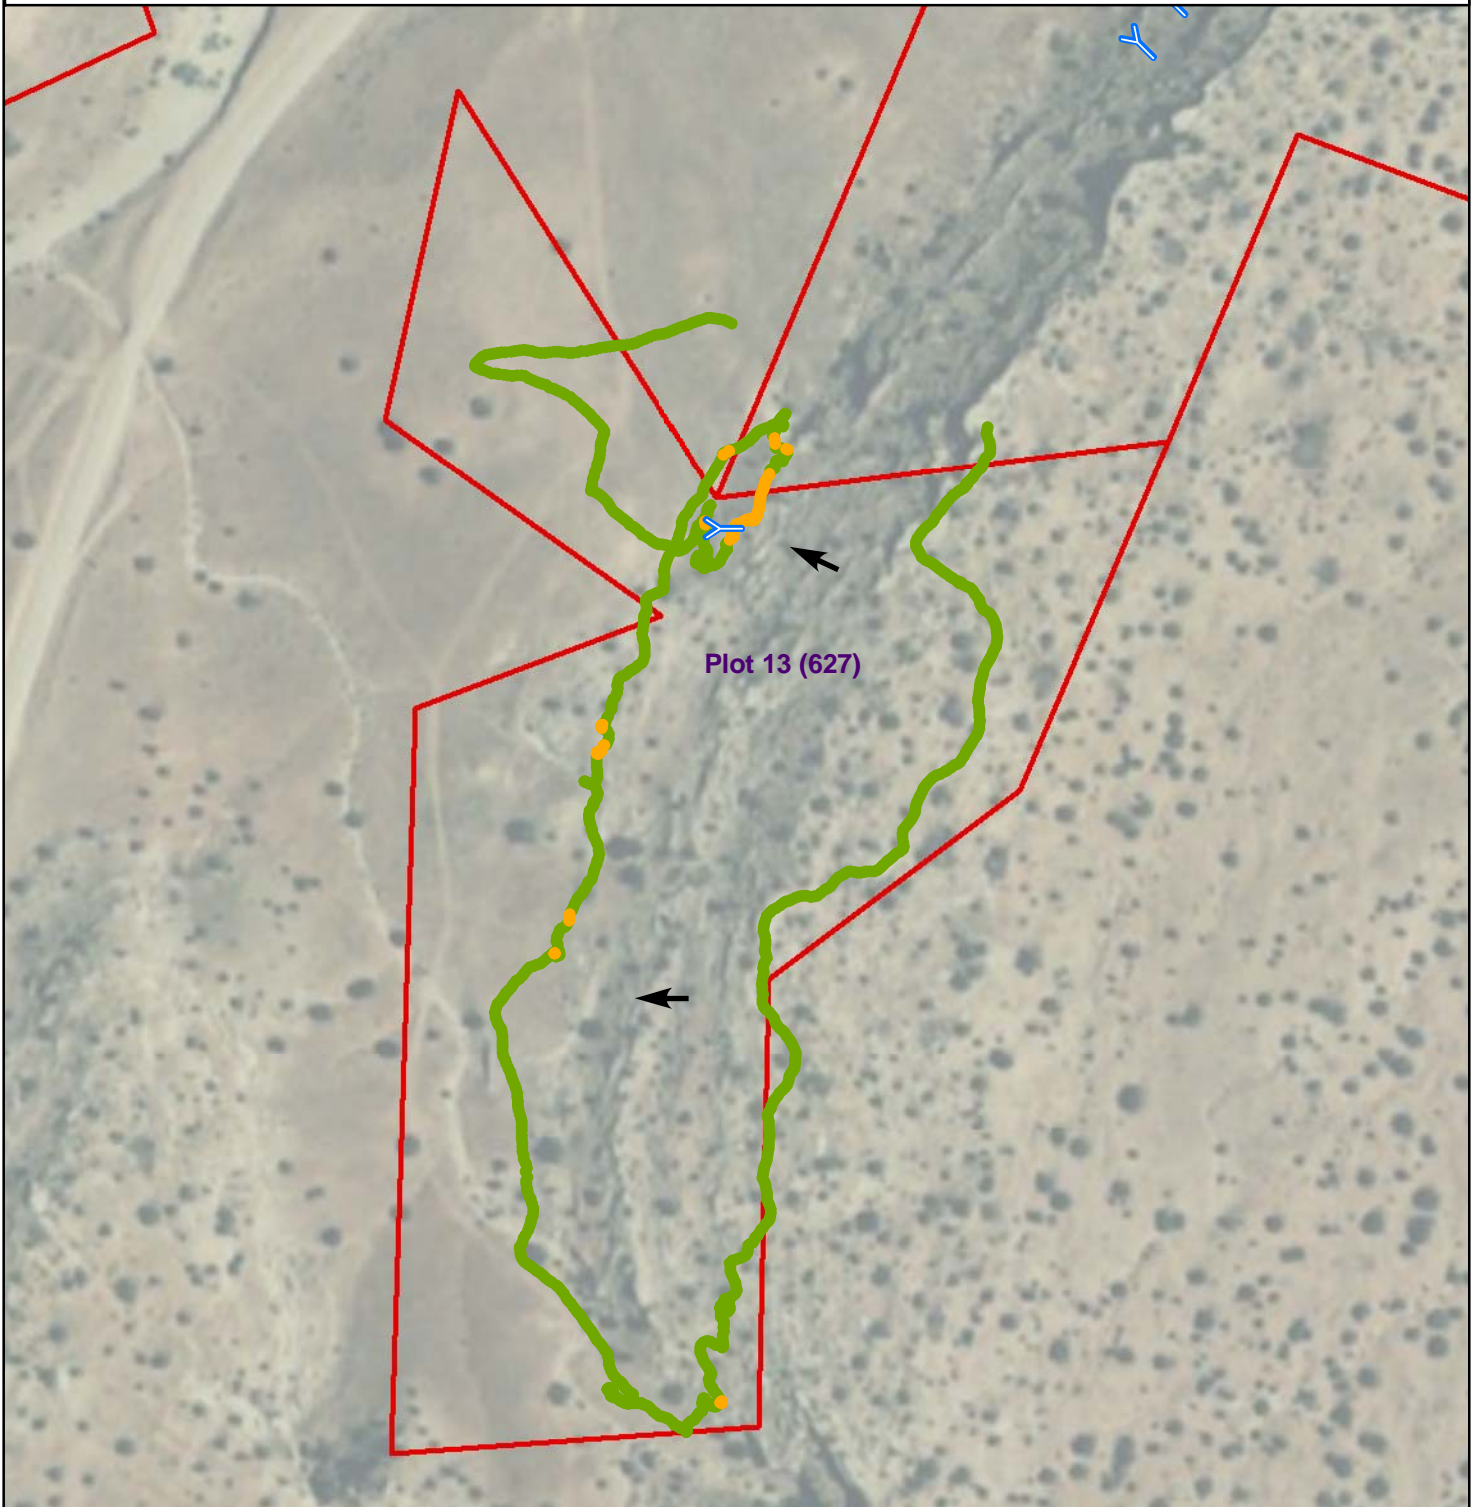
**Figure 1 - Gamma Radiation Measurements, Above Two Times Background  
Plot 13 (627)  
Sweetwater, Navajo Nation**

A total of 1,356 gamma radiation measurements were collected from the mine site, ranging from 6,349 cpm to 164,704 cpm. The measurements are represented in Figures 1 and 2.

Gamma survey conducted 06/2010  
Measured as counts per minute (cpm)

Average background = 9,634 cpm

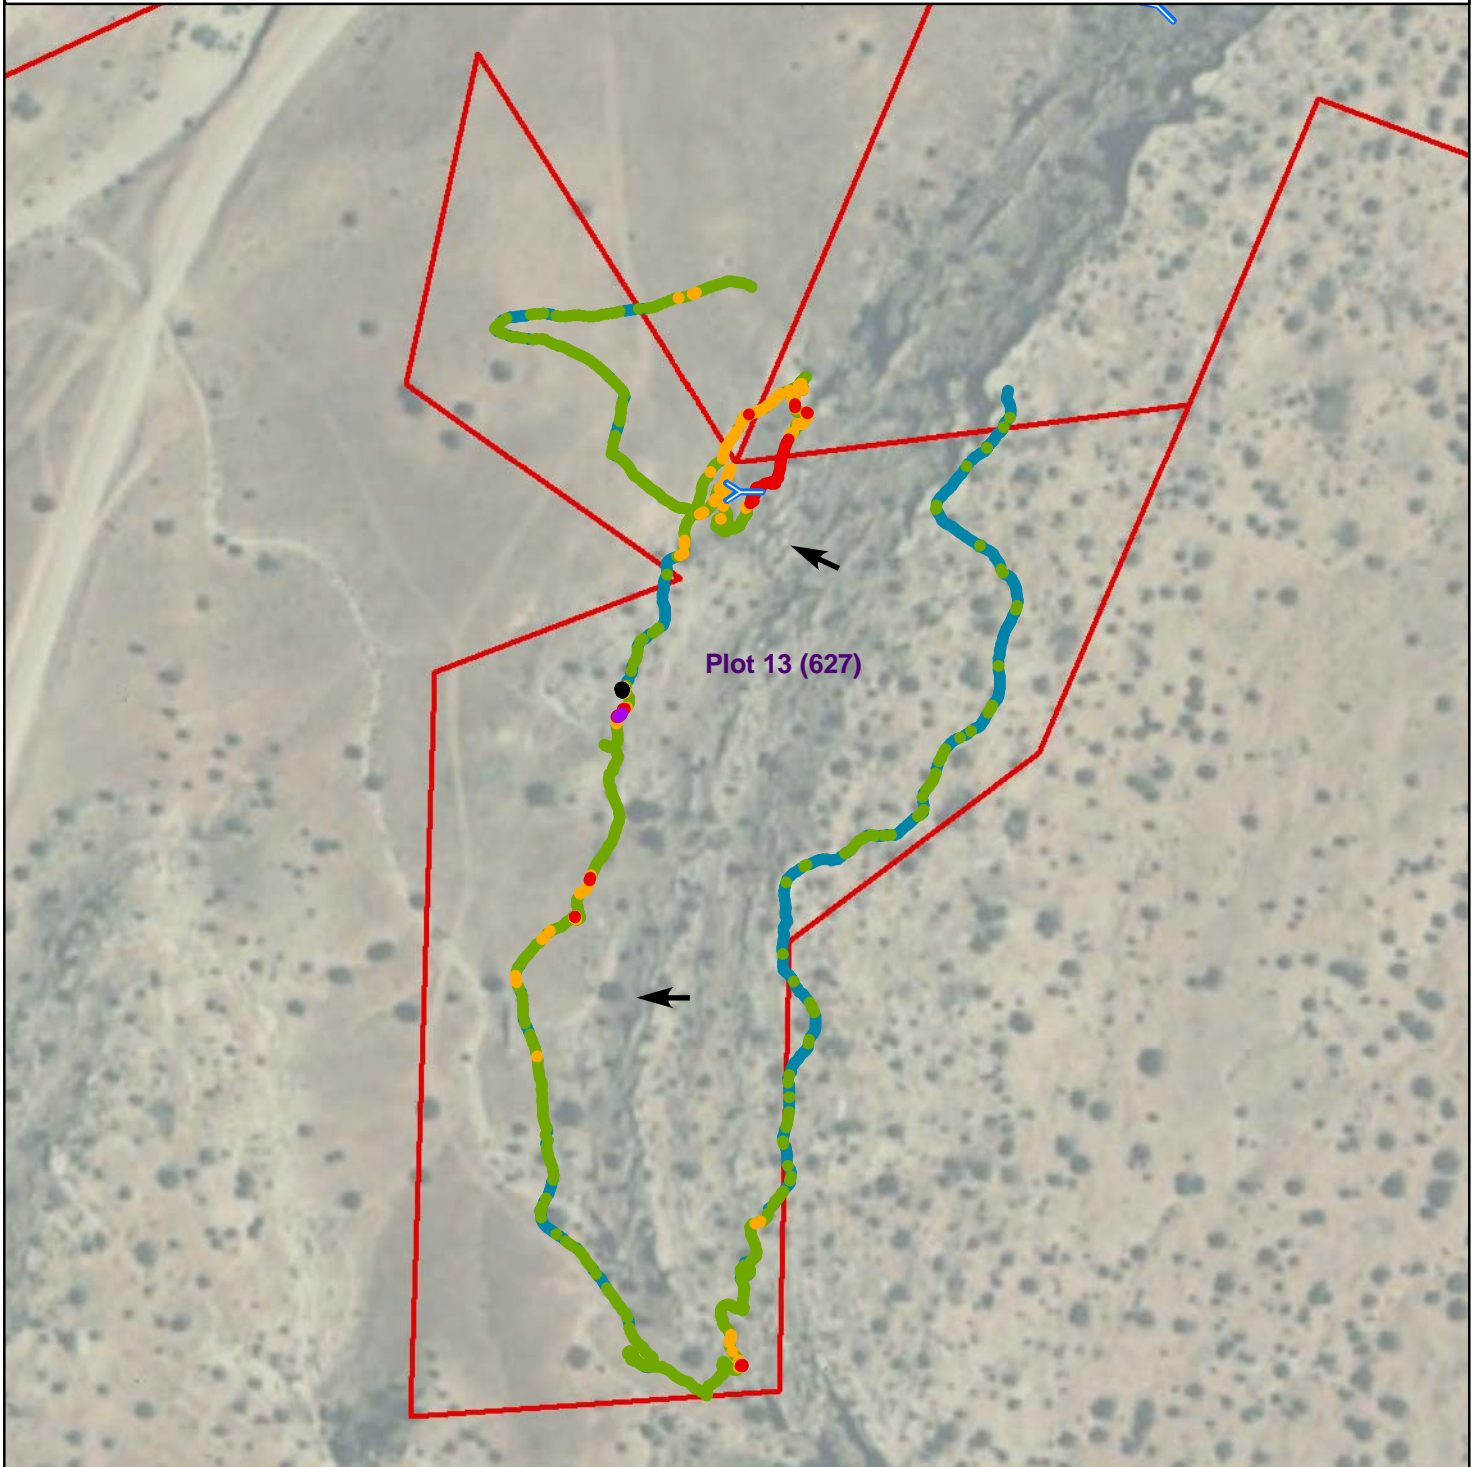
**Figure 2 - Gamma Radiation Measurements  
Plot 13 (627)  
Sweetwater, Navajo Nation**

Gamma survey conducted 06/2010  
Measured as counts per minute (cpm)

Average background 9,634 cpm
