Navajo Abandoned Uranium Mine

Site Screen Report

Plot 10 AUM Site

August 2010

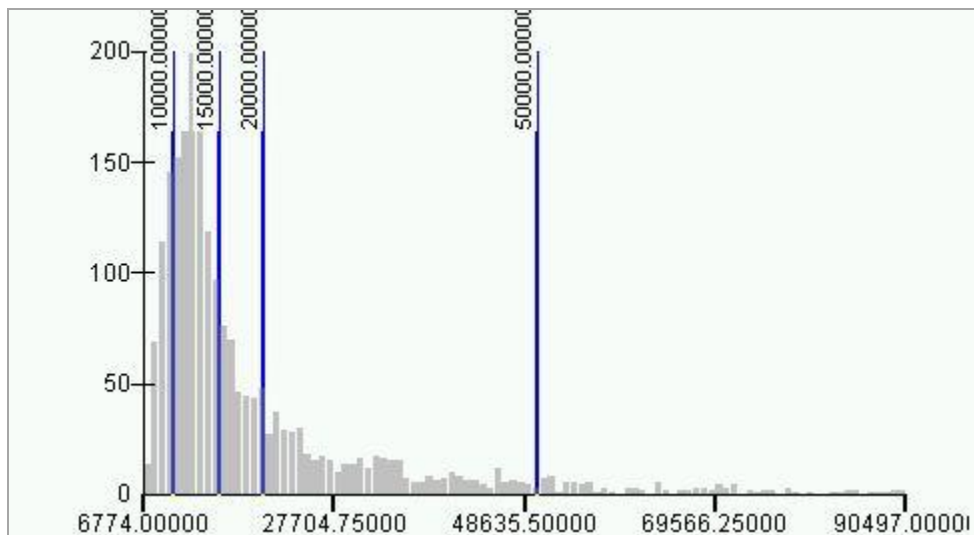
The following chart and statistics were generated by ESRI ArcGIS 9.3.1, and show the general distribution of the site gamma radiation measurements. The horizontal X axis represents the gamma radiation reading levels in cpm (lowest levels to the left). The vertical Y axis represents the frequency of each gamma radiation level.

Count:	2142
Minimum:	6774.00000
Maximum:	90497.00000
Sum:	40631765.00000
Mean:	18969.07796
Median:	13667.50000
Standard Deviation:	13616.08456

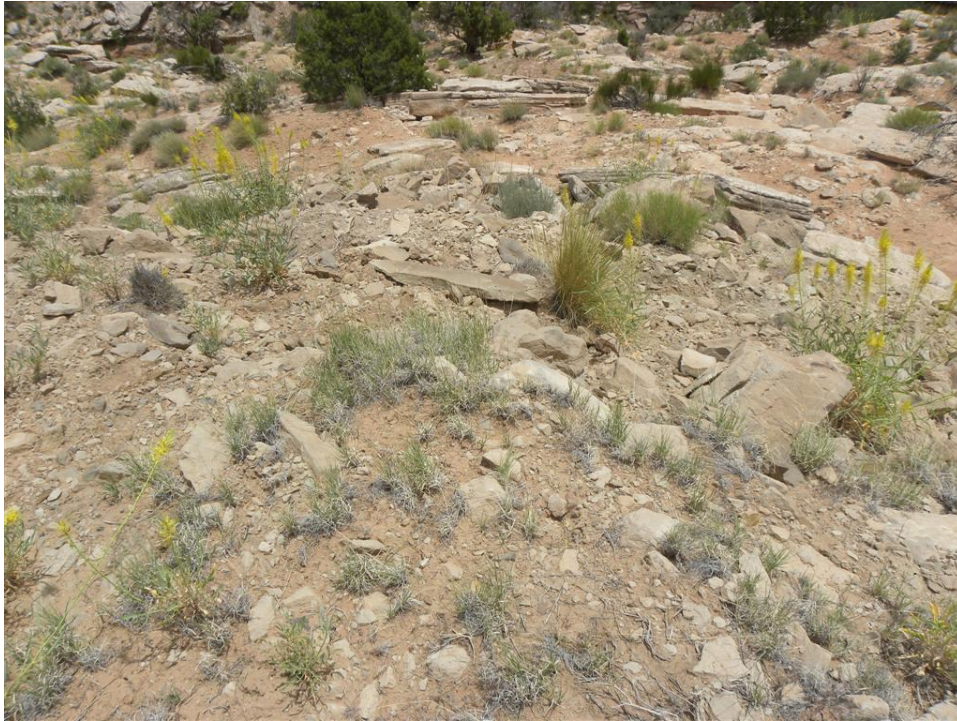
Photo 1. Plot 10 site

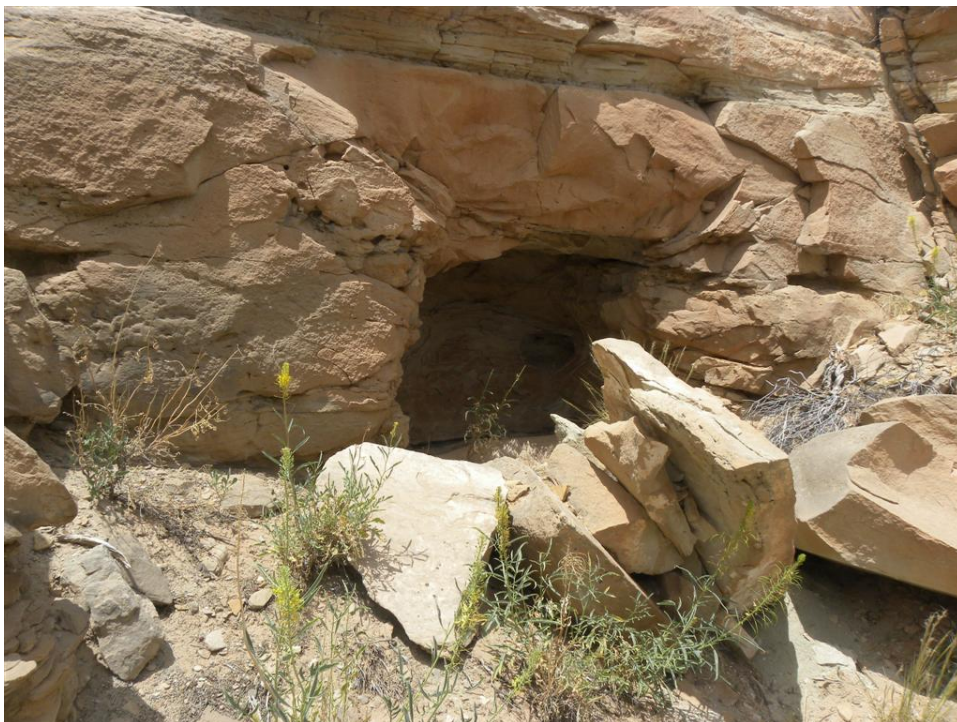
2 unfinished adits, 5'x5' & 4'x4'

Waste pile beneath adit 1 30'x20'x5'; waste pile beneath adit 2 15'x10'x3'

Photo 2. Plot 10 site, unfinished adit 1

2 unfinished adits, unreclaimed waste rock

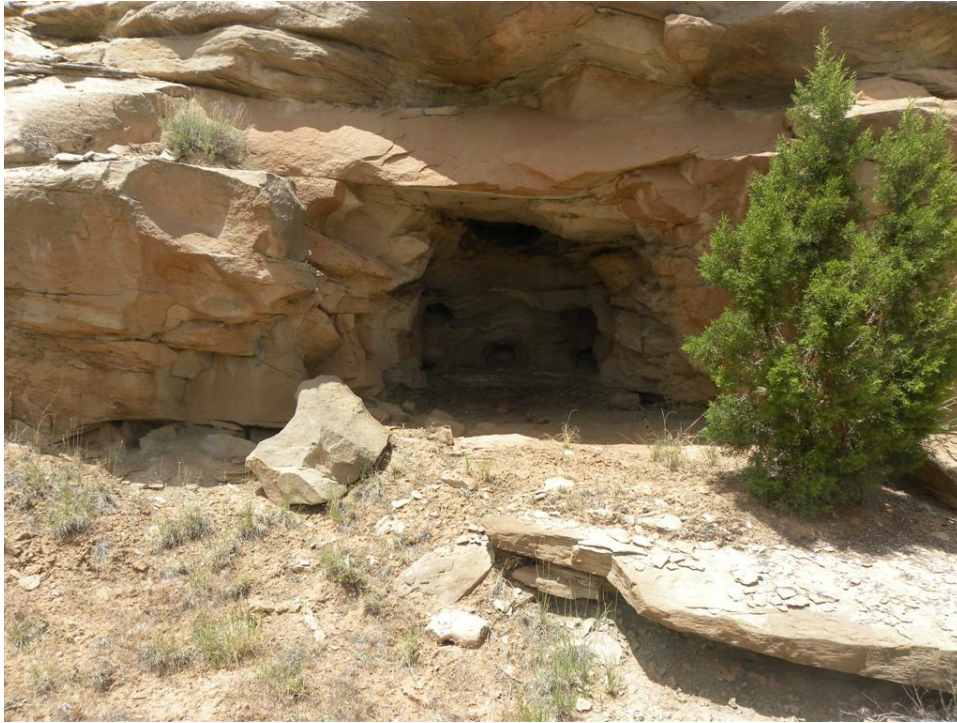
Photo 3. Plot 10 site, unfinished adit 2

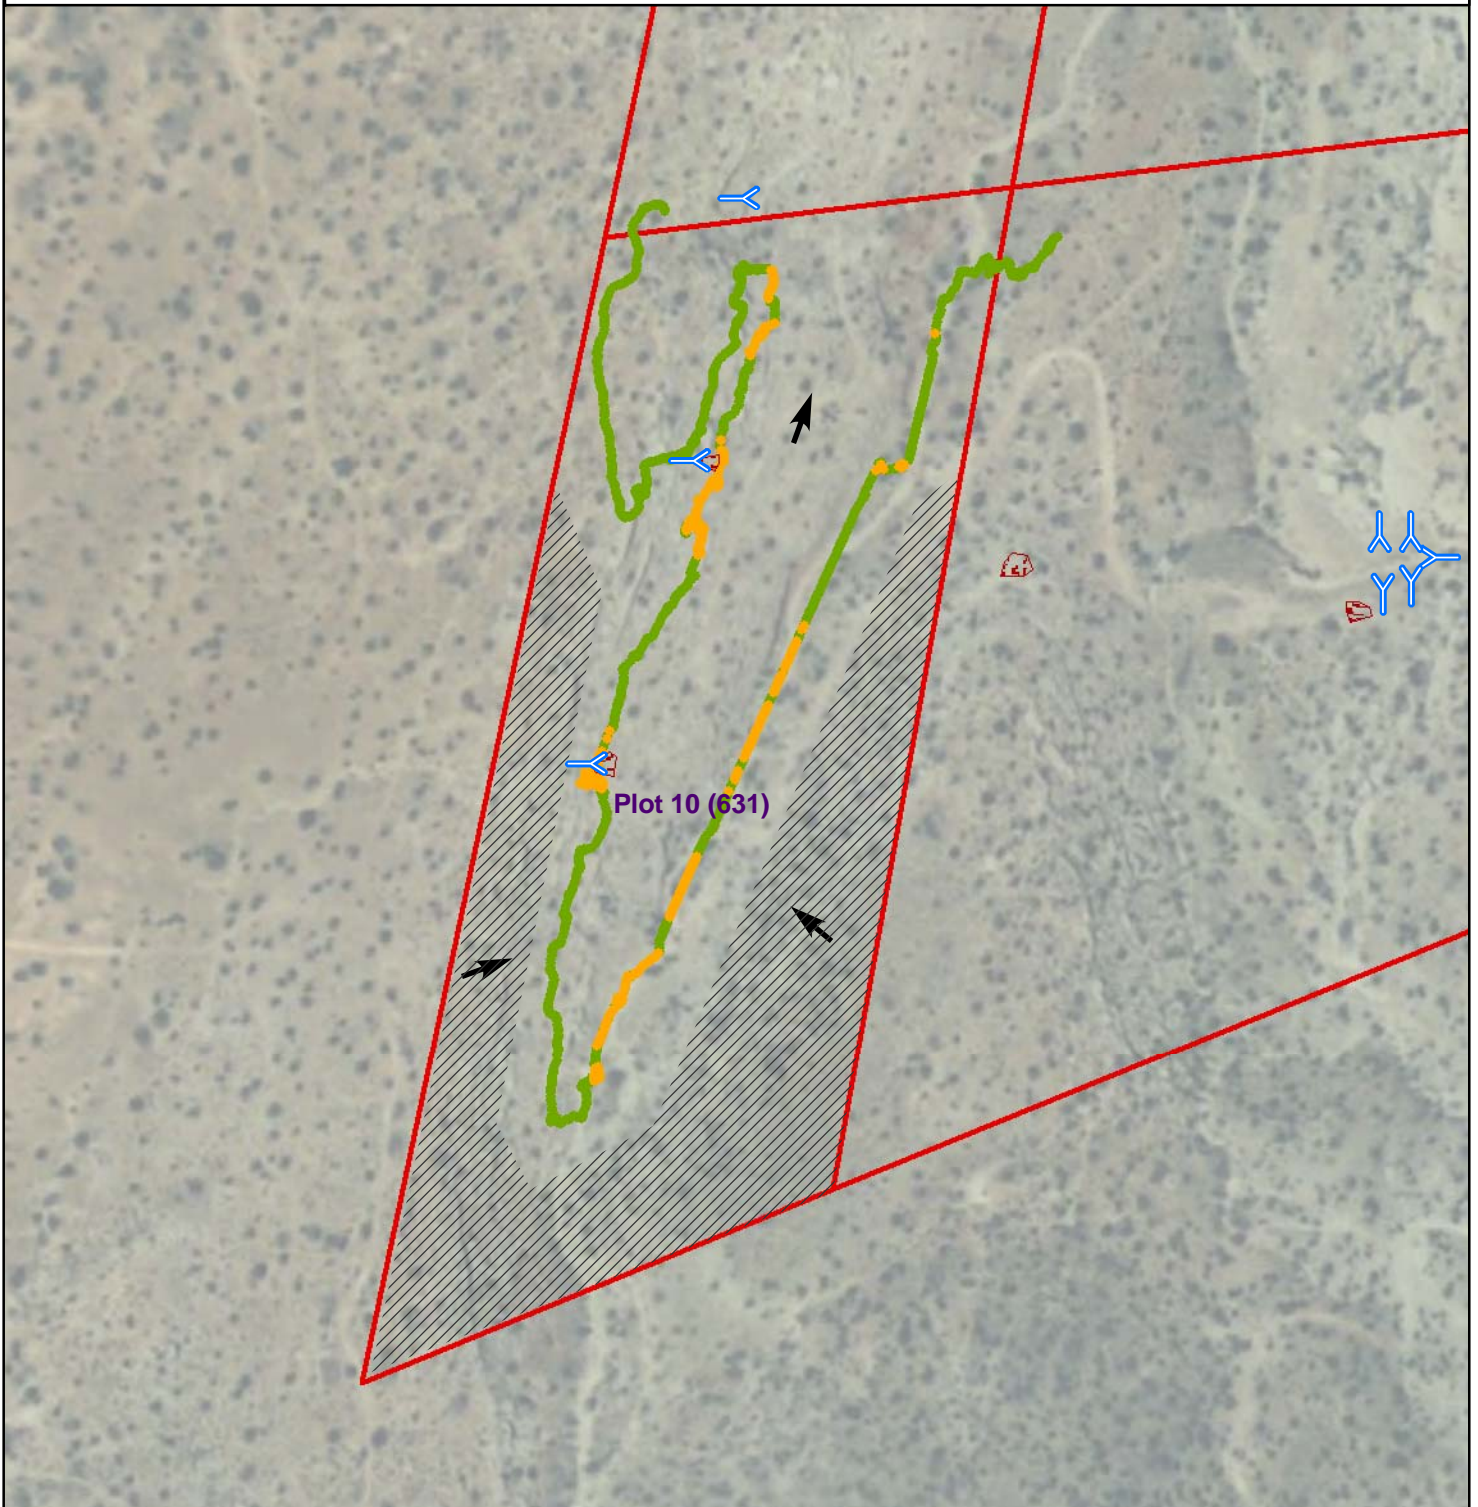
A total of 2,142 gamma radiation measurements were collected from the mine site, ranging from 6,774 cpm to 90,497 cpm. Measurements collected in the vicinity of the waste debris were found at levels up to approximately 90,000 cpm, and near the adits at levels up to approximately 60,000 cpm. The measurements are represented in Figures 1 and 2.

**Figure 1 - Gamma Radiation Measurements, Above Two Times Background
Plot 10 (631)
Teec Nos Pos Chapter, Navajo Nation**

Gamma survey conducted 06/2010
Measured as counts per minute (cpm)

Average background = 9,266 cpm

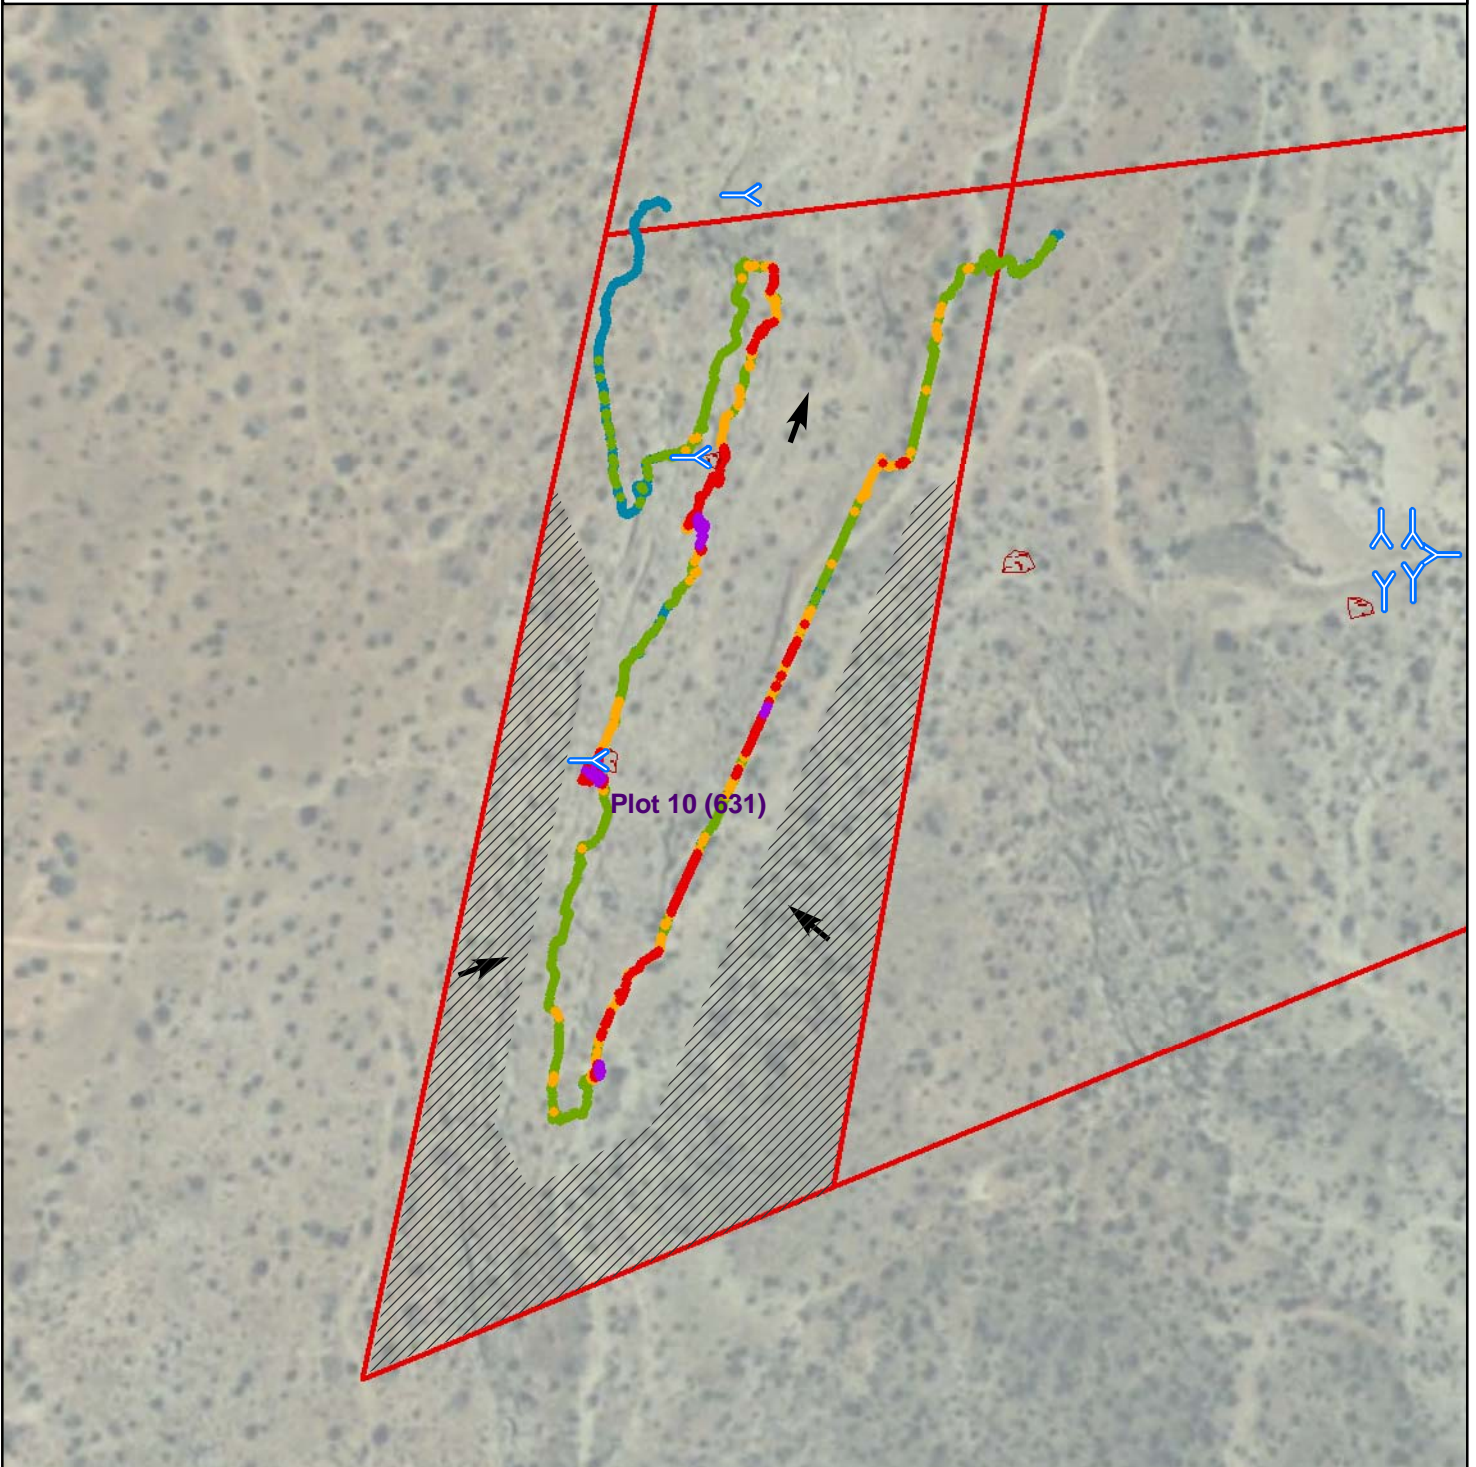
**Figure 2 - Gamma Radiation Measurements
Plot 10 (631)
Teec Nos Pos Chapter, Navajo Nation**

Gamma survey conducted 06/2010
Measured as counts per minute (cpm)

Average background 9,266 cpm
