Navajo Abandoned Uranium Mine

Site Screen Report

Block K AUM Site

August 2010

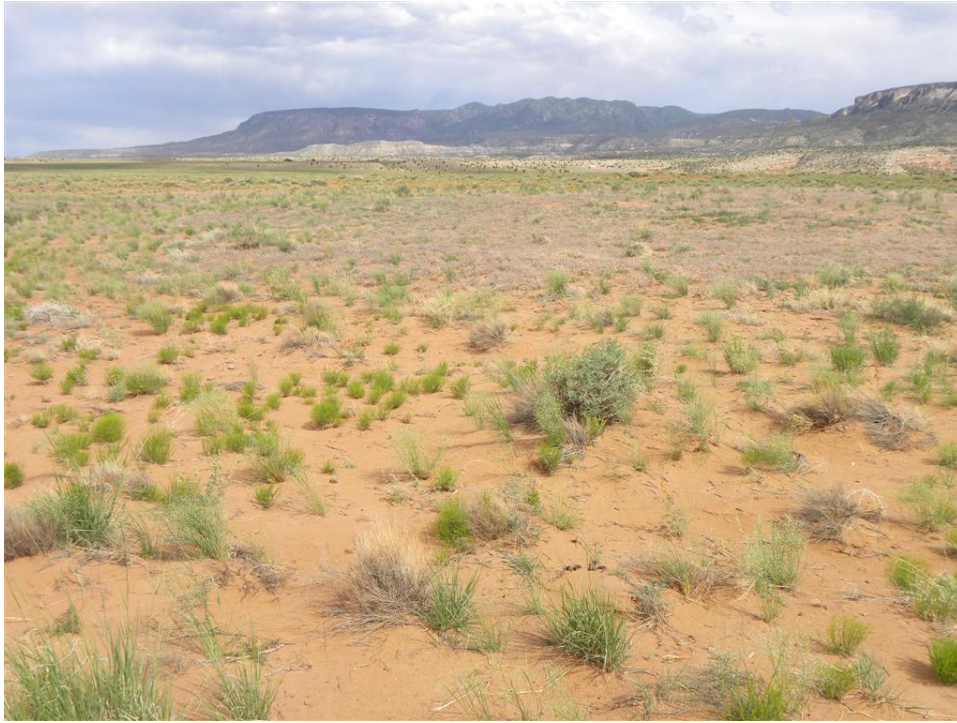
Photo 1. Block K site

150' diameter dirt mound in center of site, likely reclamation cap

Possible reclamation cap

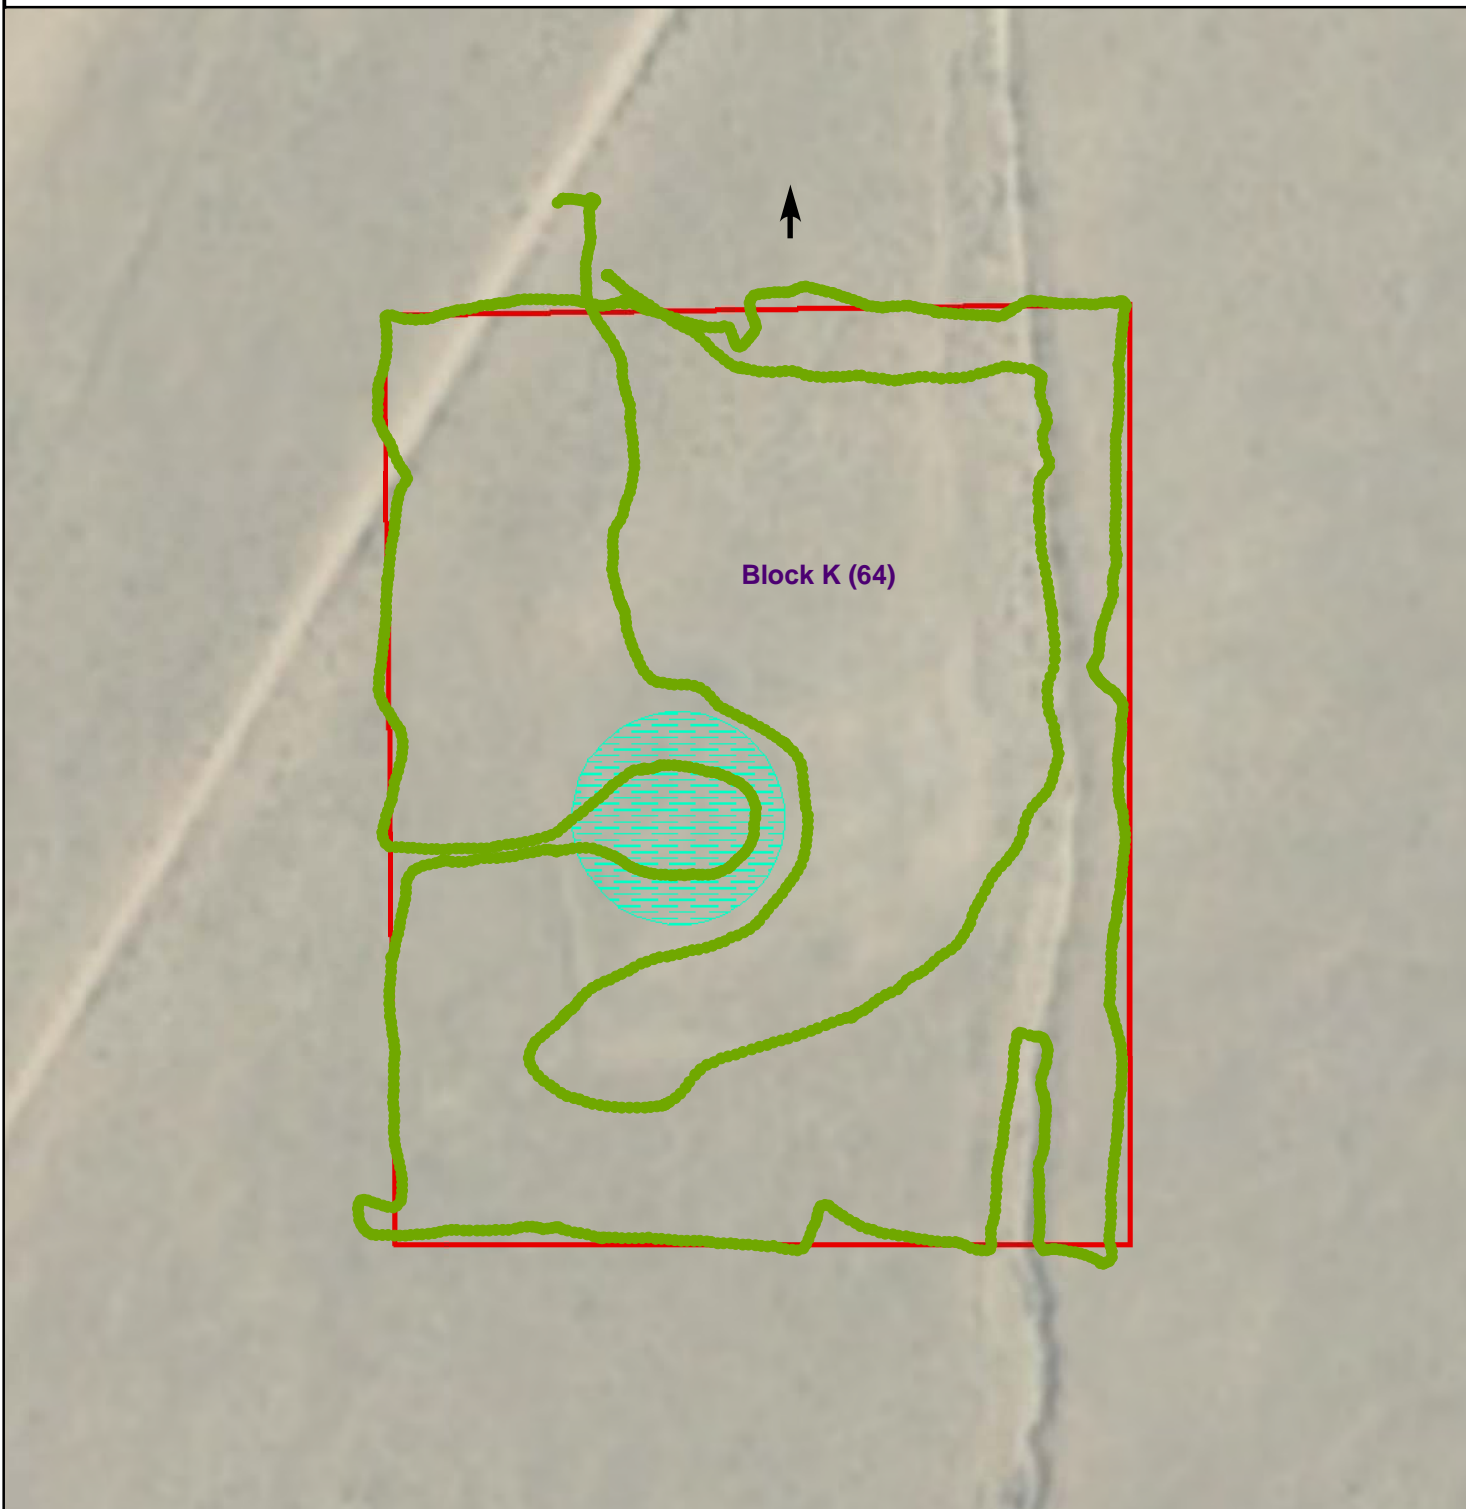
**Figure 1 - Gamma Radiation Measurements, Above Two Times Background
Block K (64)
Teec Nos Pos Chapter, Navajo Nation**

A total of 1,449 gamma radiation measurements were collected from the mine site, ranging from 5,918 cpm to 12,225 cpm. The measurements are represented in Figures 1 and 2.

Gamma survey conducted 06/2010
Measured as counts per minute (cpm)

Average background = 7,684 cpm

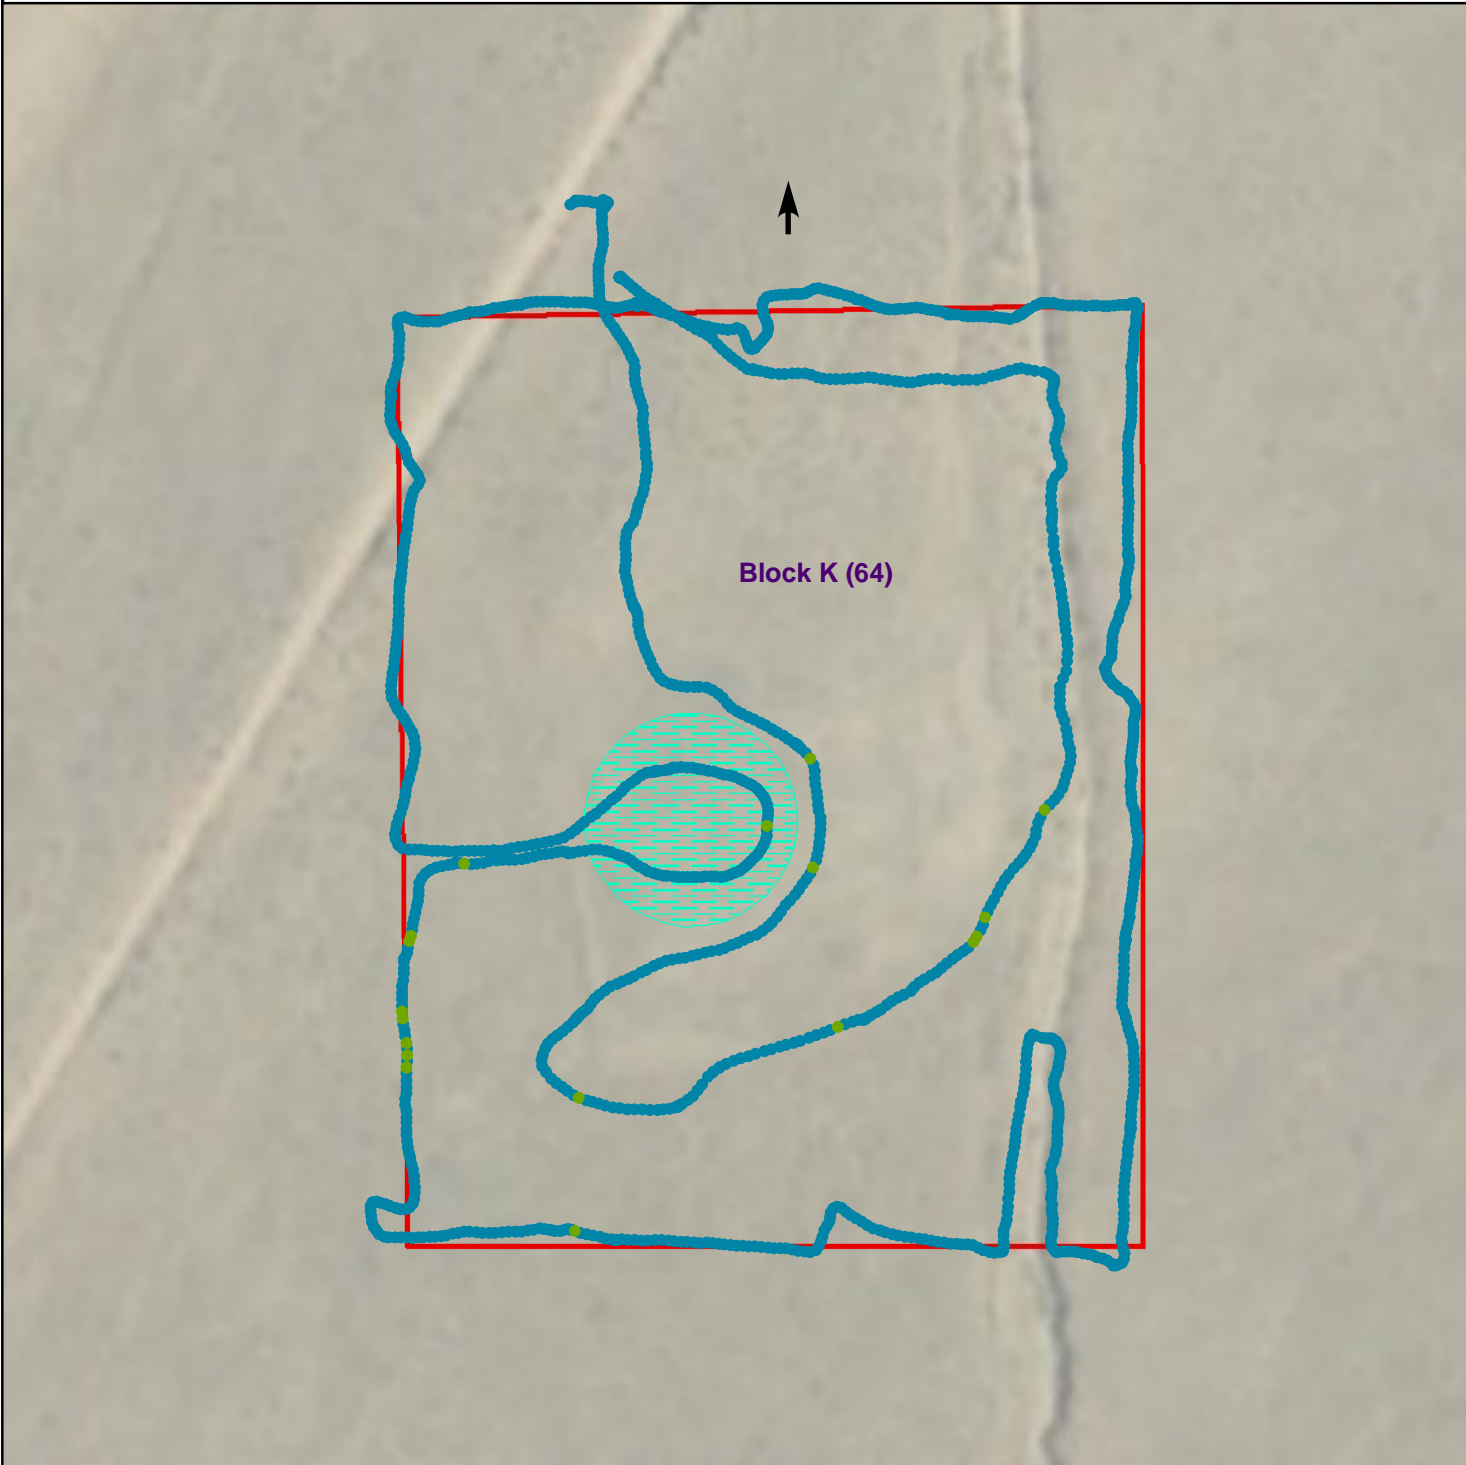
**Figure 2 - Gamma Radiation Measurements
Block K (64)
Teec Nos Pos Chapter, Navajo Nation**

**Gamma survey conducted 06/2010
Measured as counts per minute (cpm)**

Average background 7,684 cpm
