Navajo Abandoned Uranium Mine

Site Screen Report

Plot 4 AUM Site

August 2010

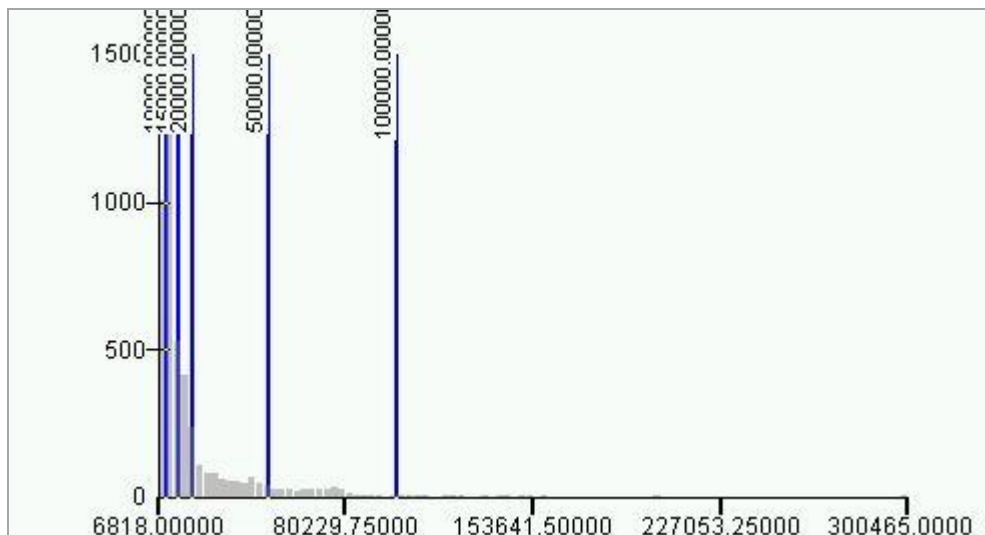
The following chart and statistics were generated by ESRI ArcGIS 9.3.1, and show the general distribution of the site gamma radiation measurements. The horizontal X axis represents the gamma radiation reading levels in cpm (lowest levels to the left). The vertical Y axis represents the frequency of each gamma radiation level.

Count:	4615
Minimum:	6818.00000
Maximum:	300465.00000
Sum:	106897047.00000
Mean:	23162.95710
Median:	12498.00000
Standard Deviation:	29330.38442

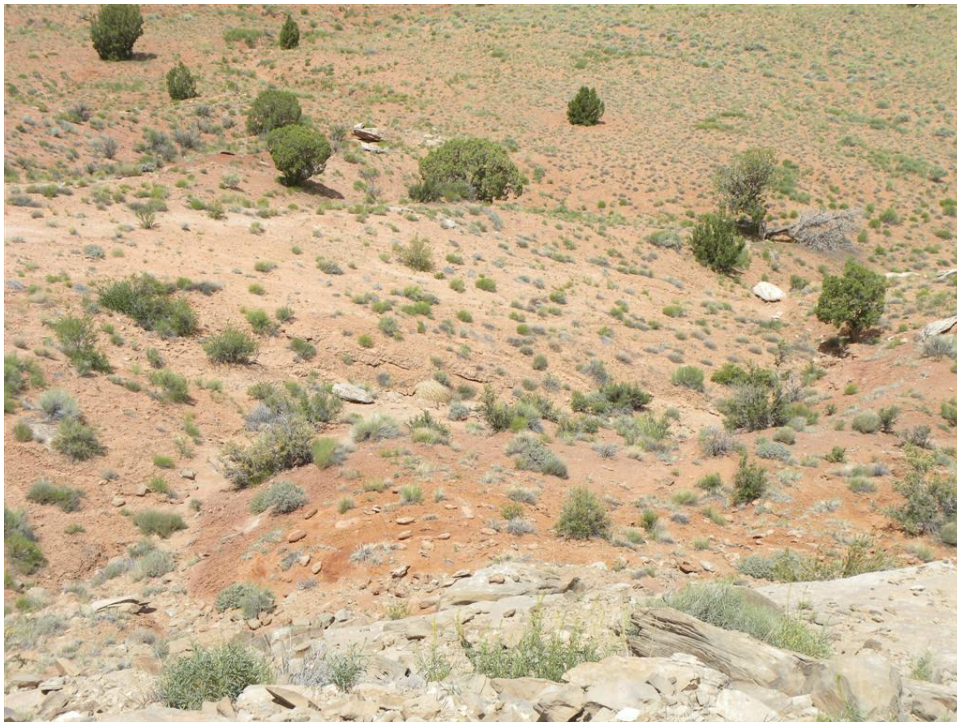
Furrow running E-W at N boundary, 100 ft long; cap above ridge at W boundary; black vent in concrete pad

Is there a reclamation cap or sealed adit in place at the site? Yes

Is the cap/seal functionally intact? Yes

Photo 2. Plot 4 site, cap

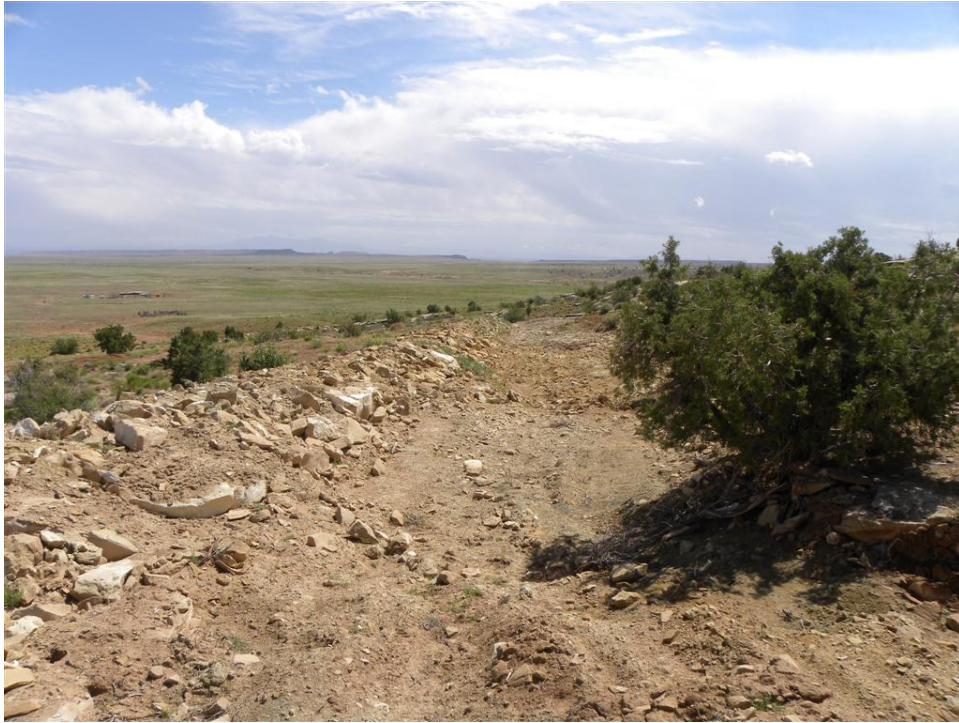
Photo 3. Plot 4 site, furrow

Reclamation cap; furrow; unreclaimed waste rock

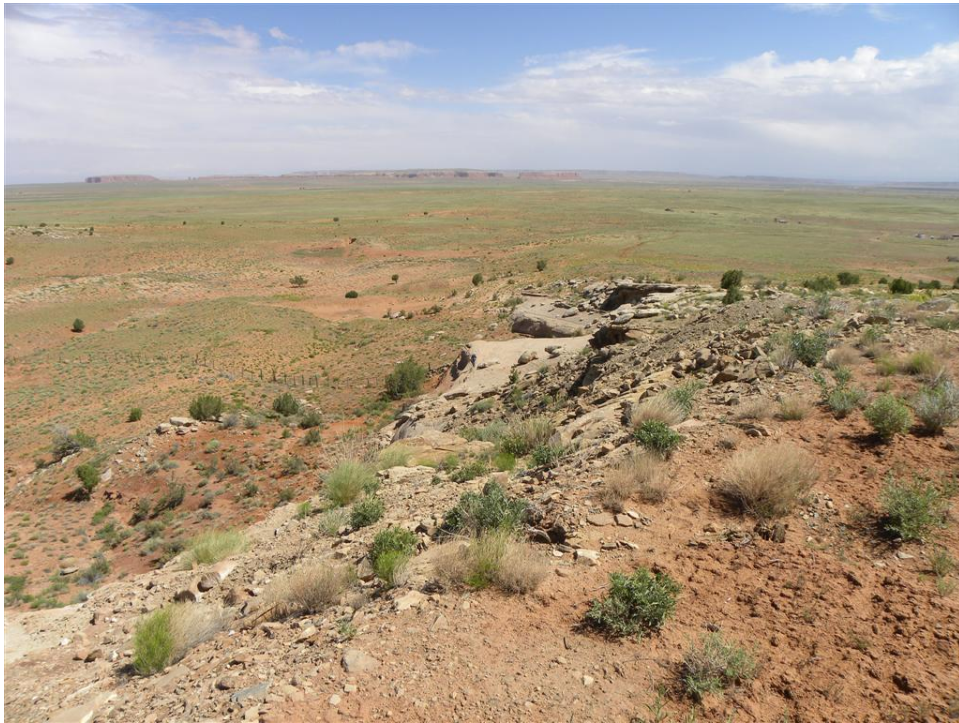
2 waste piles along ridge of reclamation cap 25'x25'x5'; piles fall off edge towards drainage 50'x50'x5'

Photo 4. Plot 4 site, slope

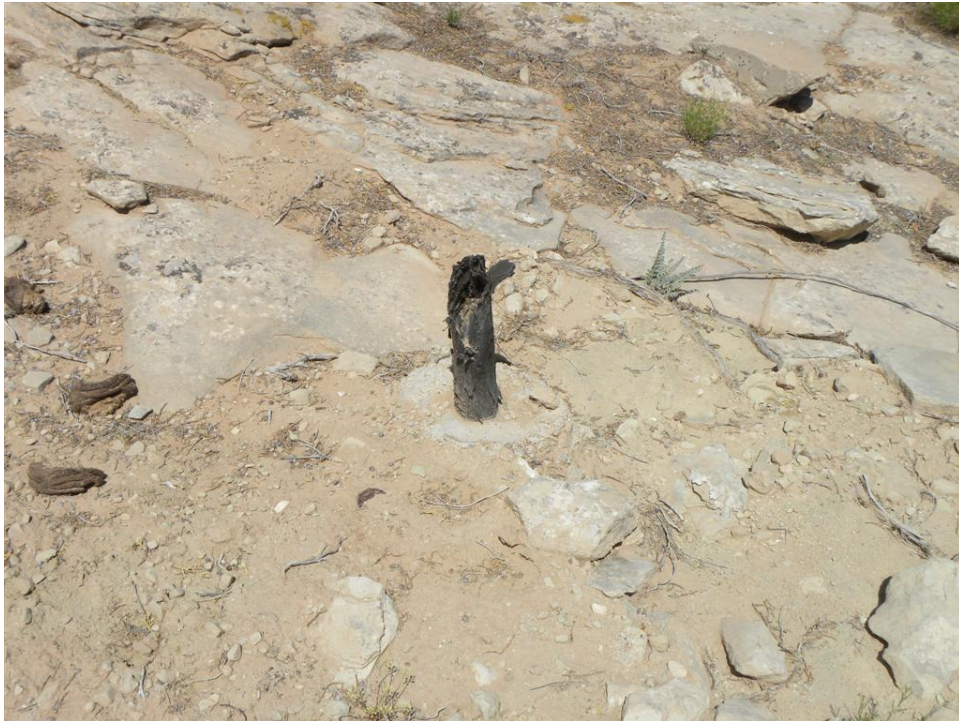
Photo 5. Plot 4 site, vent pipe

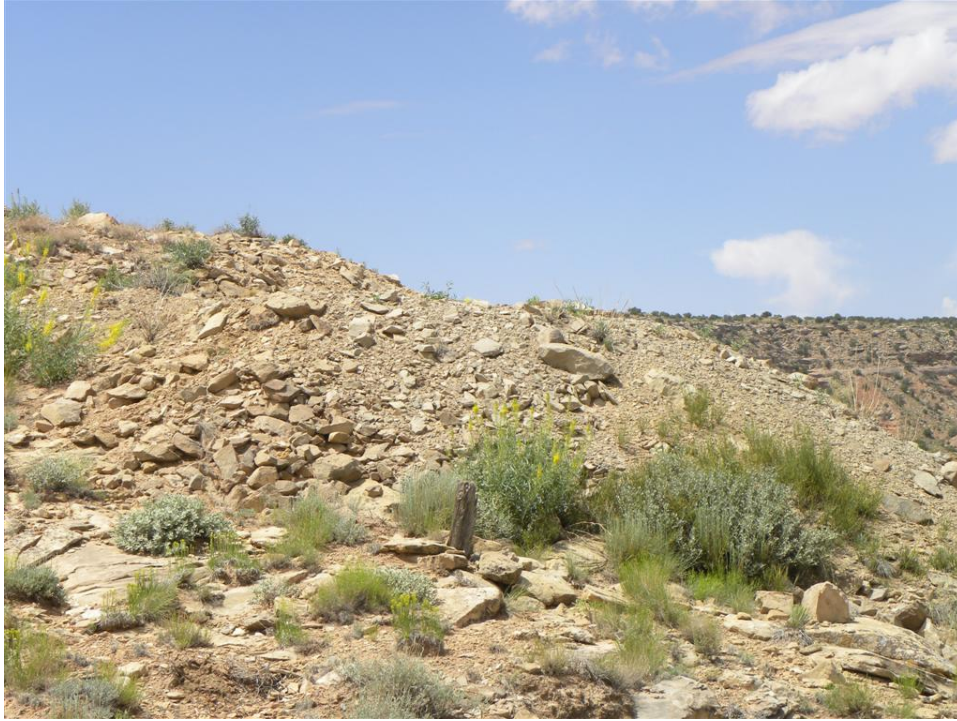
Is there an unreclaimed waste pile at the site? Yes

Photo 6. Plot 4 site, unreclaimed waste

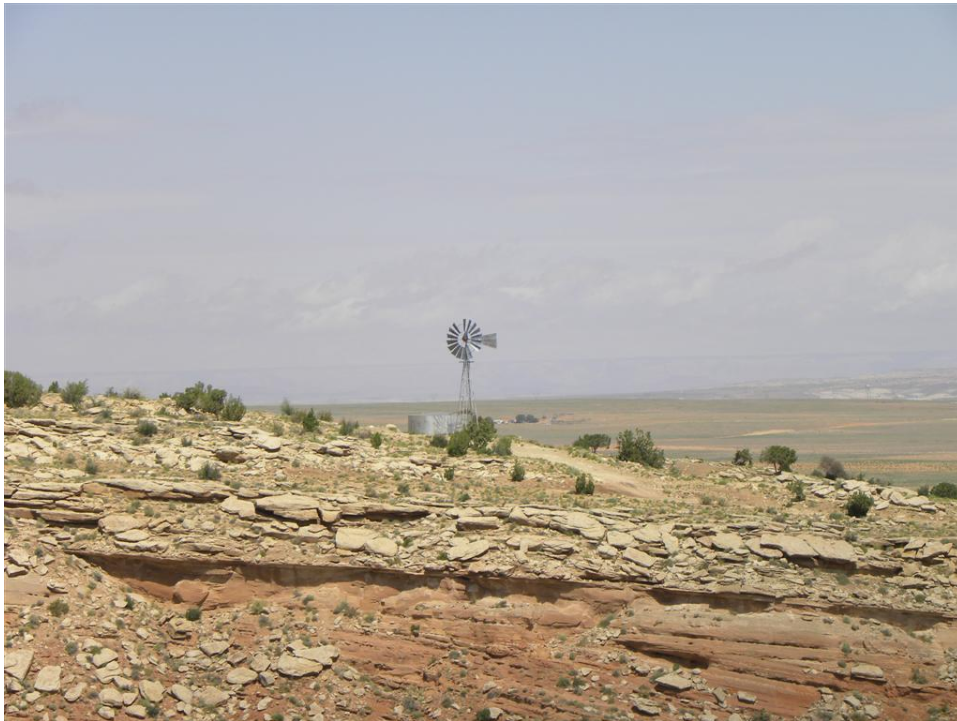
0.25 miles to 4 miles: Windmill well 0.25 mi NW of site

Photo 7. Plot 4 site, windmill well

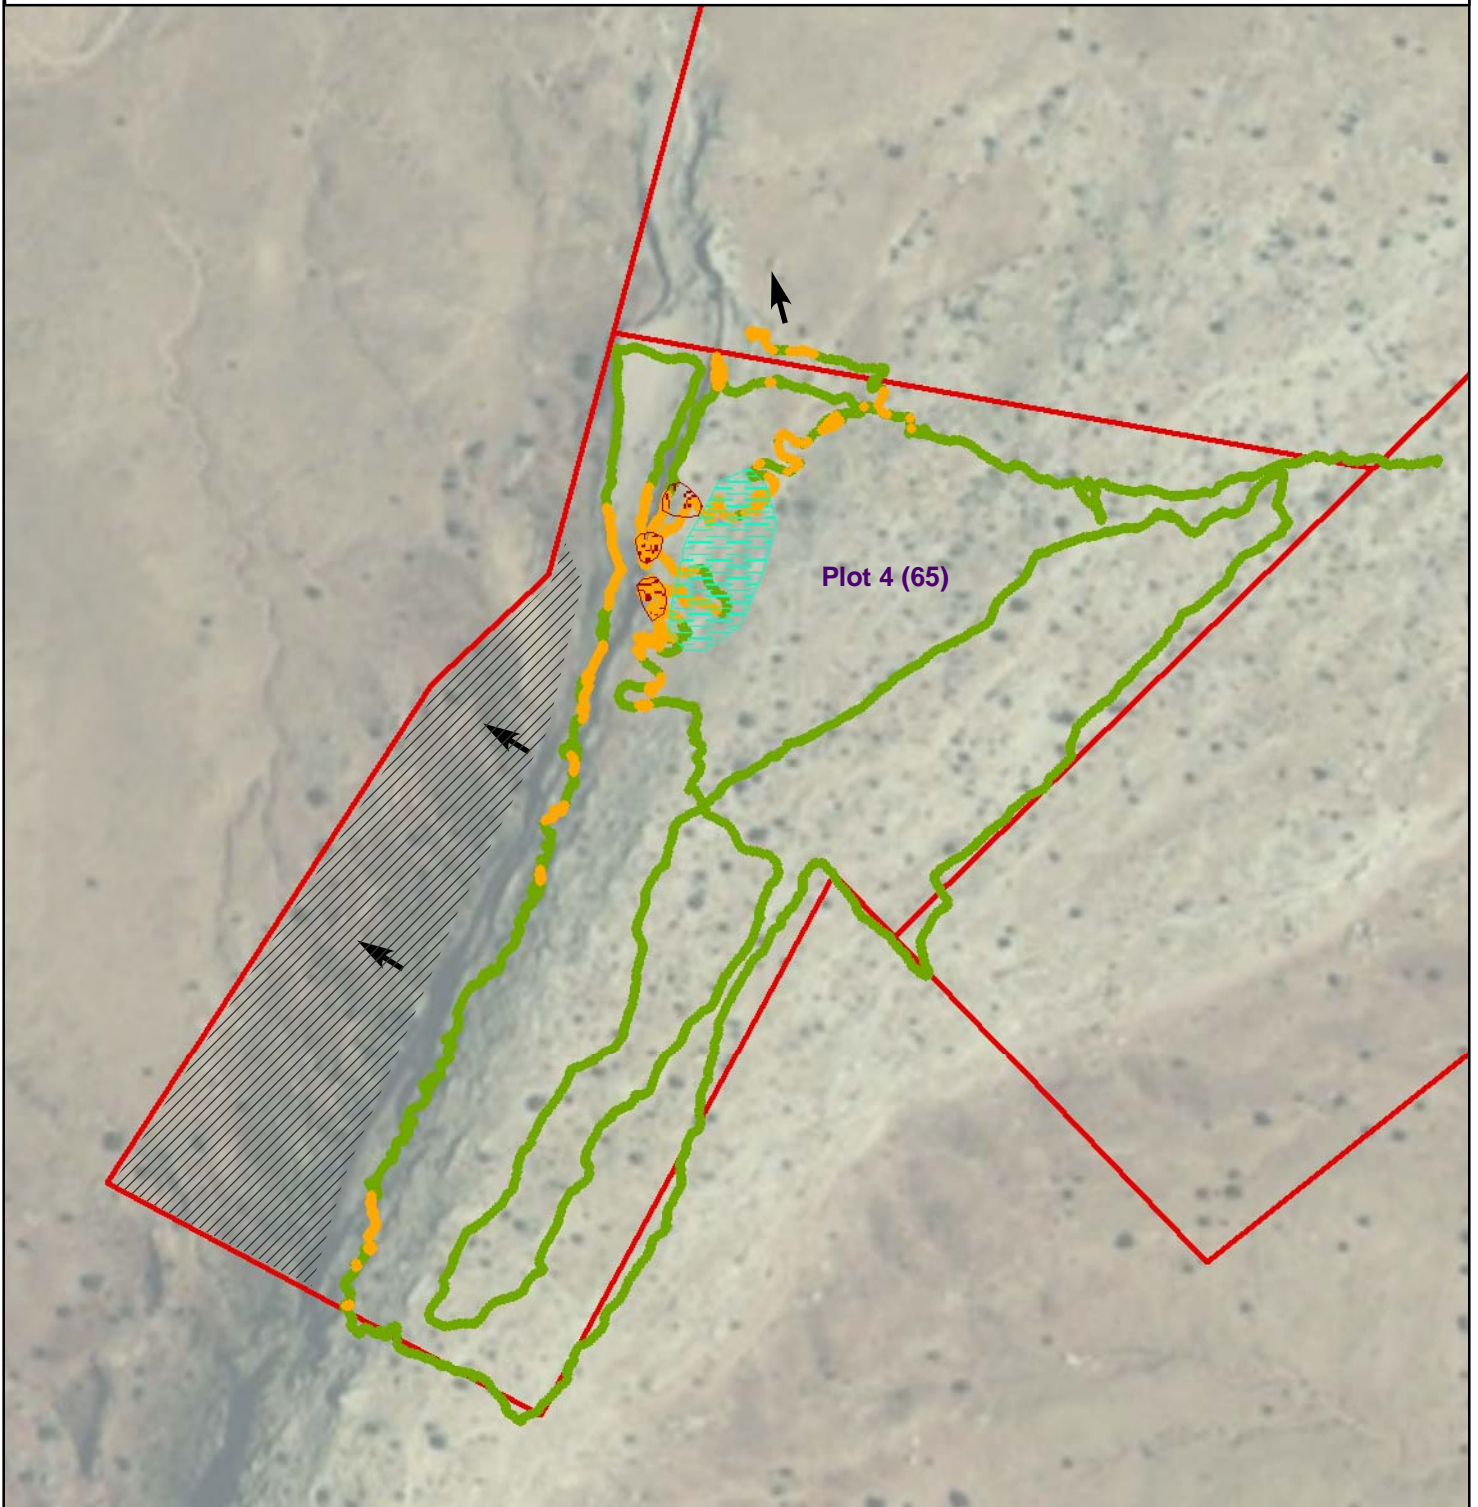
**Figure 1 - Gamma Radiation Measurements, Above Two Times Background
Plot 4 (65)
Sweetwater / Teec Nos Pos Chapter, Navajo Nation**

A total of 4,615 gamma radiation measurements were collected from the mine site, ranging from 6,818 cpm to 300,465 cpm. Measurements collected in the vicinity of the waste debris were found at levels ranging from approximately 15,000 cpm to 100,000 cpm, and at a spot of exposed uranium ore at levels up to approximately 300,000 cpm. The measurements are represented in Figures 1 and 2.

Gamma survey conducted 06/2010
Measured as counts per minute (cpm)

Average background = 10,130 cpm

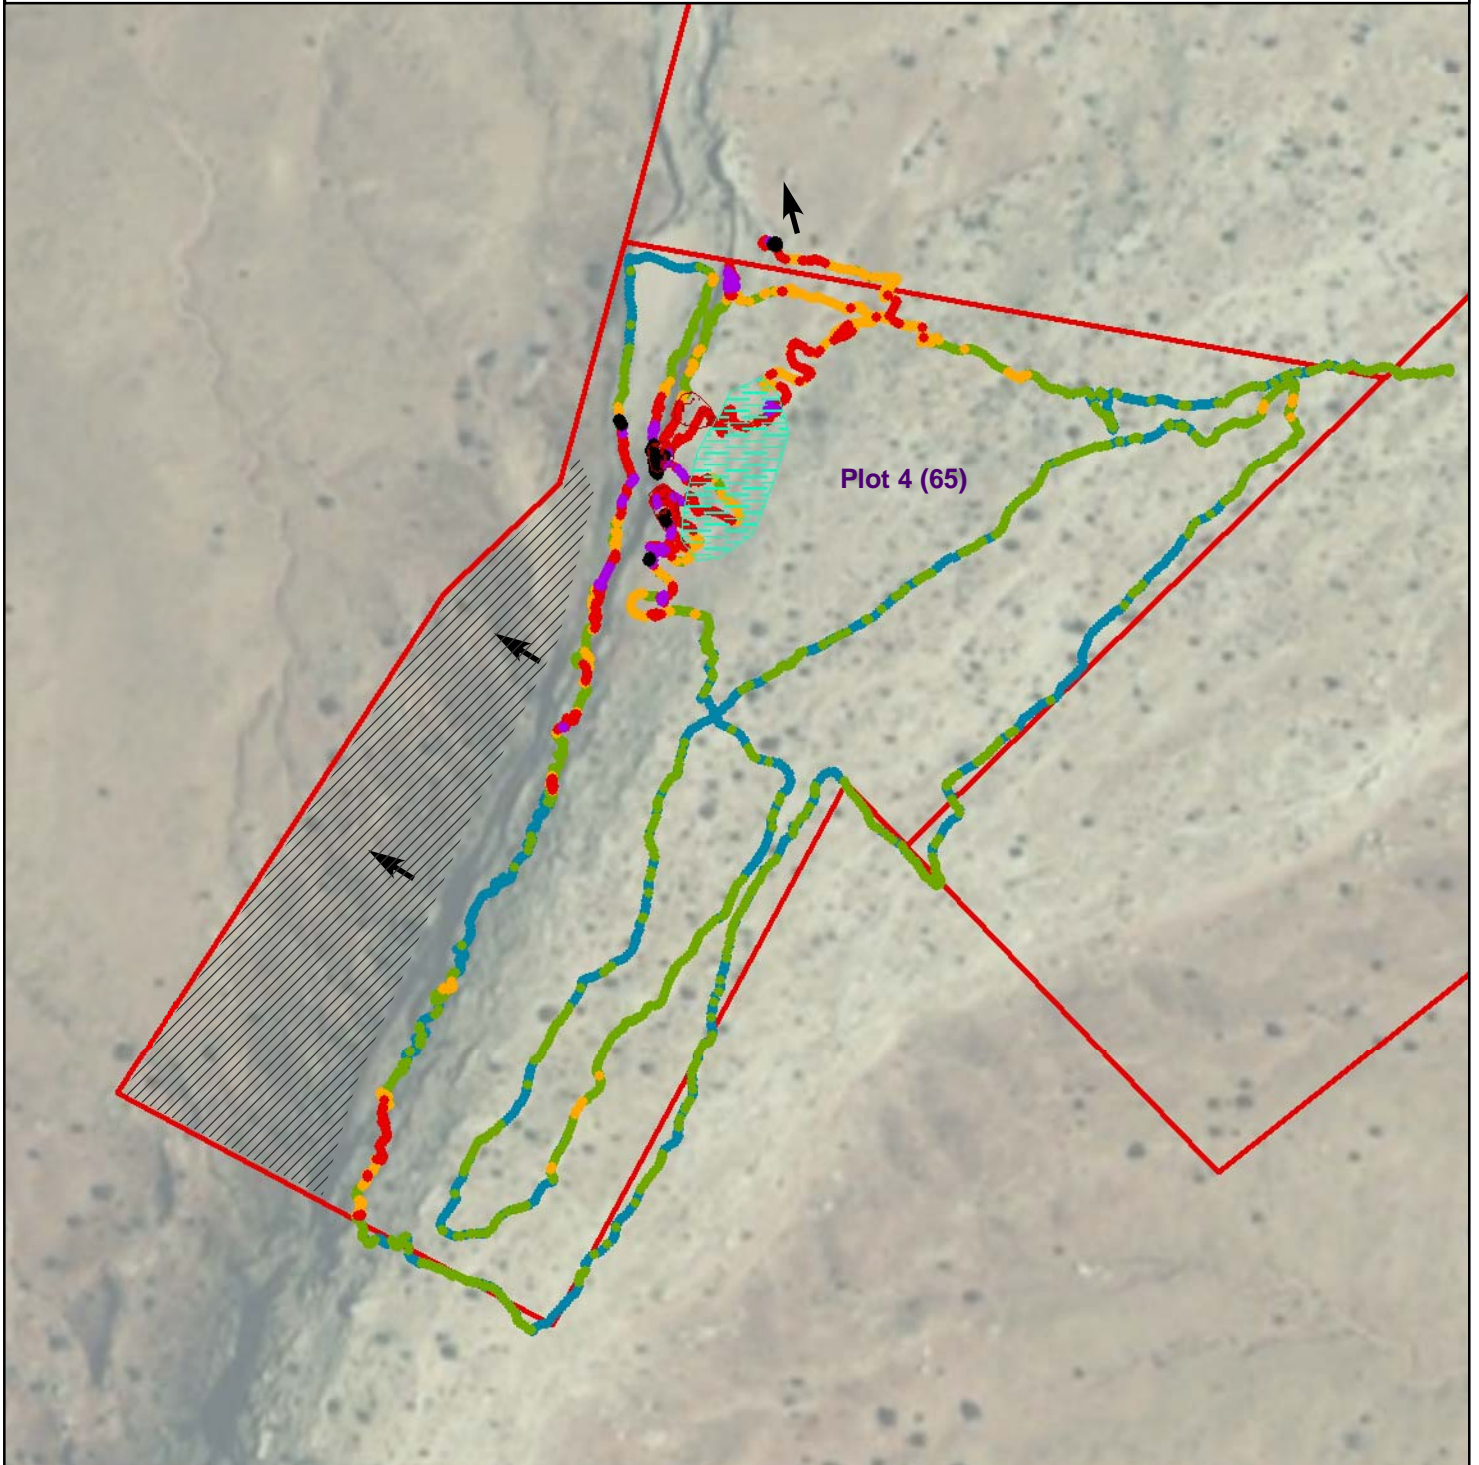
**Figure 2 - Gamma Radiation Measurements
Plot 4 (65)
Sweetwater / Teec Nos Pos Chapter, Navajo Nation**

**Gamma survey conducted 06/2010
Measured as counts per minute (cpm)**

Average background 10,130 cpm
