Navajo Abandoned Uranium Mine

Site Screen Report

School Boy AUM Site

August 2010

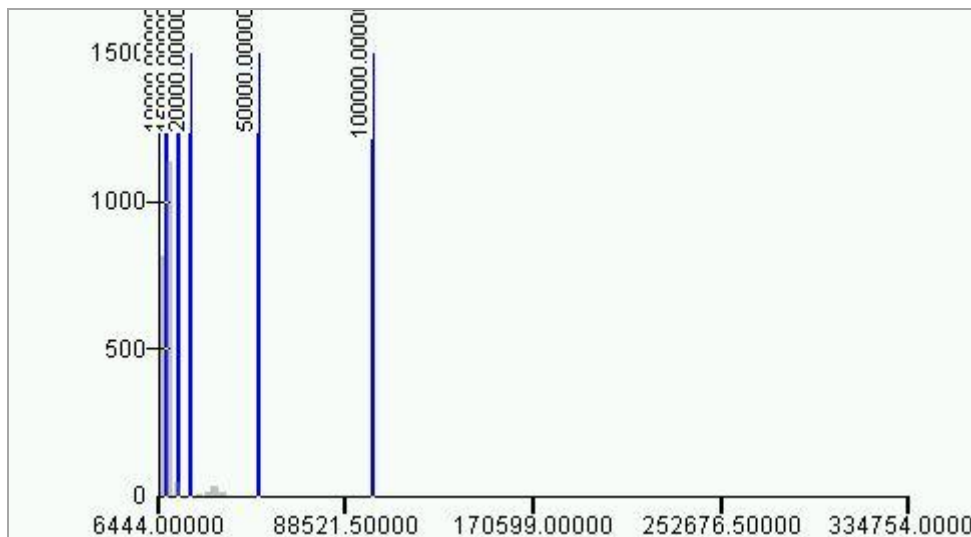
The following chart and statistics were generated by ESRI ArcGIS 9.3.1, and show the general distribution of the site gamma radiation measurements. The horizontal X axis represents the gamma radiation reading levels in cpm (lowest levels to the left). The vertical Y axis represents the frequency of each gamma radiation level.

Count:	2089
Minimum:	6444.00000
Maximum:	334754.00000
Sum:	26852772.00000
Mean:	12854.36668
Median:	10074.00000
Standard Deviation:	21912.48540

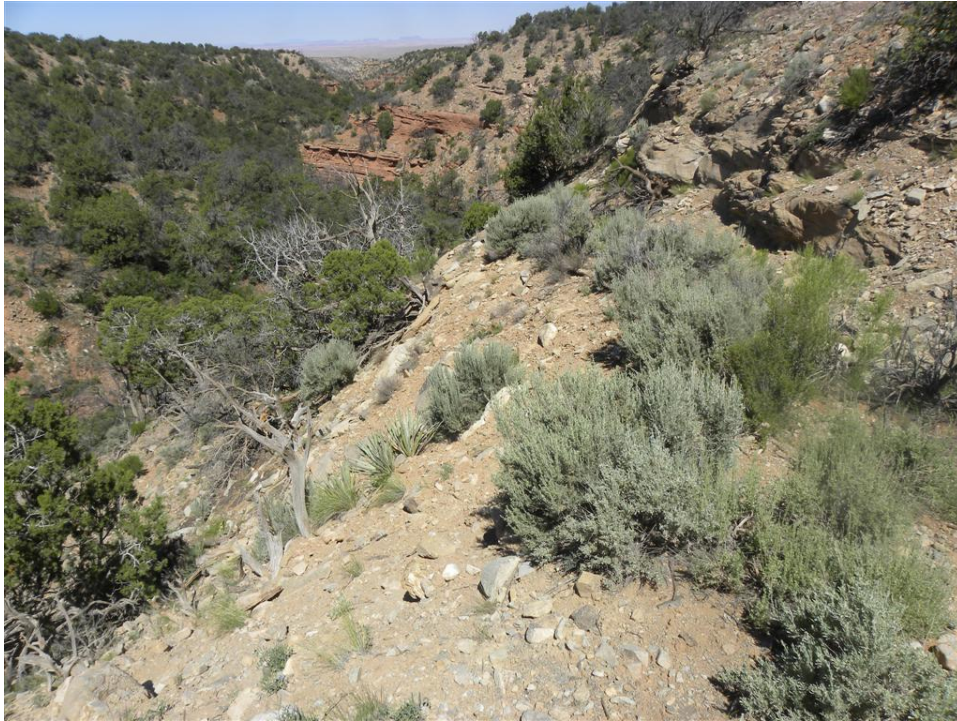
Photo 1. School Boy site

Possible waste pile 100' x 100' (more likely is wall erosion)

Wall erosion (or possibly a waste pile onsite, 100' x 100')

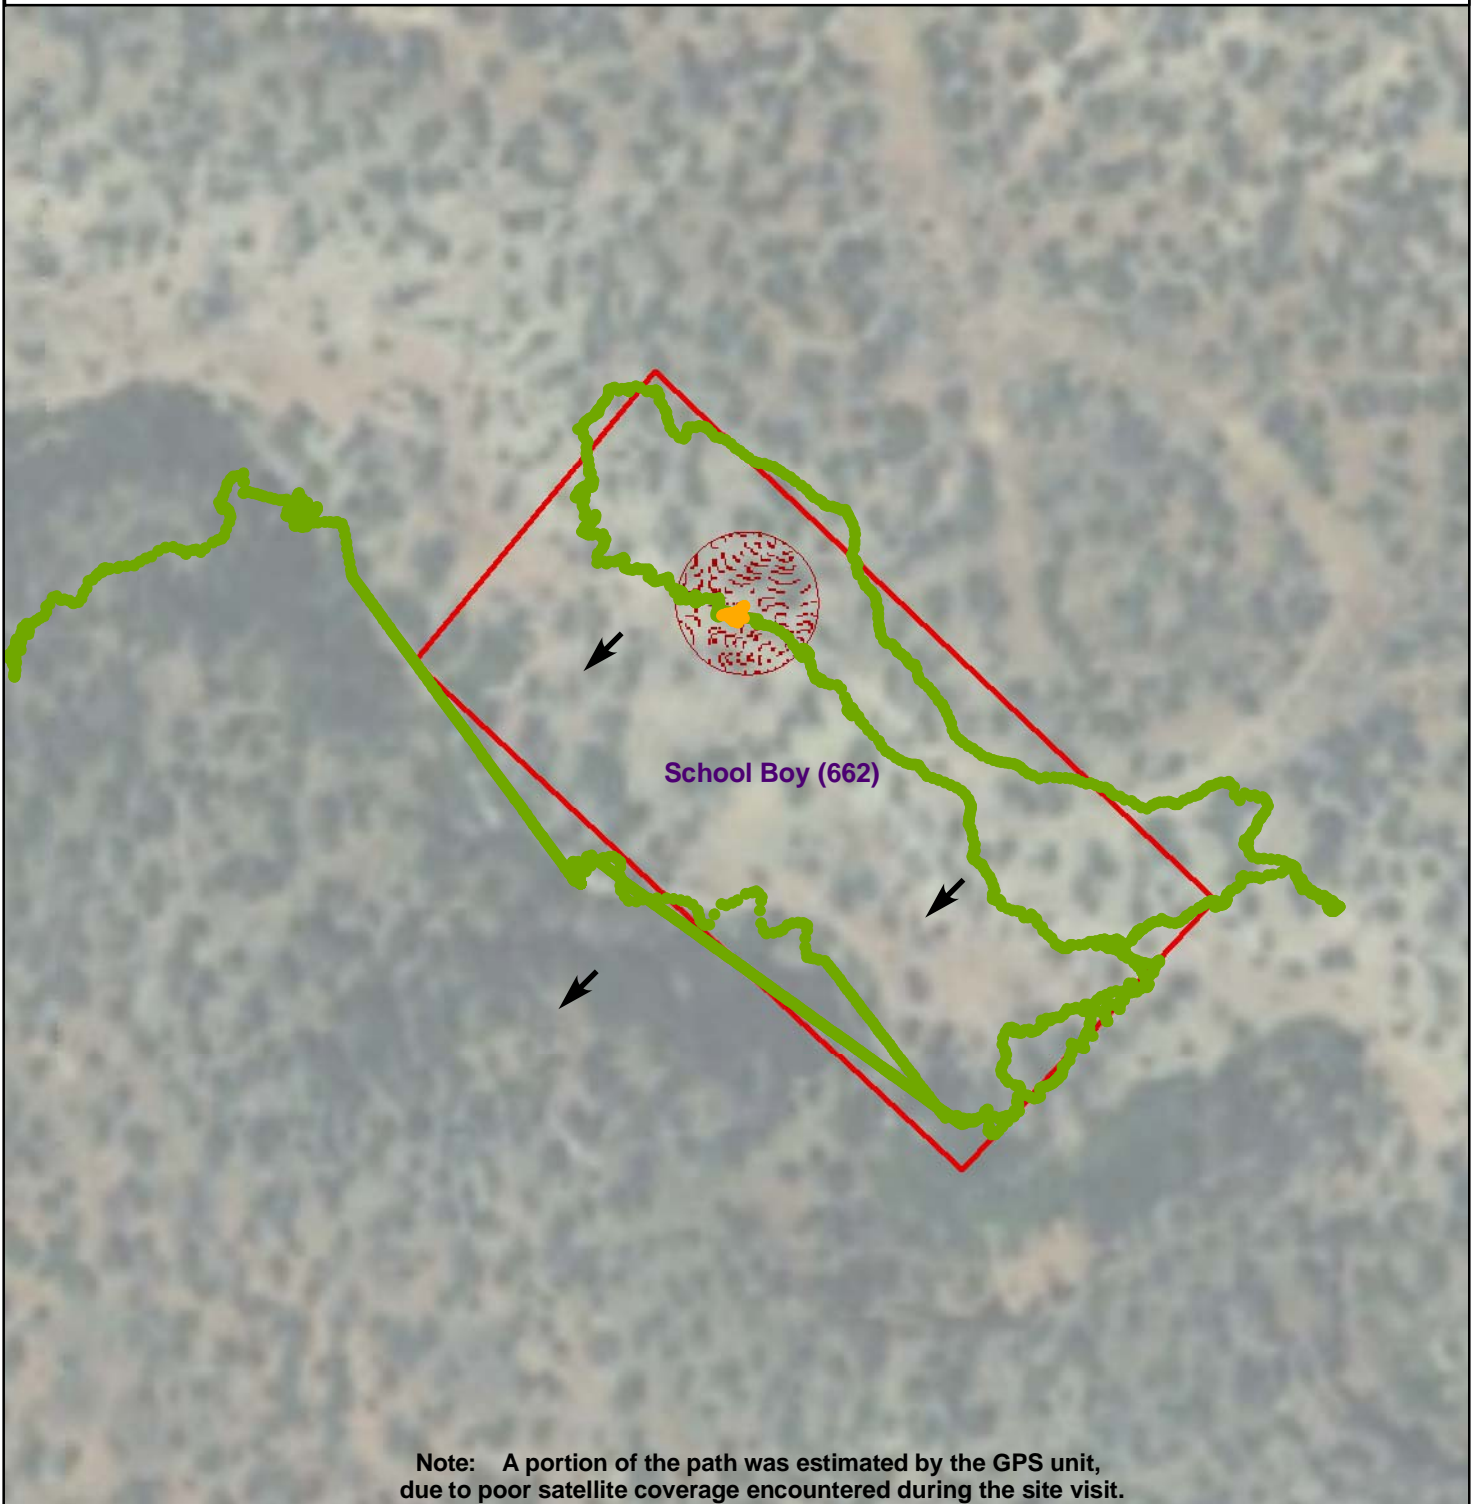
**Figure 1 - Gamma Radiation Measurements, Above Two Times Background
School Boy (662)
Sweetwater Chapter, Navajo Nation**

A total of 2,089 gamma radiation measurements were collected from the mine site, ranging from 6,444 cpm to 334,754 cpm. Measurements collected in the vicinity of the waste debris were found at levels ranging from approximately 60,000 cpm to 330,000 cpm. The measurements are represented in Figures 1 and 2.

Gamma survey conducted 06/2010
Measured as counts per minute (cpm)

Average background = 10,312 cpm

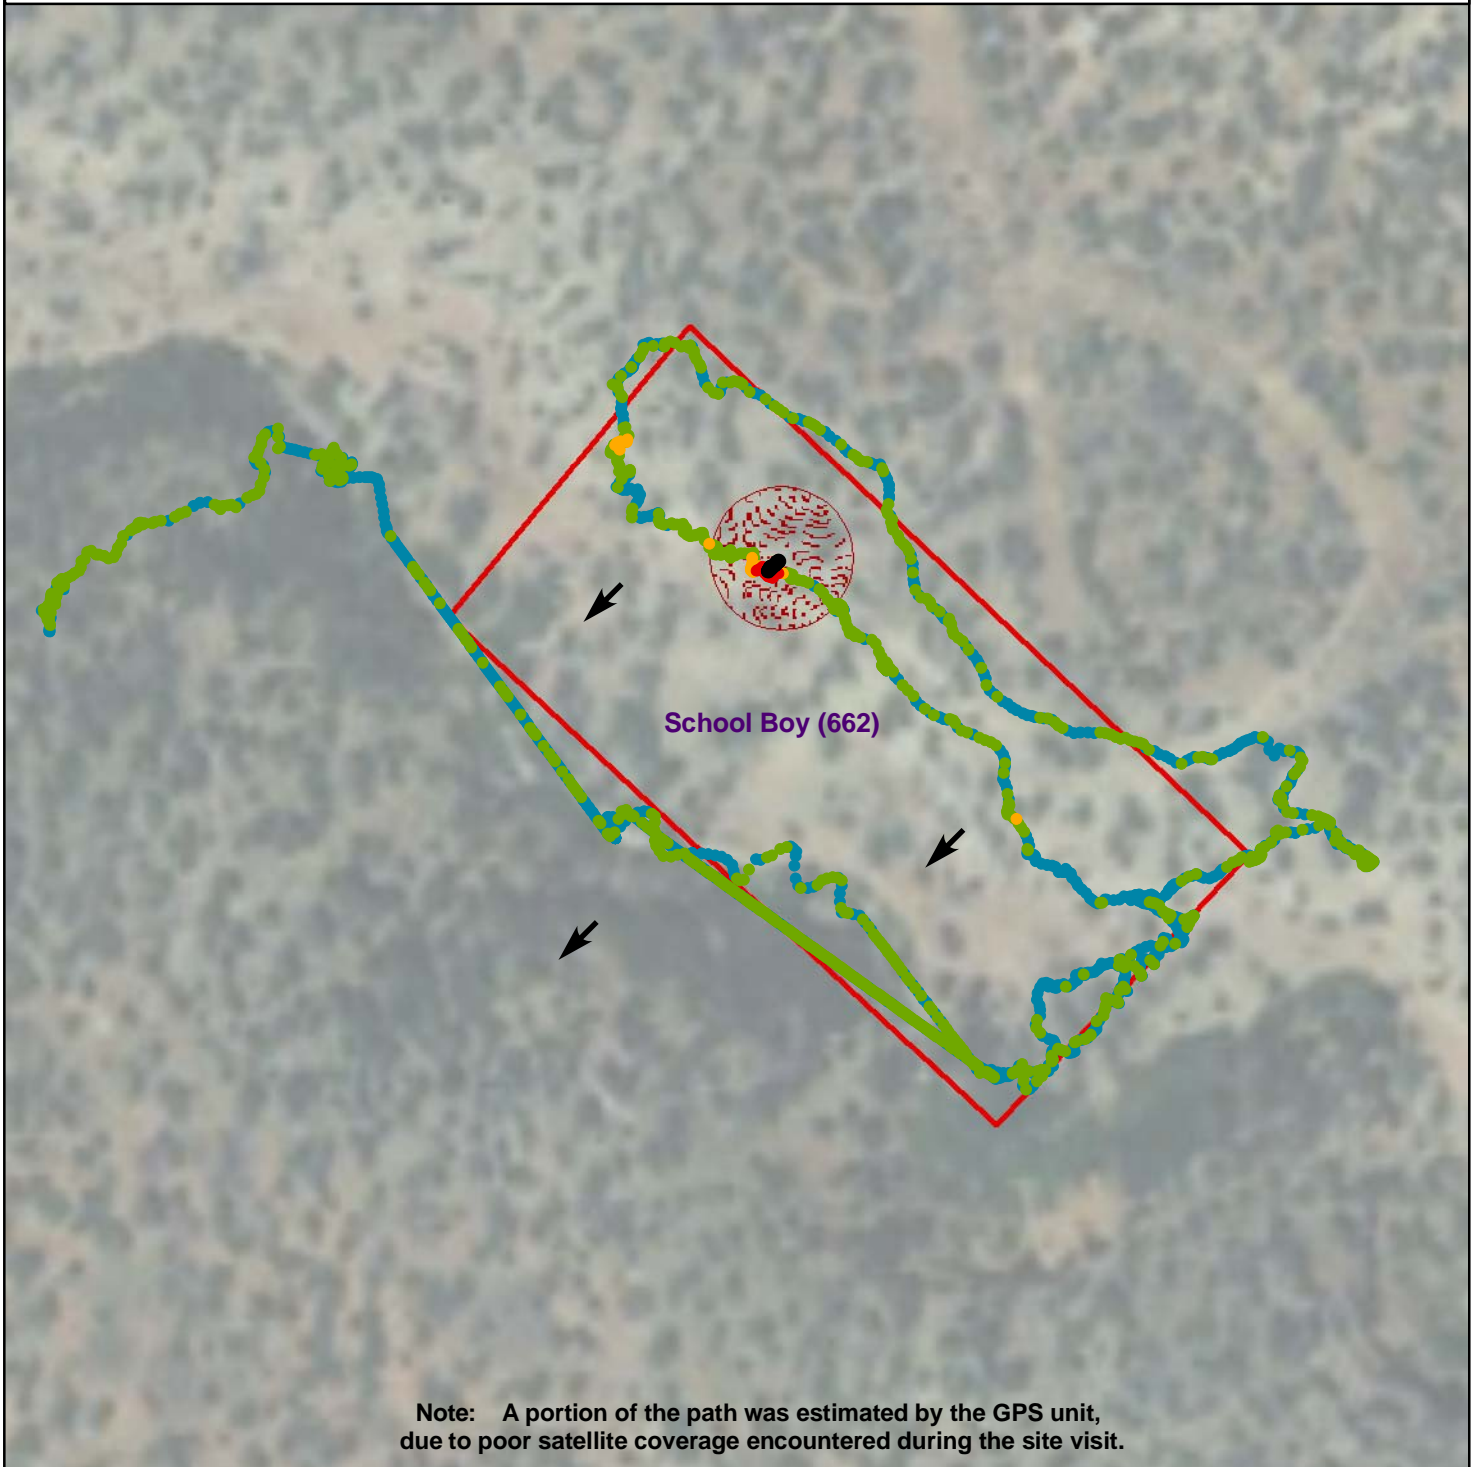
**Figure 2 - Gamma Radiation Measurements
School Boy (662)
Sweetwater Chapter, Navajo Nation**

Gamma survey conducted 06/2010
Measured as counts per minute (cpm)

Average background 10,312 cpm
