Navajo Abandoned Uranium Mine

Site Screen Report

Mine Name: Harvey Blackwater No. 1
Mine ID: 700

April 2012

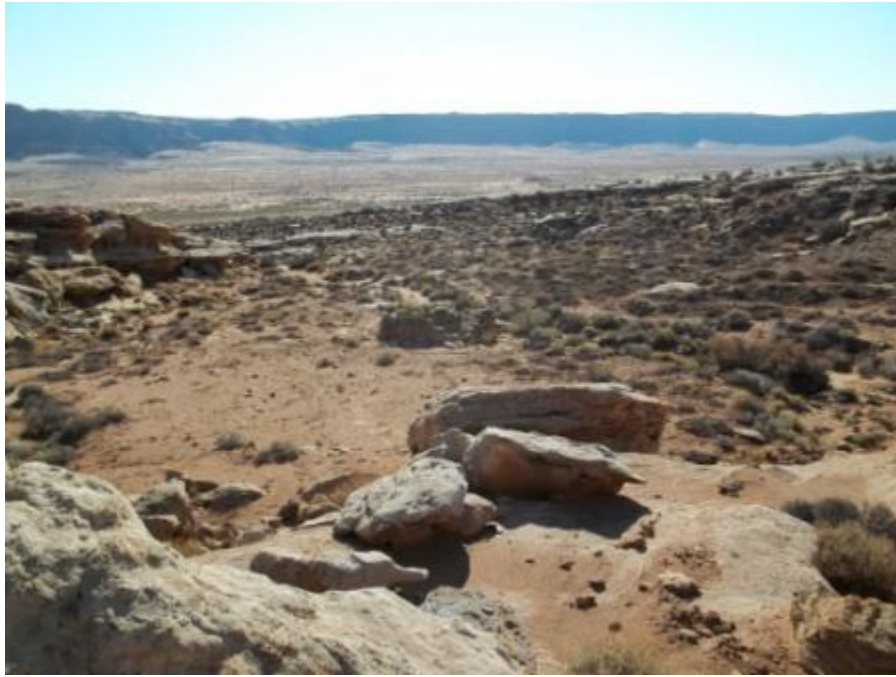
Photo 1

0 to 200 feet: Onsite - Stone hogan in center of site, with no roof

Hogan - 30,000 cpm

Mine Site #700 - Hogan

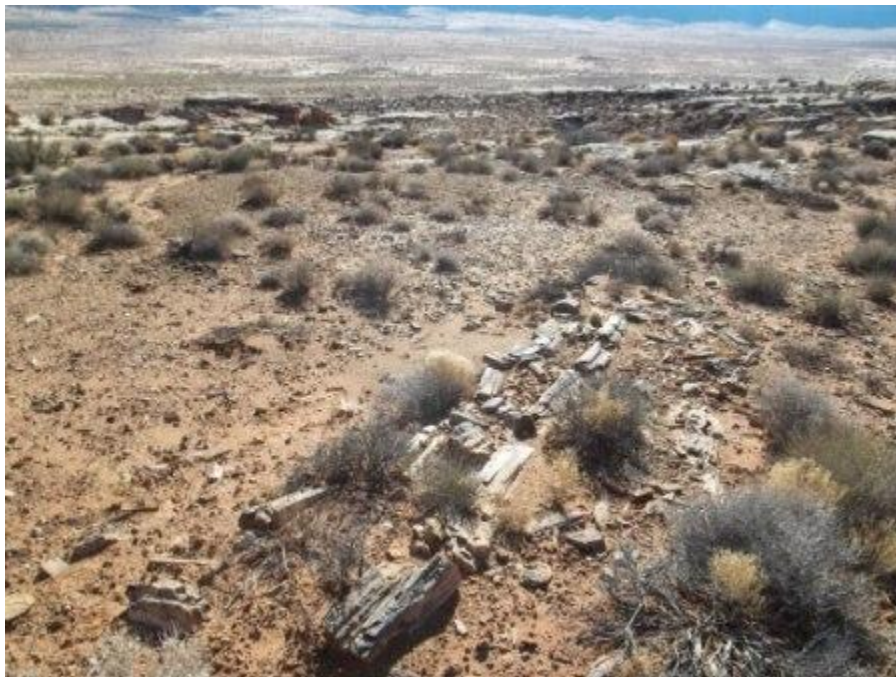
Photo 2

Mine Site #700 – Petrified log

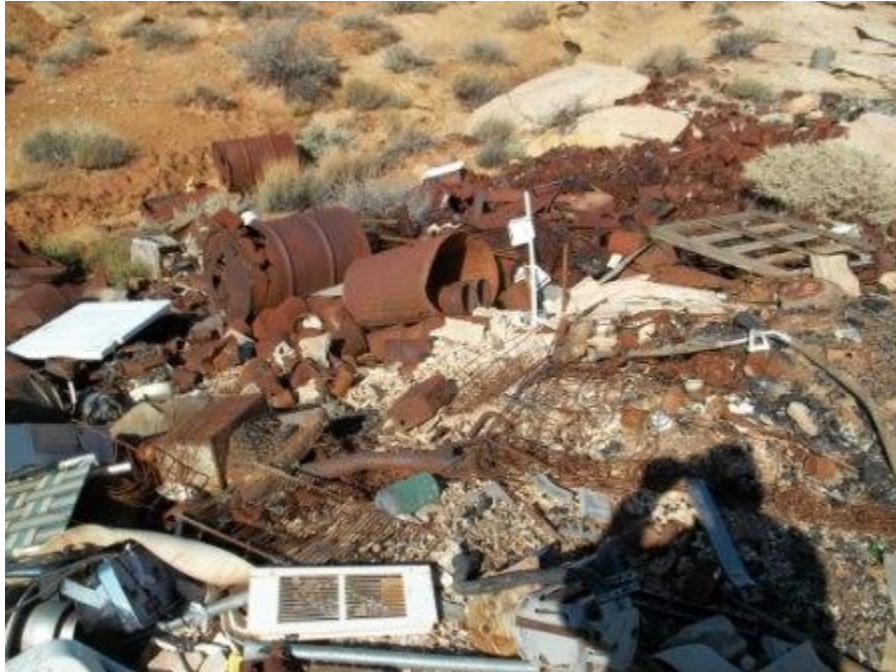
Photo 5

Household dump area immediately north of the site; exploratory borings in the northern part of the site

Mine Site #700 – Dump area

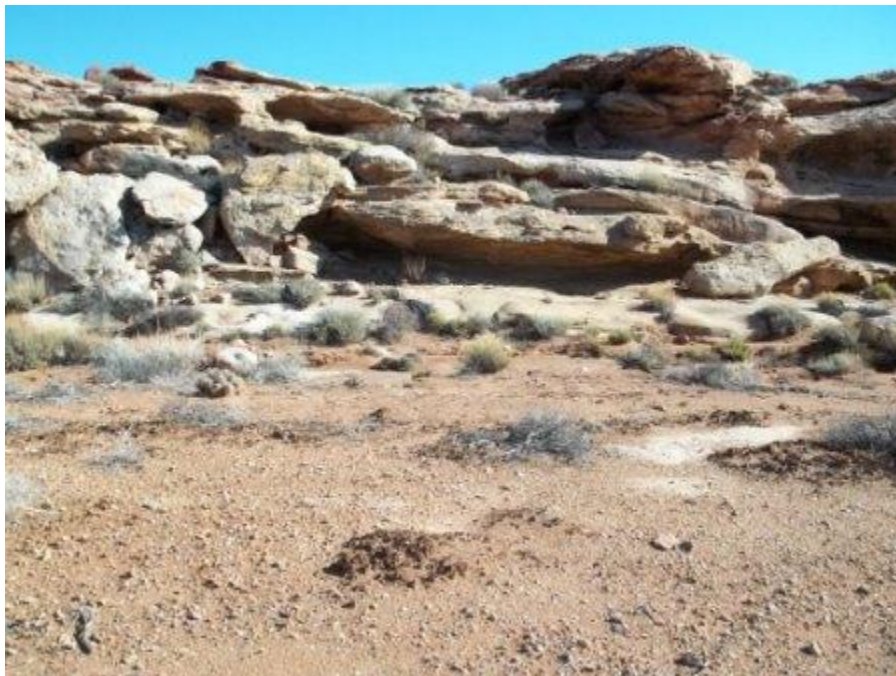
Photo 6

Mine Site #700 – Elevated gamma readings

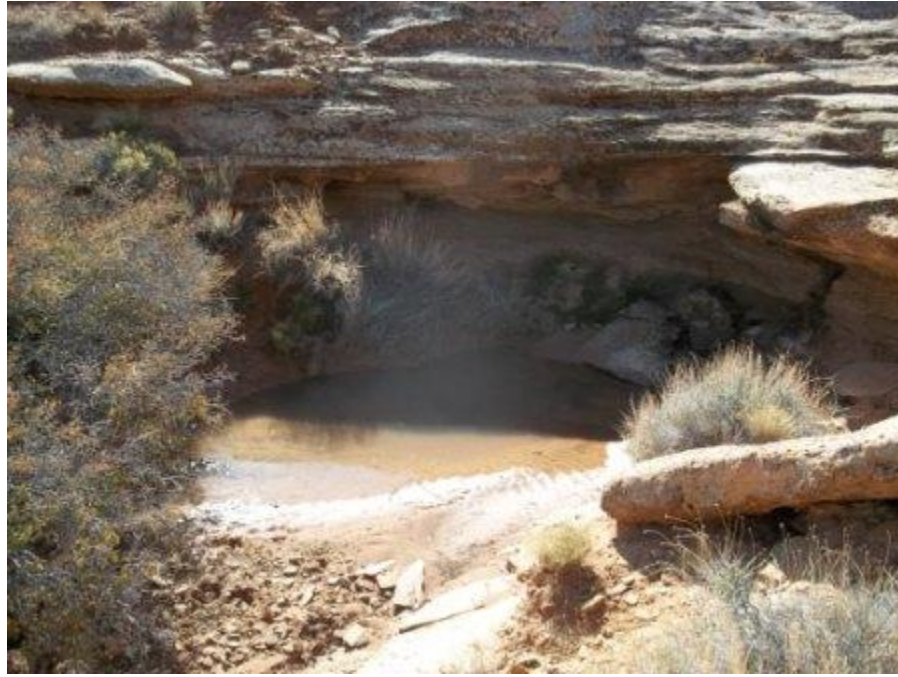
Photo 7

0 to 0.25 miles: Onsite - Pond (700)

Mine Site #700 - Pond
