Navajo Abandoned Uranium Mine

Site Screen Report

Black Rock Point Mines AUM Site

August 2010

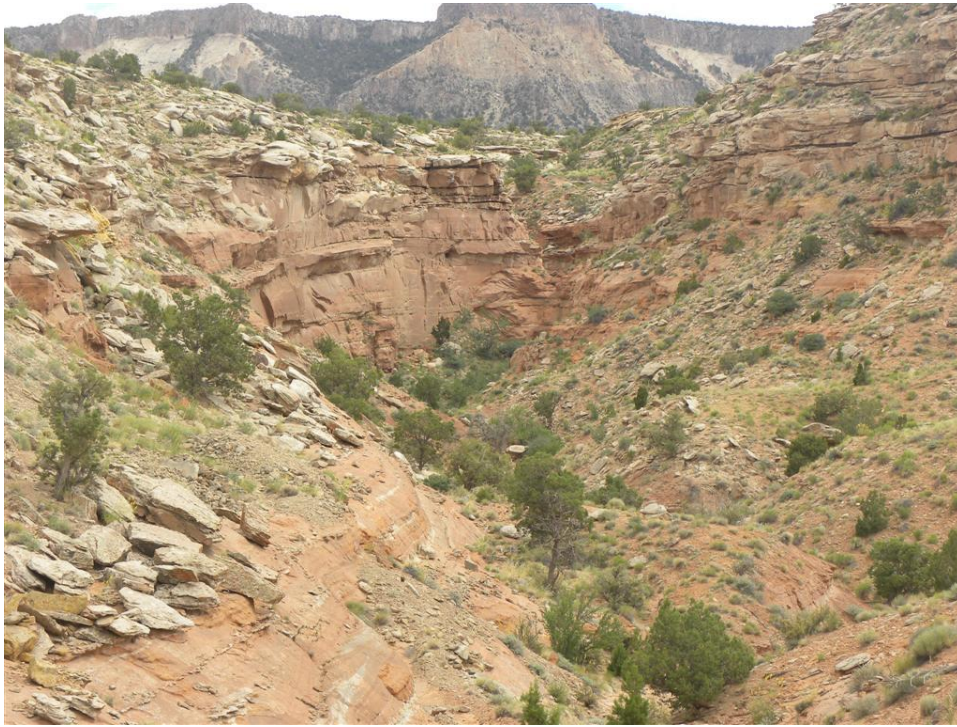
Photo 1. Black Rock Point Mines, western (Owl Canyon) area

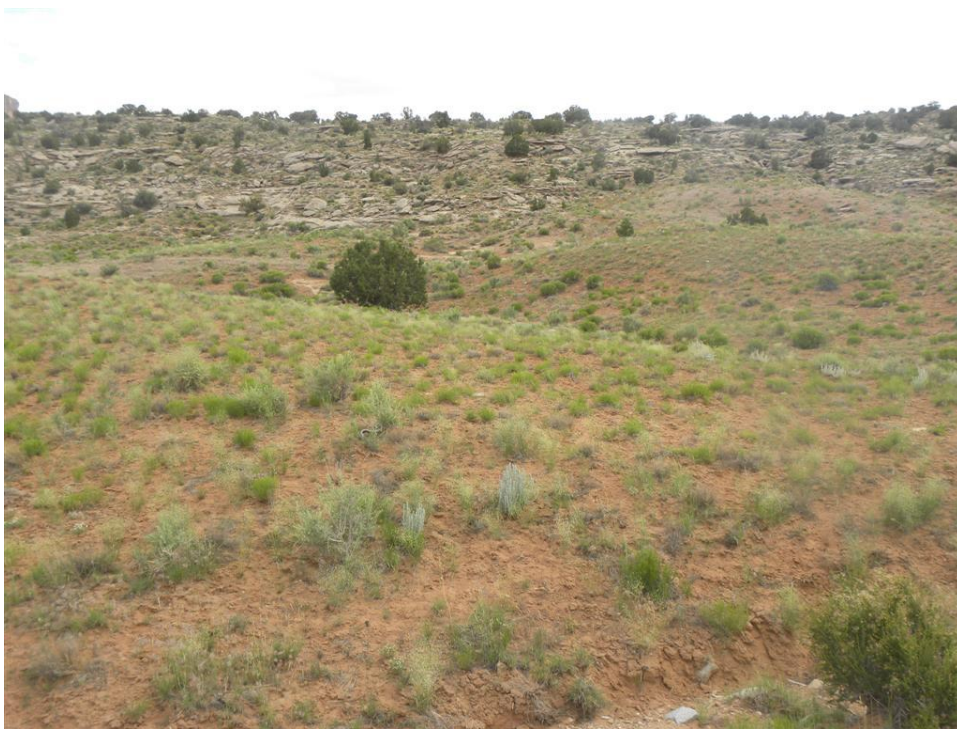
Photo 2. Black Rock Point Mines, eastern open area

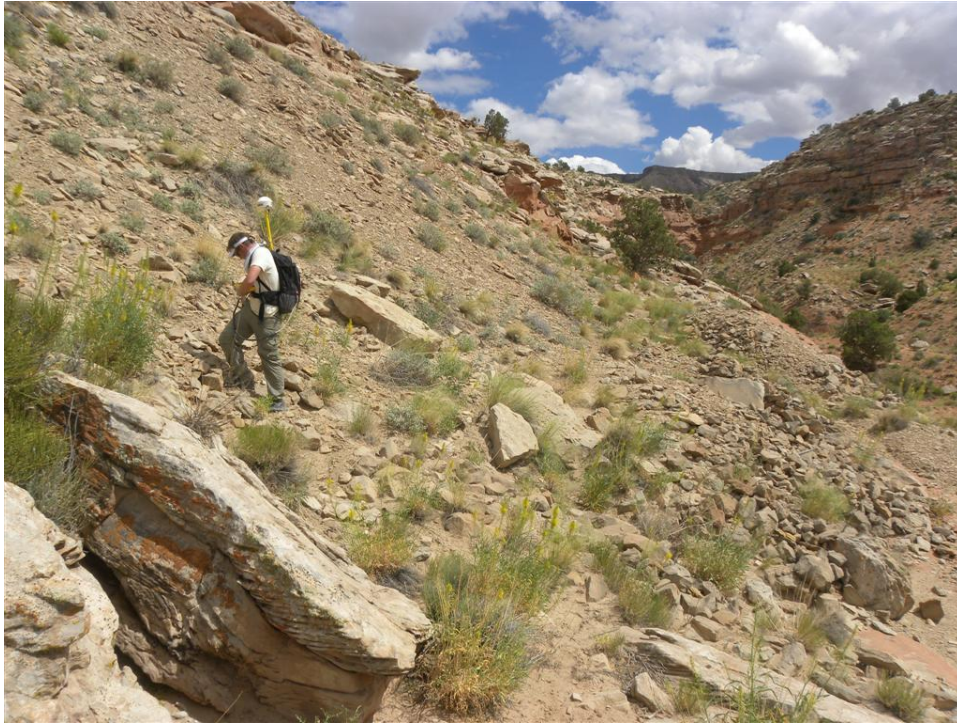
Photo 3. Black Rock Point Mines, slope

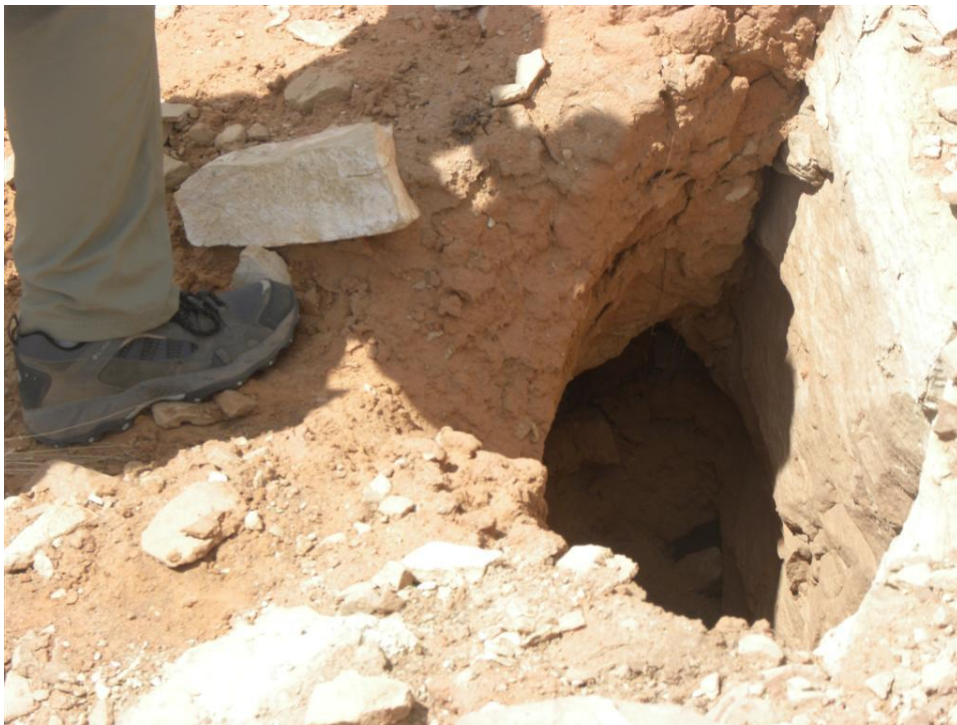
4' x 3' hole, local resident claimed it was actually a dirt covered steel-sealed adit

Photo 4. Black Rock Point Mines, hole above buried adit

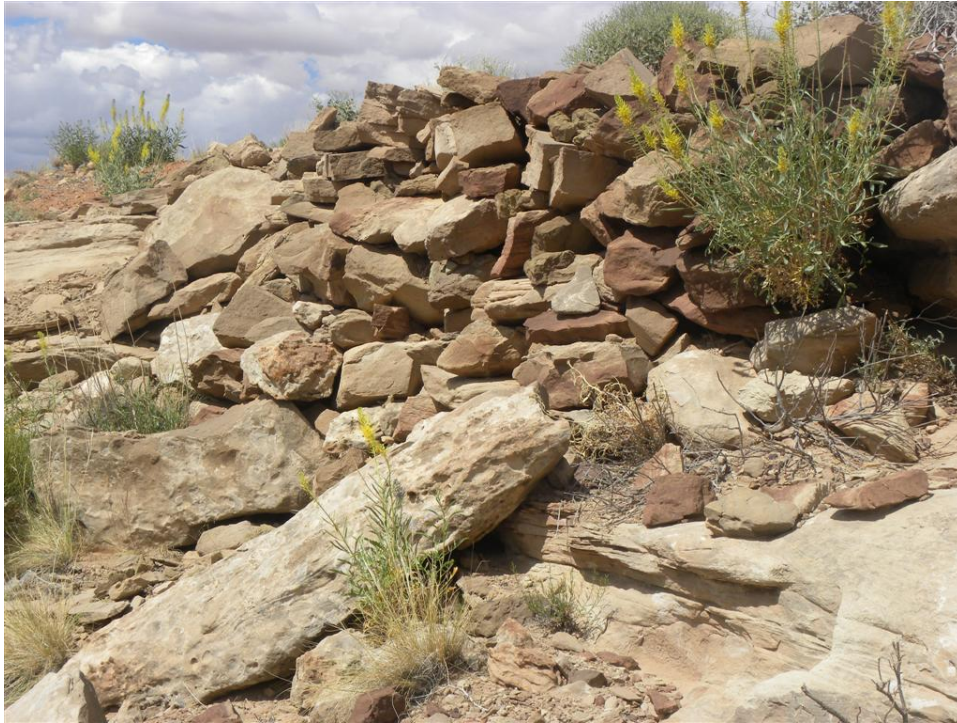
Photo 5. Black Rock Point Mines, rock with elevated gamma readings

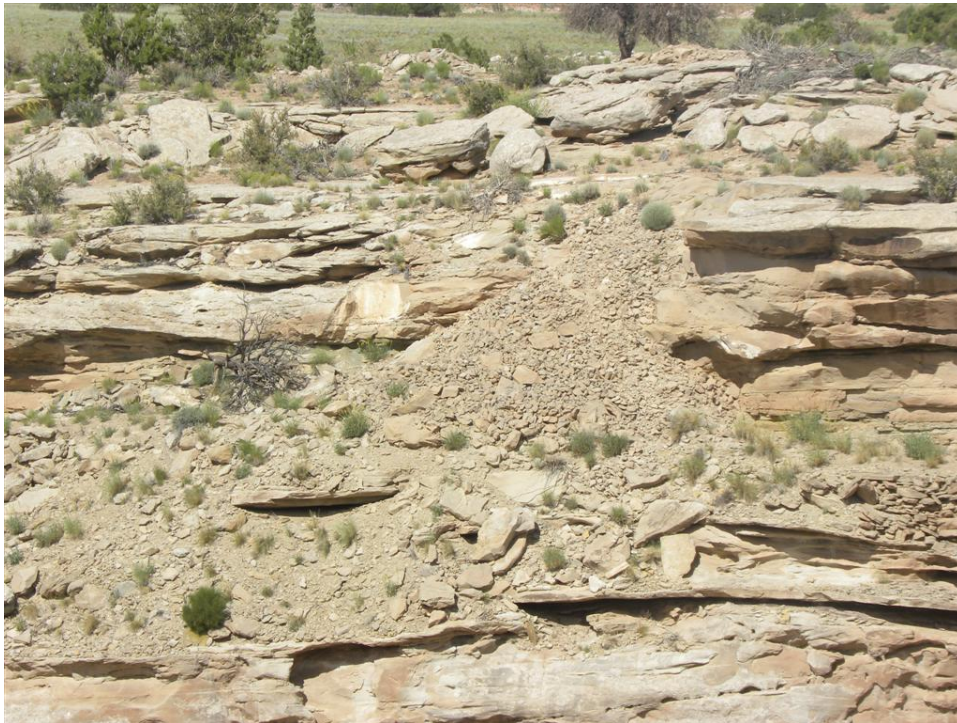
200' x 75' x 5' down-hill below hole area; additional rock scattered throughout site

Photo 6. Black Rock Point Mines, waste rock down slope

Sealed/buried adit; unreclaimed waste rock
