Navajo Abandoned Uranium Mine

Site Screen Report

Mesa II ¼ Mine AUM Site

Navajo AUM Northern Region

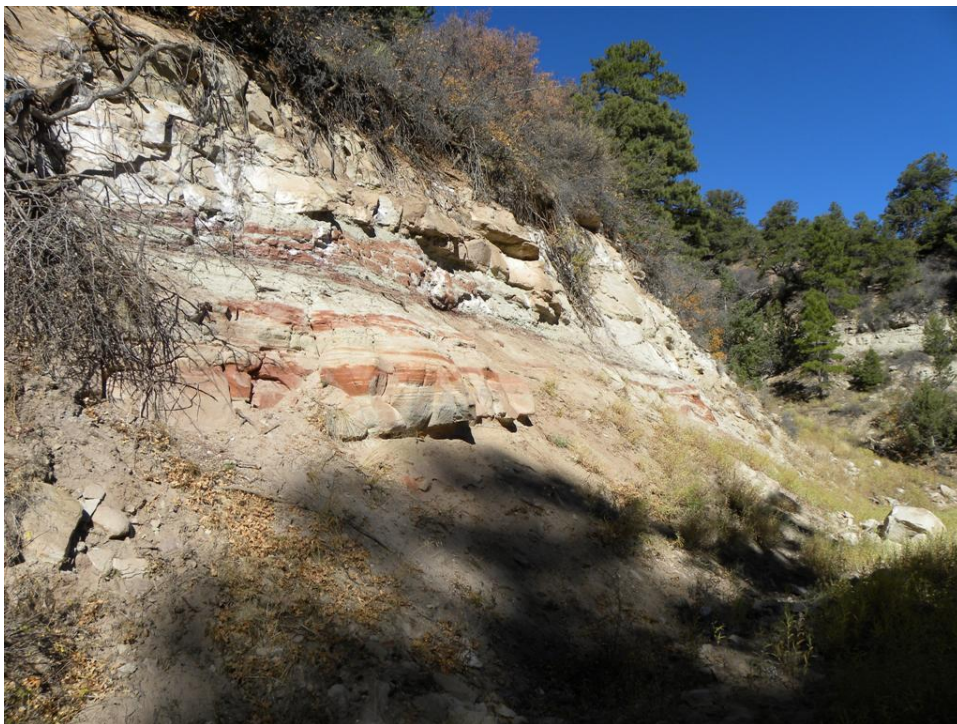
Photo 4. Mine site waste pile

Waste debris from rock face at north side of site (30' h x 75' w) extends northeast into drainage area, with a total estimated volume of 417 yd³

Unreclaimed waste pile
