SUBJECT: CLEAN AIR ACT INSPECTION REPORT
Holcim, Inc.- Chicago, Illinois

Facility: Holcim, Inc. (Holcim)- Chicago Skyway Facility

Date of Inspection: September 5, 2014

Purpose of the Inspection:

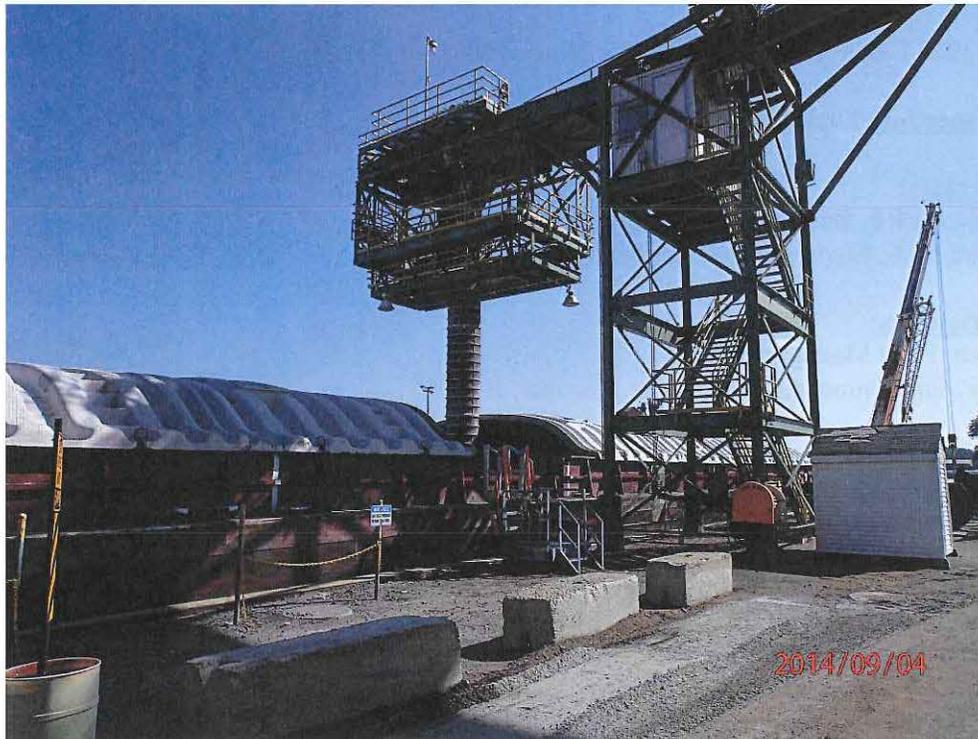
Barges are loaded at the dock (Figure 1). There is only enough room at the dock for one barge. The finished product is delivered from the storage silos via a bucket elevator and enclosed conveyor to the barge loading station. The finished product is loaded into the barge via a loading spout (Figure 2). The loading spout consists of an inner spout and an outer spout. The finished product passes through the inner spout and into the barge while the outer spout draws in air to control any potential emissions (Figure 3). The air is drawn through cartridge filters on top of the barge loading station. The finished product is weather sensitive and during loading only one cover is removed from the barge at a time. It takes about 8 hours to fill one barge and each barge contains 1,500 tons of finished product.

Figure 1 Barge loading station

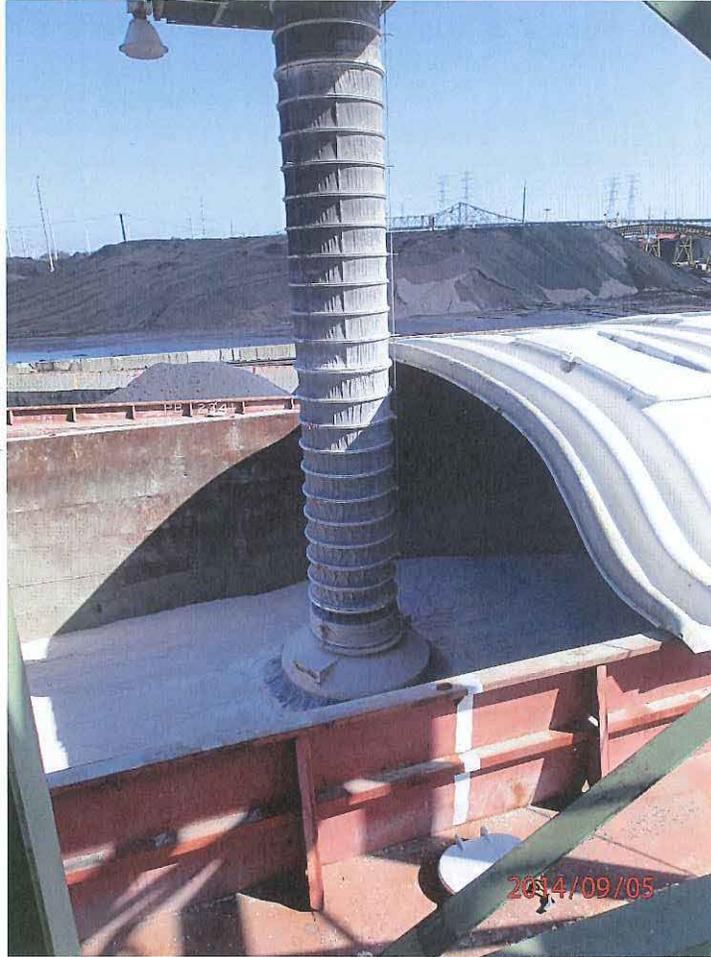
Figure 2 Barge loading (with spout pictured)

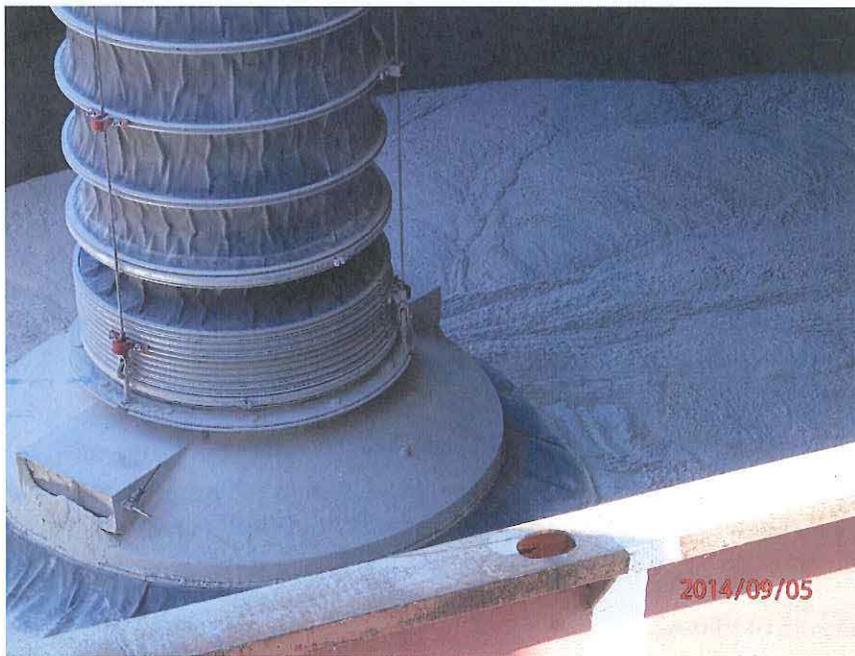
Figure 3 Barge loading spout (close up)

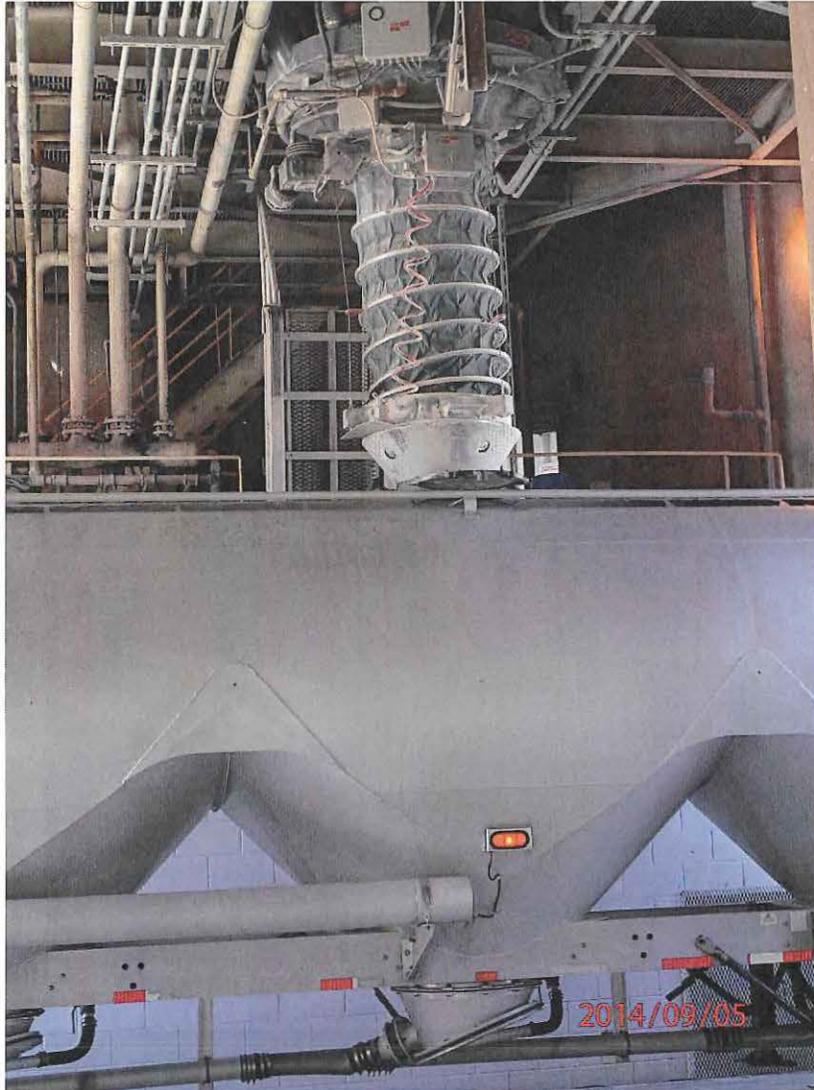
Trucks are also used to ship finish product. The truck loading area is located directly beneath the storage silos. The finished product is dispensed through a loading spout similar to the barge loading spout (Figure 4). Truck loading is controlled by a cartridge filter system as well.

Figure 4 Truck loading
