# NONPOINT SOURCE SUCCESS STORY

### Cleanup of Abandoned Copper Mine Restores the Ompompanoosuc River and Lords Brook

EPA 841-F-15-001T  
March 2015

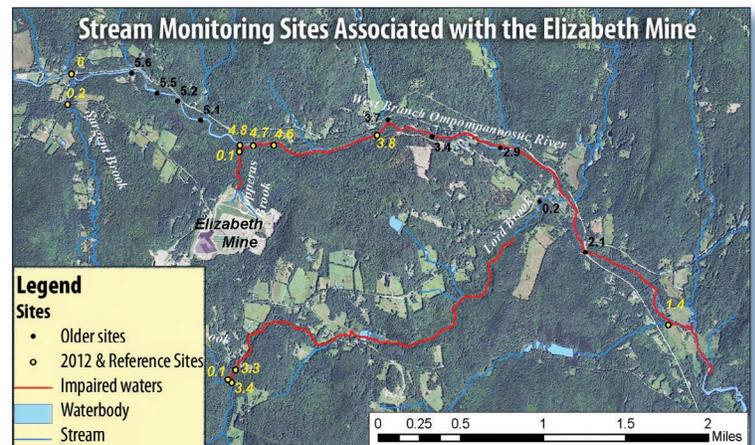
Figure 1. Monitoring locations and impaired sections on the West Branch of the Ompompanoosuc River and Lords Brook.

The Elizabeth Mine site is an abandoned copper mine in the towns of Strafford and Thetford, Vermont. The mine operated from the early 1800s until its closure in 1958. Numerous studies, including biological surveys performed in 1986, and again in 1998, by the Vermont Department of Environmental Conservation (VTDEC) reported biological impacts (i.e., very low numbers and species of macroinvertebrates and fish) in waterbodies downstream of the mined area, including an approximately four-mile reach on the WBOR (Figure 1) and a small tributary stream known as Lords Brook.

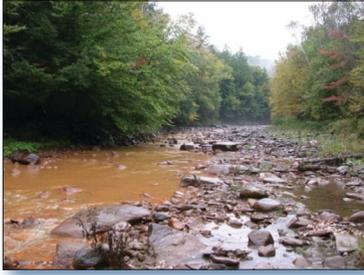
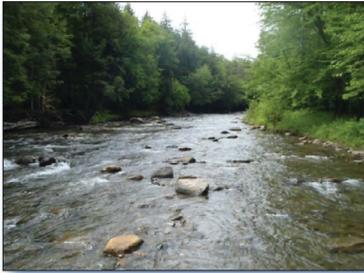
Figure 2. The WBOR before (top: pre-2009) and after (bottom: post-2012) implementation of restoration efforts.

VTDEC’s Monitoring, Assessment and Planning Program–Biomonitoring and Aquatic Studies Section conducted biological assessments before and after restoration efforts, which were compared with the Class B water guidelines for aquatic life support. Data show that both the WBOR and Lords Brook now meet applicable aquatic life use support biocriteria guidelines for Class B at all previously impaired sites (Table 1). Based on all these assessments, both the WBOR and Lords Brook are eligible for removal from the state’s 2014 impaired waters list because they now support their aquatic life designated uses (Figure 2).
