NONPOINT SOURCE SUCCESS STORY

Stream Daylighting Restores Atlanta's Candler Park Brook

EPA 841-F-20-001II
December 2020

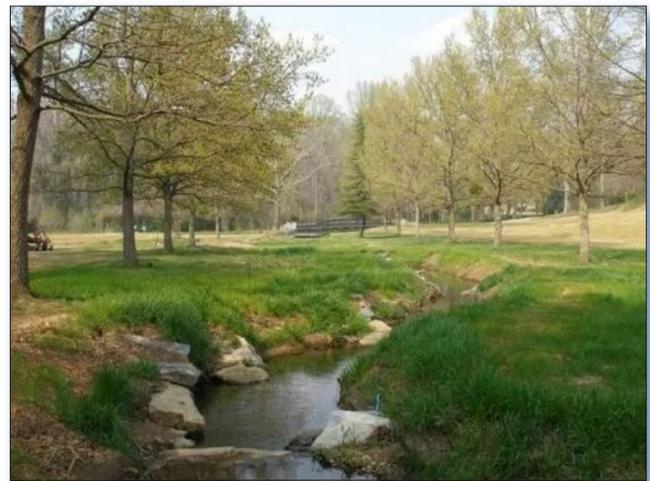
Figure 1. The restored Candler Park Brook flows through an Atlanta park.

Candler Park Brook is a headwaters stream that drains into Lullwater Creek, Peavine Creek, Peachtree Creek, the Chattahoochee River, and ultimately into the Gulf of Mexico. The brook flows through a public park and golf course in Atlanta (Figure 1).

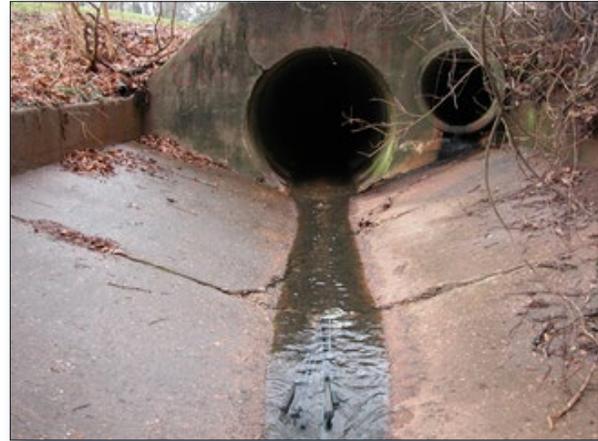
Figure 2. Before the restoration project, Candler Park Brook emerged from an underground culvert and flowed through a concrete channel.

In the 1950s, Candler Park Brook was contained in an underground pipe and a surface concrete channel (Figure 2). After 50 years, the culverts that had housed the stream were collapsing, leading to sink holes in the ground surface. The surface concrete channel was also deteriorating. In addition, the brook was impacted by illegal dumping, stormwater overflows and urban runoff. The biological health of the stream was very poor, supporting only fly larvae and aquatic worms, and the riparian habitat was virtually nonexistent. Biological monitoring and assessment of Candler Park Brook in 1999 indicated impaired biological condition, and habitat assessments indicated a *poor* rating. Benthic macroinvertebrate samples also indicated *suboptimal* or *poor* habitat condition ratings. Project partners wanted to restore the biologic health of Candler Park Brook and provide a healthier ecosystem for fish and other wildlife, as well as the community, to enjoy.

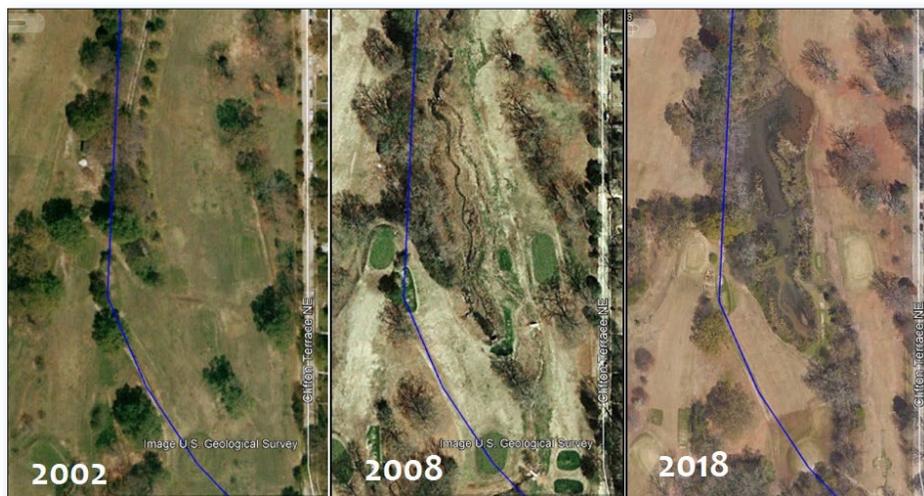
Figure 3. Changes can be seen by comparing the project area in 2002 (left, before restoration), 2008 (middle, after stream restoration), and 2018 (right, after a beaver dam impoundment formed in the restored stream channel).

Daylighting the stream also opened the door for beavers to colonize in the park. First documented in 2009, this unplanned but ecologically significant outcome has created an estimated 1.3 acres of wetlands (per interpretation from 2019 Google Earth maps). Two beaver dams have created sizable ponds and wetlands, which offers new habitat for wading birds, ducks, frogs and other wildlife (Figure 3).
