Red River Basin Riparian Project: Turtle River Site Passes the Test

Successful bioengineering practices

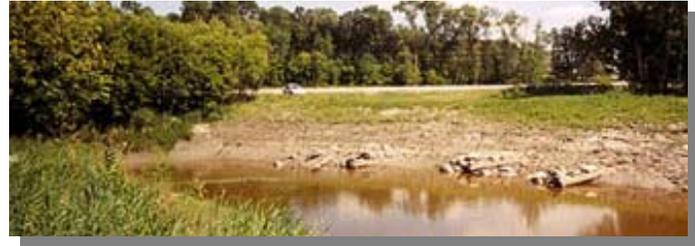
The lack of woody vegetation along the river left the streambank vulnerable to severe erosion.

The project sponsors plan to establish up to nine demonstration sites in the Red River Basin, restoring at least 100 river miles during the 5-year project term. At one demonstration site, the Turtle River site, the lack of woody vegetation had left the streambank vulnerable to severe erosion. The situation was compounded by groundwater seeps above the baseflow elevation of the river. Between 1978 and 1995, the river migrated approximately 3.5 feet per year to the east until it was only 80 feet from the county road. When the bioengineering project was initiated 1995, the site had a vertical bank about 14 feet high.

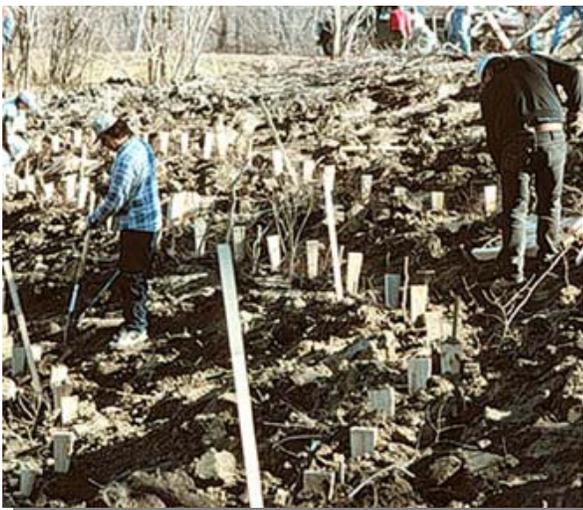
Willows were planted along the restoration site to provide long-term stability

To stabilize the bank and stop further migration toward the road, several bioengineering techniques were implemented. The first step was to create a stable slope for the vegetation. The 14-foot vertical bank was reshaped to a 3:1 slope, using the waste from the top as fill at the toe. Riprap was then installed along the toe to the bankfull elevation. Bioengineering practices were installed as part of a workshop featuring the Natural Resources Conservation Services' bioengineering team from Michigan. Willow fascines and a brush mattress were installed along the 300-foot length to armor the bank and to begin the revegetation process.

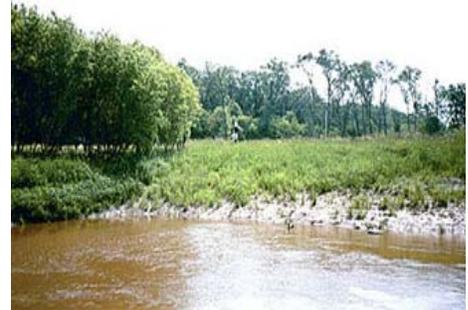
After the bioengineering work was complete, the streambank was able to withstand spring floods and an unusual 17-inch rainstorm in July 2000.

Although some maintenance was required each spring in 1996 and 1997, the project bioengineering has survived both spring floods and a 17-inch rainstorm in July 2000. The lessons learned from experience at the Turtle River site include the following:

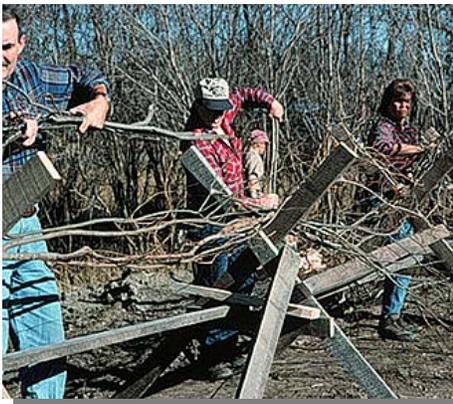
At a workshop, the Natural Resources Conservation Service demonstrated the implementation of several bioengineering techniques.
