Subject: April 19, 2021 Inspection Report for Cleveland Cliffs Burns Harbor,  
NPDES Permit Number IN0000175

**CWA COMPLIANCE EVALUATION INSPECTION REPORT  
U.S. ENVIRONMENTAL PROTECTION AGENCY, REGION 5**

**Attachment A - Photolog**  
**Cleveland Cliffs Burns Harbor - Inspection April 19, 2021**

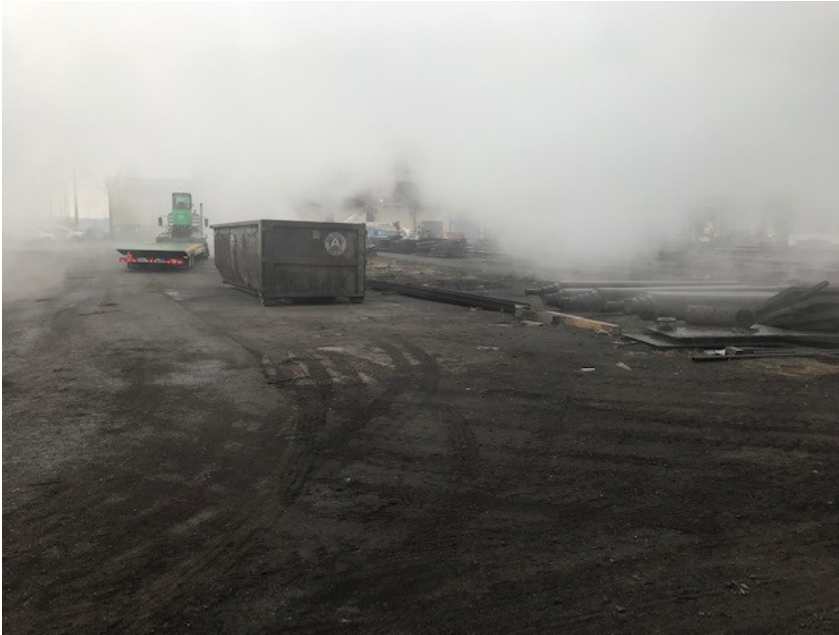
Description: Area near the cooling towers.

Location: Near the Cooling Towers

EPA and IDEM inspection team then accompanied the facility personnel outside and observed the Cooling Towers. All five of the BFRS cooling towers have been rehabbed and there are now two cooling towers for ammonia reduction. The inspection team also saw the area next to the cooling towers where the new ammonia treatment will be installed.

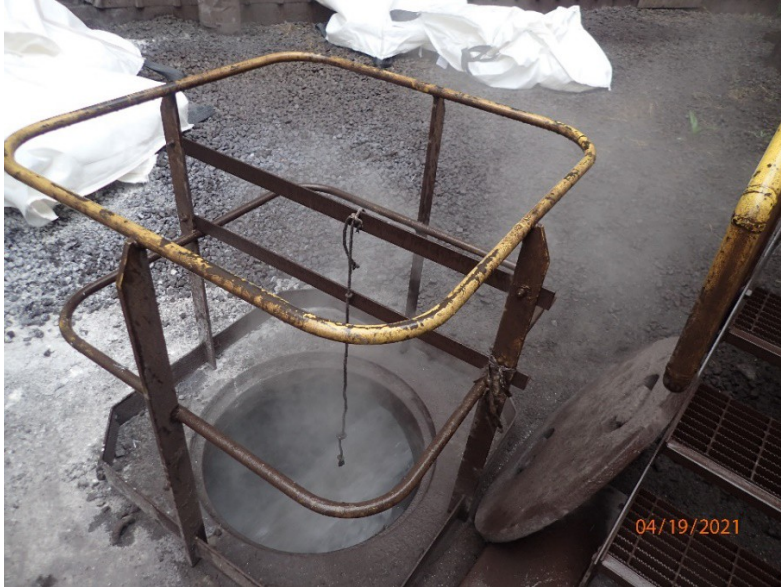
1: P4190001

Description: Outfall 111 is an internal outfall for Hi-Cap Thickener and RSB Thickener effluent flows.

Location: Near the BFRS

EPA and IDEM then observed Outfall 111. This is an internal outfall for water from the Hi-Cap Thickener and the RSB Final Thickener effluents. Currently, these flows go to the Dirty Industrial Wastewater (DIW) pipe which takes the flow to the SWTP. As mentioned in the Ammonia Treatment Processes section above, in the future, the plan is to divert these flows to a centrifuge to remove solids. The solids will be landfilled and the centrate will be piped back into the BFRS. When the water leaves the BFRS through the blowdown, it will be treated for ammonia.

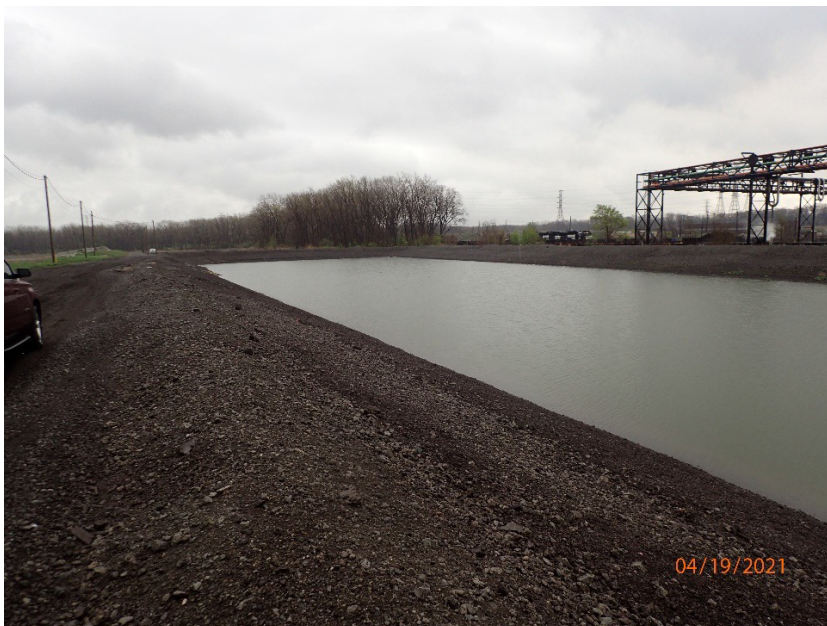
2: P4190002

Description: Deerfield Retention Basin was designed for leachate for the 75-acre landfill.

Location: South of the Deerfield Landfill.

At 12:27 P.M., EPA and IDEM inspectors drove to and observed the Deerfield Retention Basin. The level of the water in the basin on the day of the inspection was 80" and the basin has a capacity of 144" to the top of the berm.

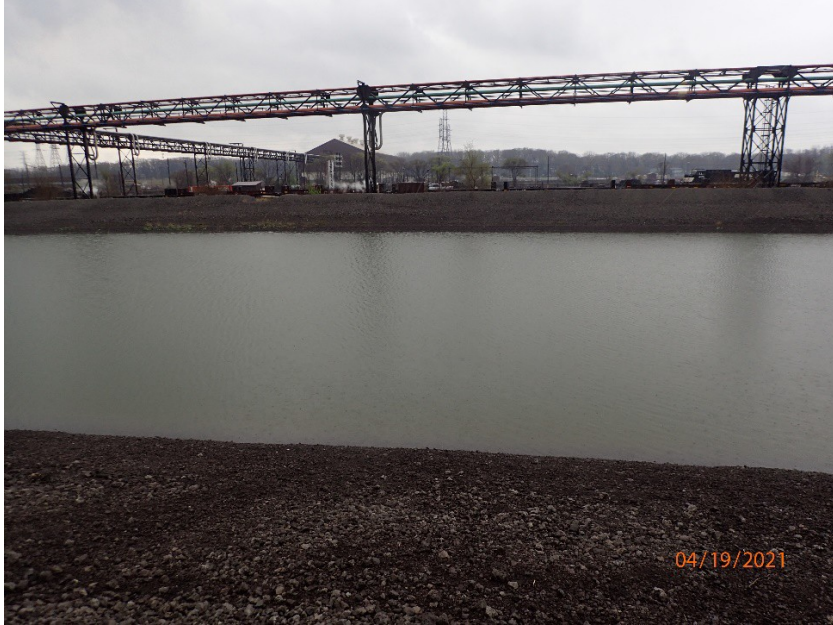
3: P4190003

Description: Deerfield Retention Basin.

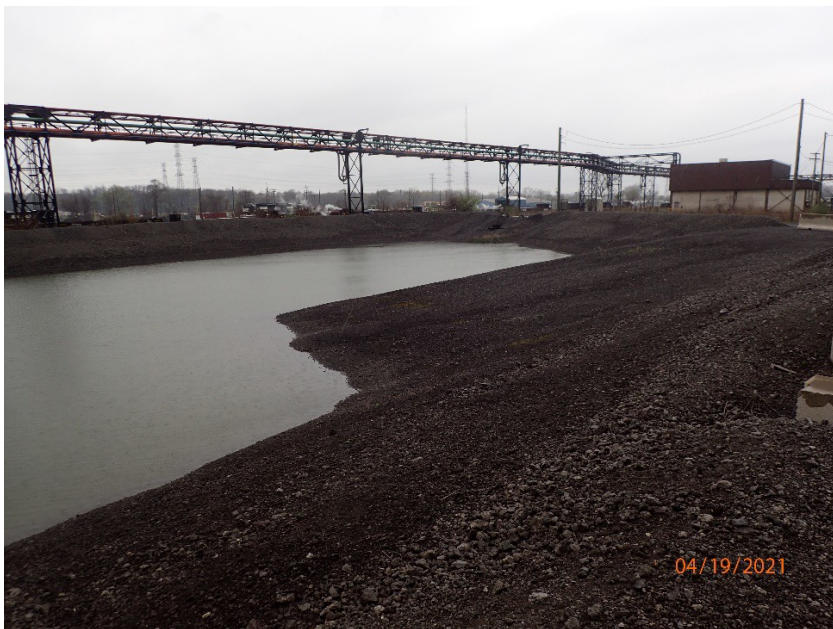
4: P4190004

Description: Deerfield Retention Basin.

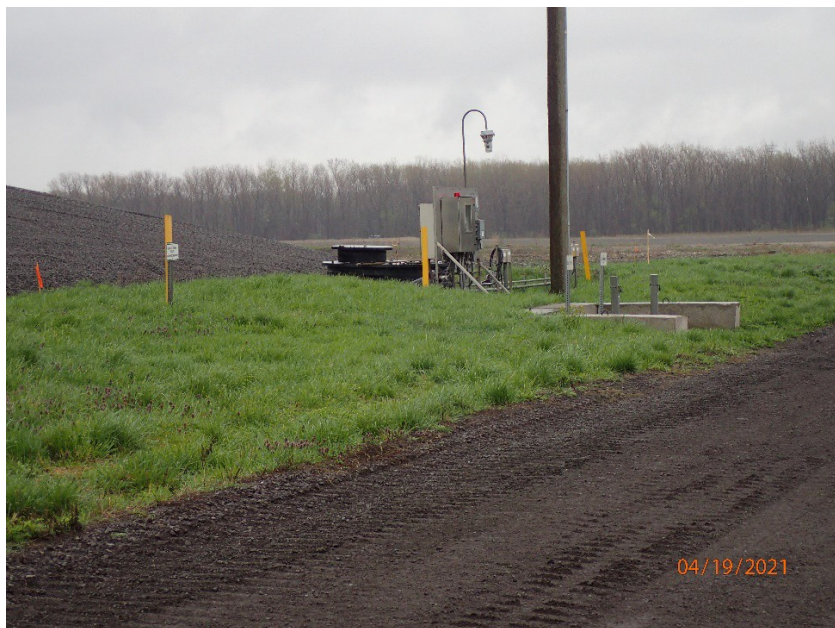
5: P4190005

Description: Pump station for the leachate from the Deerfield Landfill to the Deerfield Retention Basin.

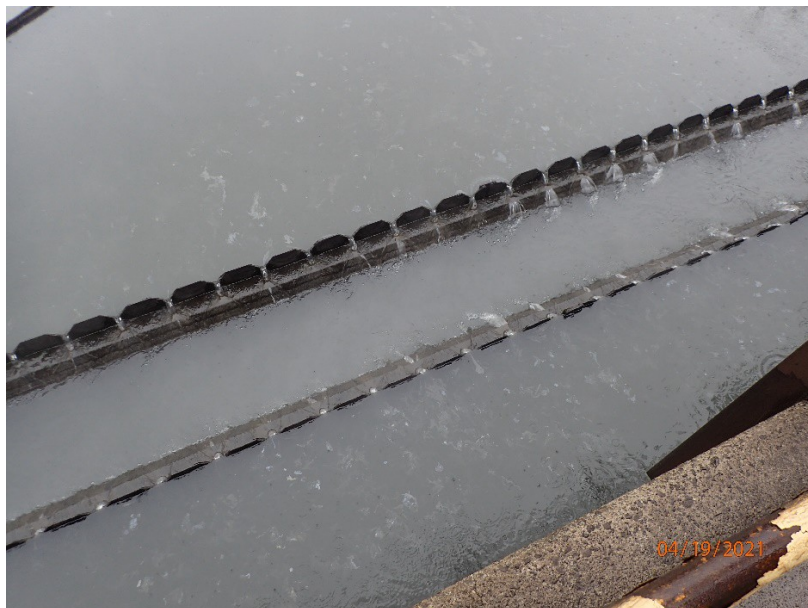
6: P4190006

Description: Oil sheen observed on the effluent from the clarifiers in the Cold Mill side of the SWTP.

Location: Clarifier in the Cold Mill side of the SWTP.

At 1:20 P.M., EPA and IDEM inspectors drove to the SWTP. CCBH Operations Manager, Mr. Rick Balunda, joined the inspection team. They began their inspection of the SWTP on the Cold Mill side. EPA and IDEM observed that there was oil on the effluent in the clarifiers. Mr. Balunda stated that he thought there was not enough solids in the influent to "grab" the oil and grease and that was the reason for the oil on the effluent.

- A. Influent channel is a pinch point for flow to the lagoons due to buildup of sludge in the channel.
- B. Oil sheen observed in the clarifier effluent in both sides of the SWTP.
- C. Algae on weirs on the Cold Mill side of the SWTP.
- D. Temperature readout on the auto-sampler at Outfall 001 is out of range.

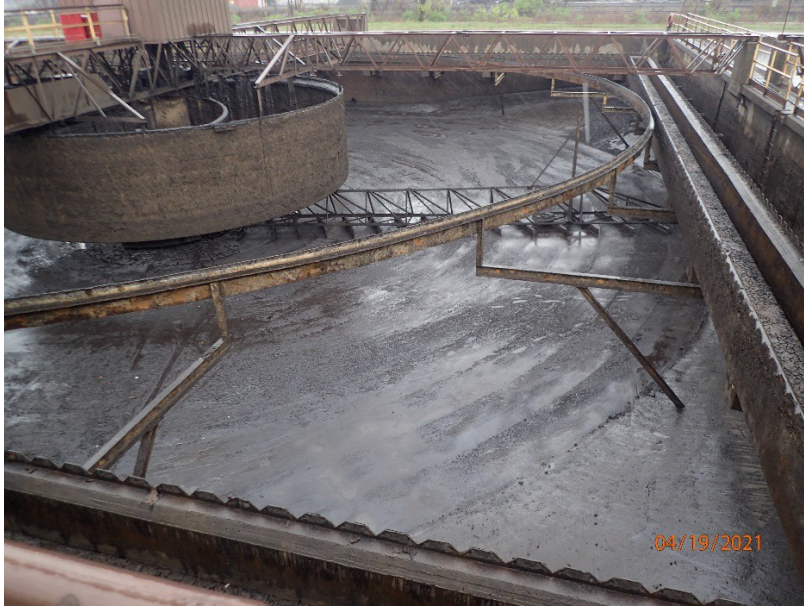
7: P4190007

Description: Clarifier is empty for cleaning. Note the build-up of sludge in the corners of the clarifier. This is a typical problem for square clarifiers, according to CCBH operator, Mr. Balunda.

Location: Clarifier in the Cold Mill side of the SWTP.

EPA and IDEM also observed a clarifier that was empty for cleaning. There were solids built up in the corners of the square clarifier. Mr. Balunda stated that this is a typical problem with square clarifiers and the sludge built up in the corners needs to be cleaned periodically. EPA and IDEM also observed vegetative growth on the weirs of one of the clarifiers.

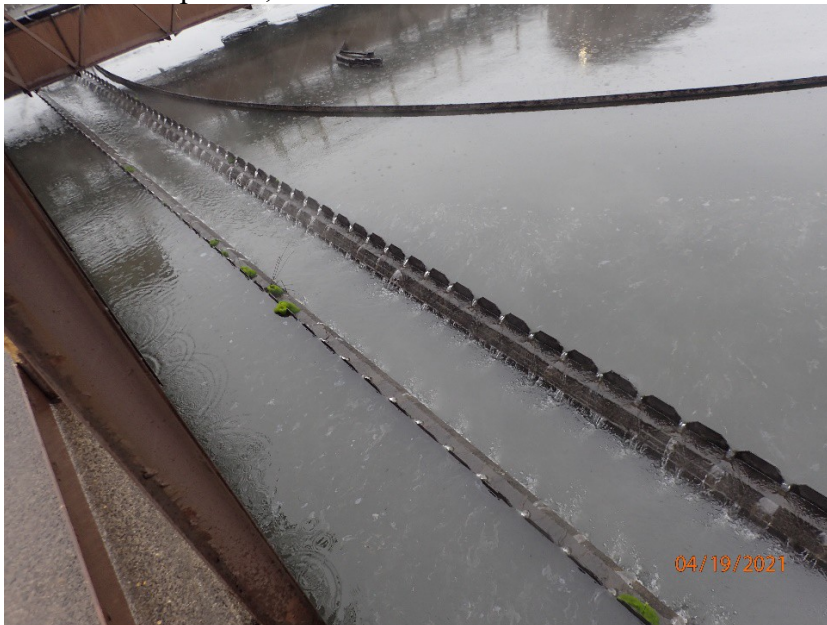
8: P4190008

Description: There was vegetative growth on the weirs of the clarifiers in the Cold Mill side of the SWTP.

Location: Cold Mill side of the SWTP.

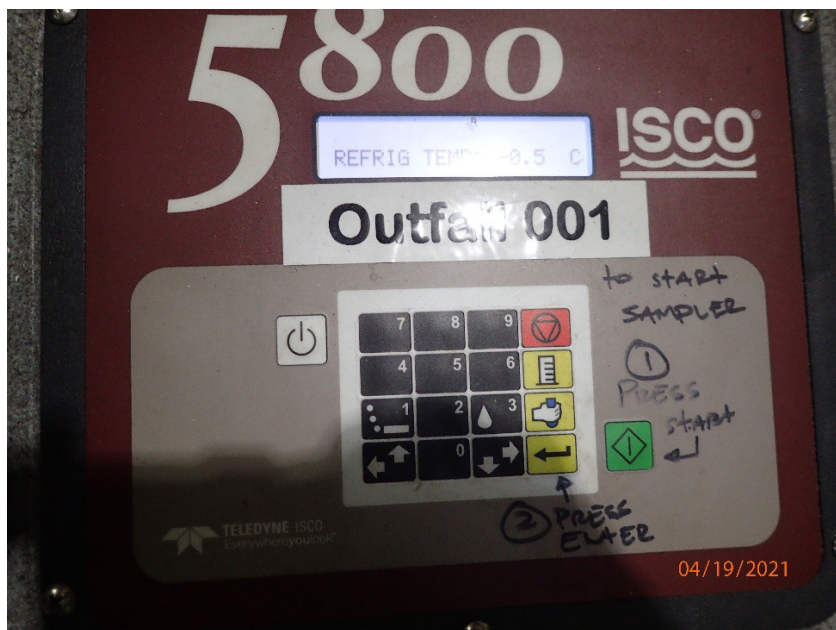
9: P4190009

Description: Readout of the auto-sampler at Outfall 001 shows that the internal temperature is -0.5°C.

Location: Inside the sample building at Outfall 001.

EPA and IDEM inspectors arrived at Outfall 001 at 2:44 P.M. The water was clear at Outfall 001. In the sample building, EPA and IDEM noted that the screen on the auto-sampler showed that the temperature in the sampler was -0.5°C, but the thermometer inside read 8°C. The thermometer was in water inside the auto sampler. EPA and IDEM looked for the logbook for the temperature observations, but it was not in the sample building. EPA and IDEM requested that the log entries be submitted electronically.

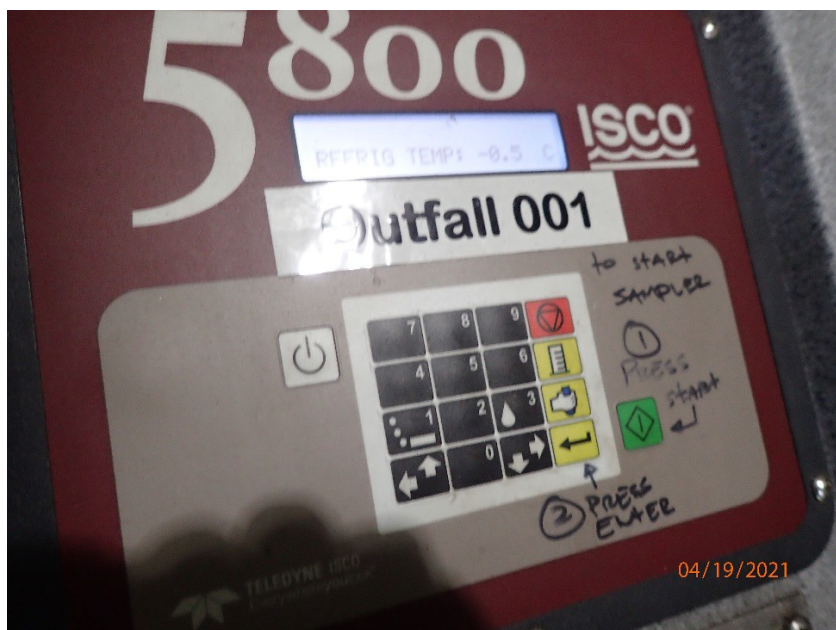
10: P4190010

Description: Duplicate photo of the readout of the auto-sampler at Outfall 001 shows that the internal temperature is -0.5°C.

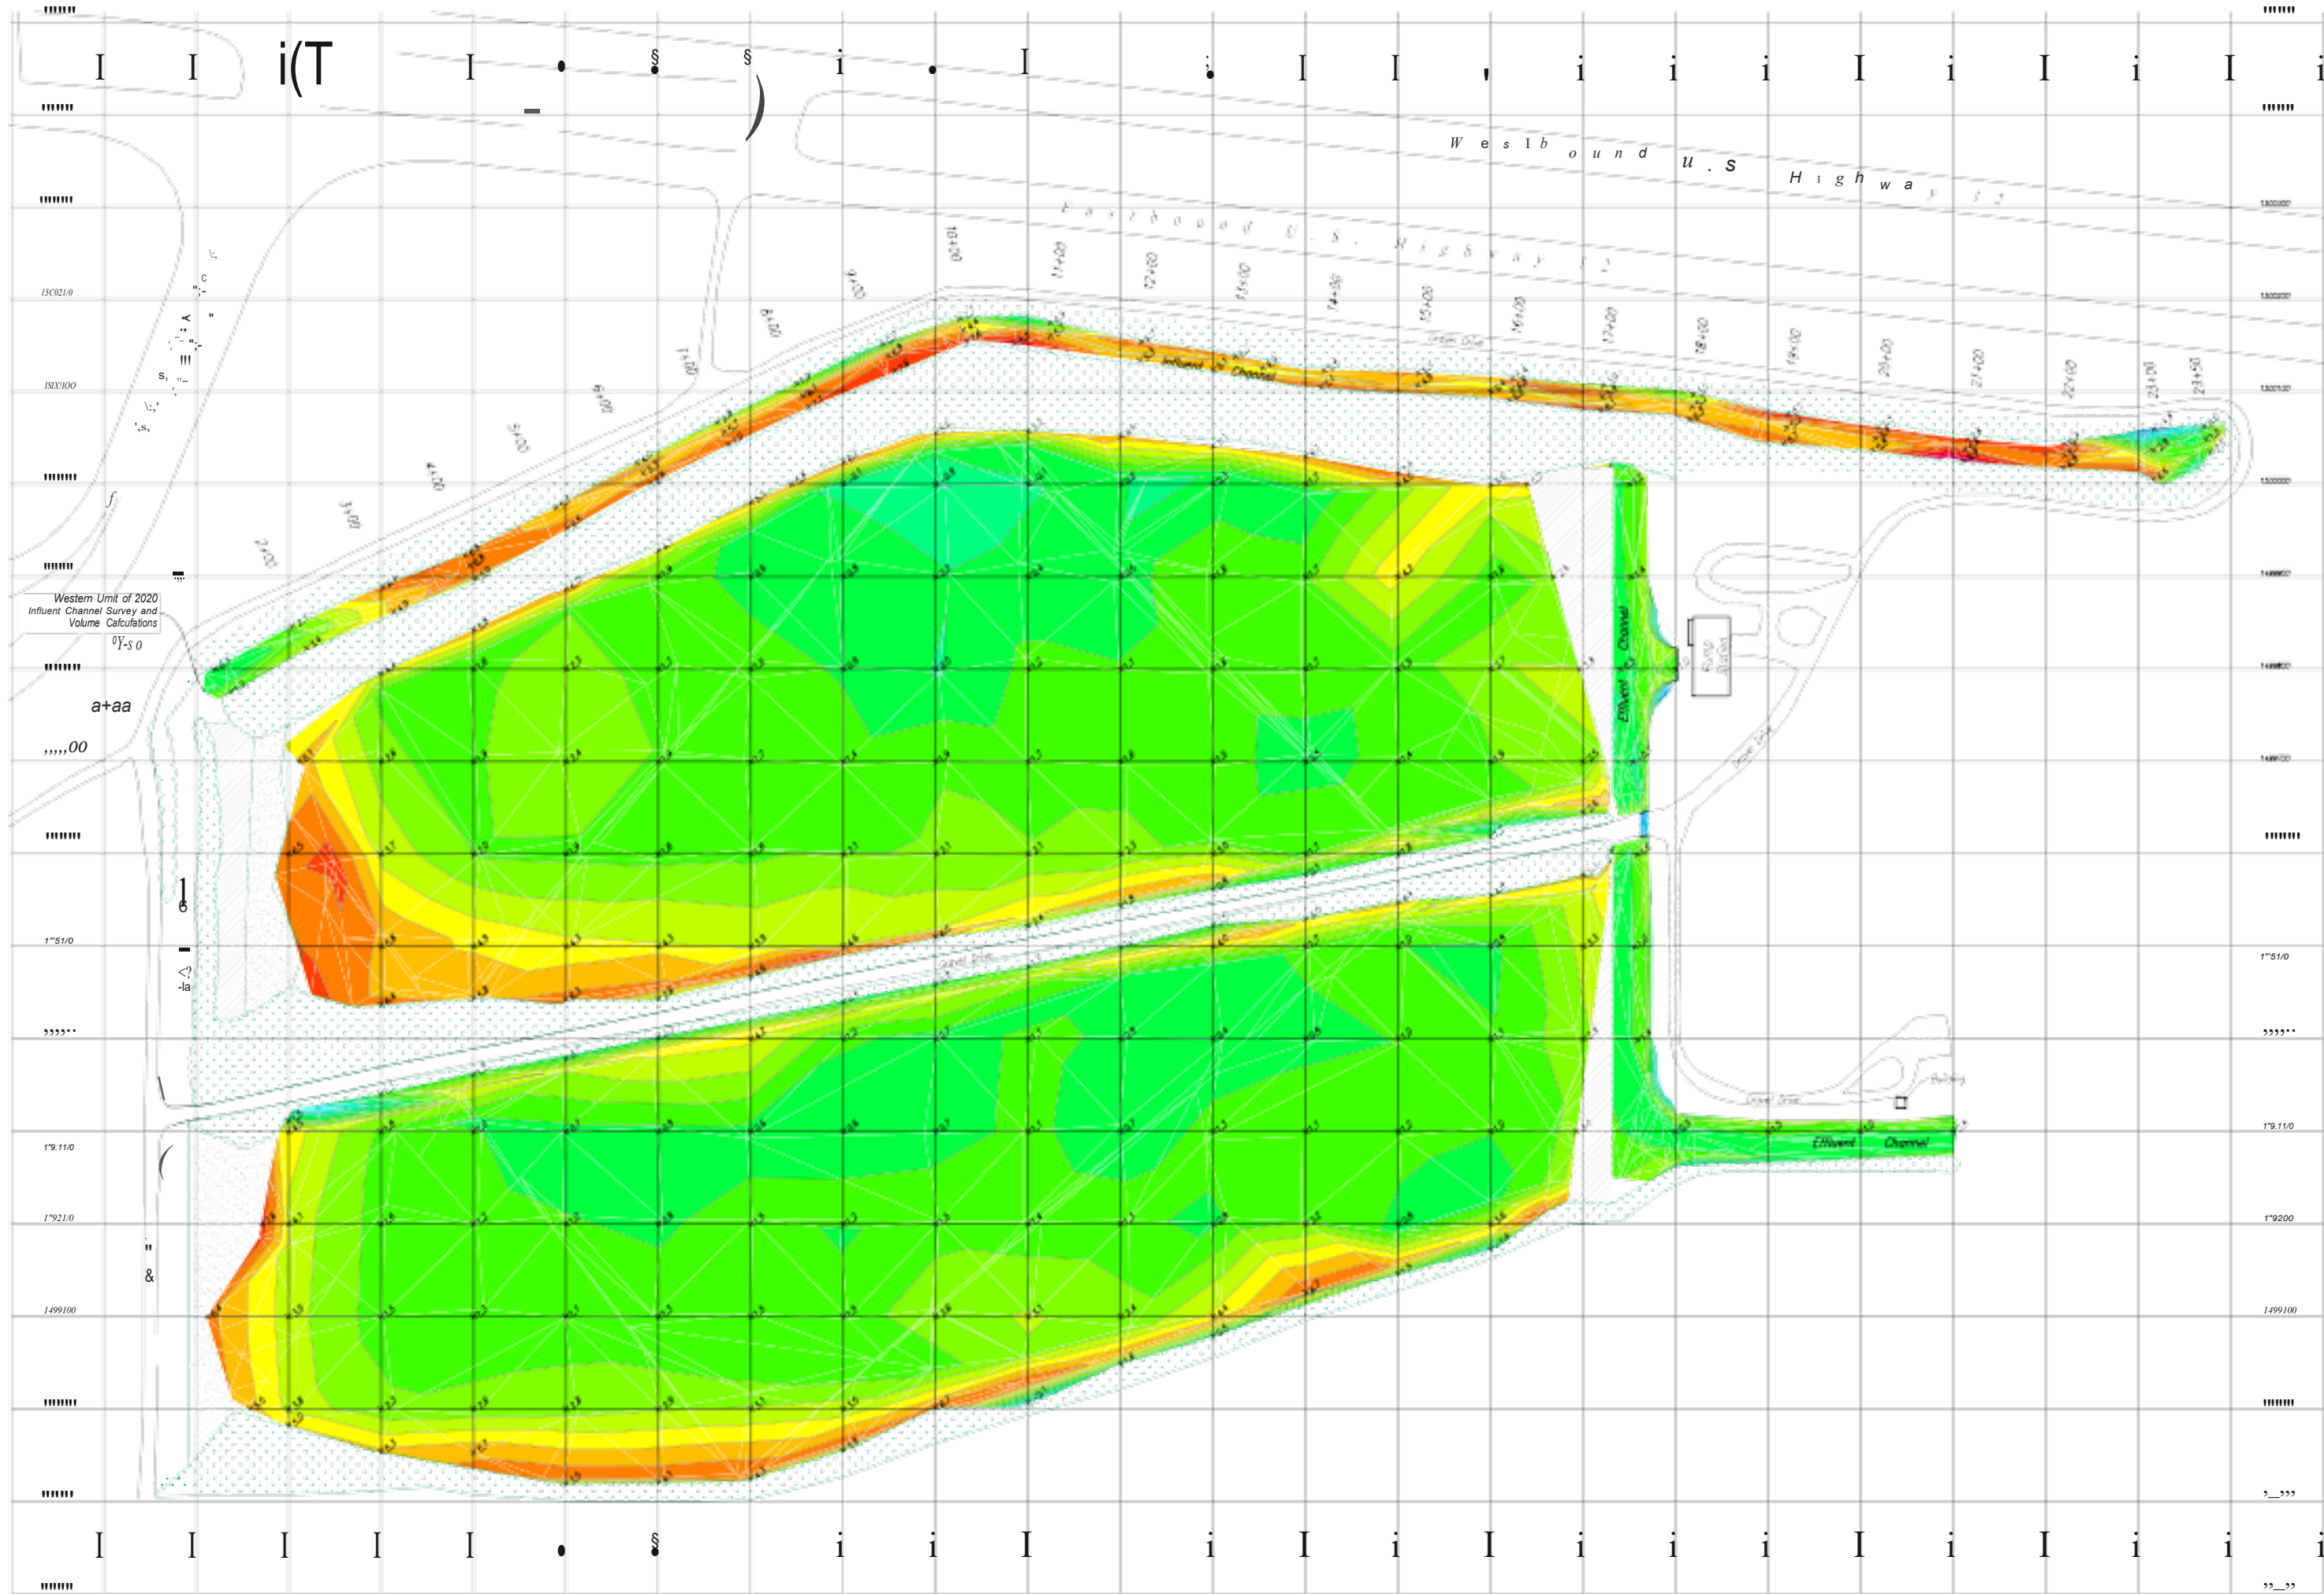
**Hydrographic Survey Depth Deviations  
December 2020**

- The depth deviations shown hereon are relative to the difference between a surface model generated for original lagoon bottom and this survey (Sheet 1).

- Areas denoted with a negative depth deviation are lower than original lagoon bottom, conversely, areas denoted with a positive depth deviation are higher than the original lagoon bottom.
