Project No. 19119232

**RE: DNAPL RECOVERY ACTIVITIES QUARTERLY REPORT – 3<sup>RD</sup> QUARTER 2020  
UNION PACIFIC RAILROAD HOUSTON WOOD PRESERVING WORKS FACILITY  
4910 LIBERTY ROAD FACILITY, HOUSTON, TEXAS  
POST-CLOSURE CARE PERMIT NO. HW-50343; INDUSTRIAL SWR NO. 31547**

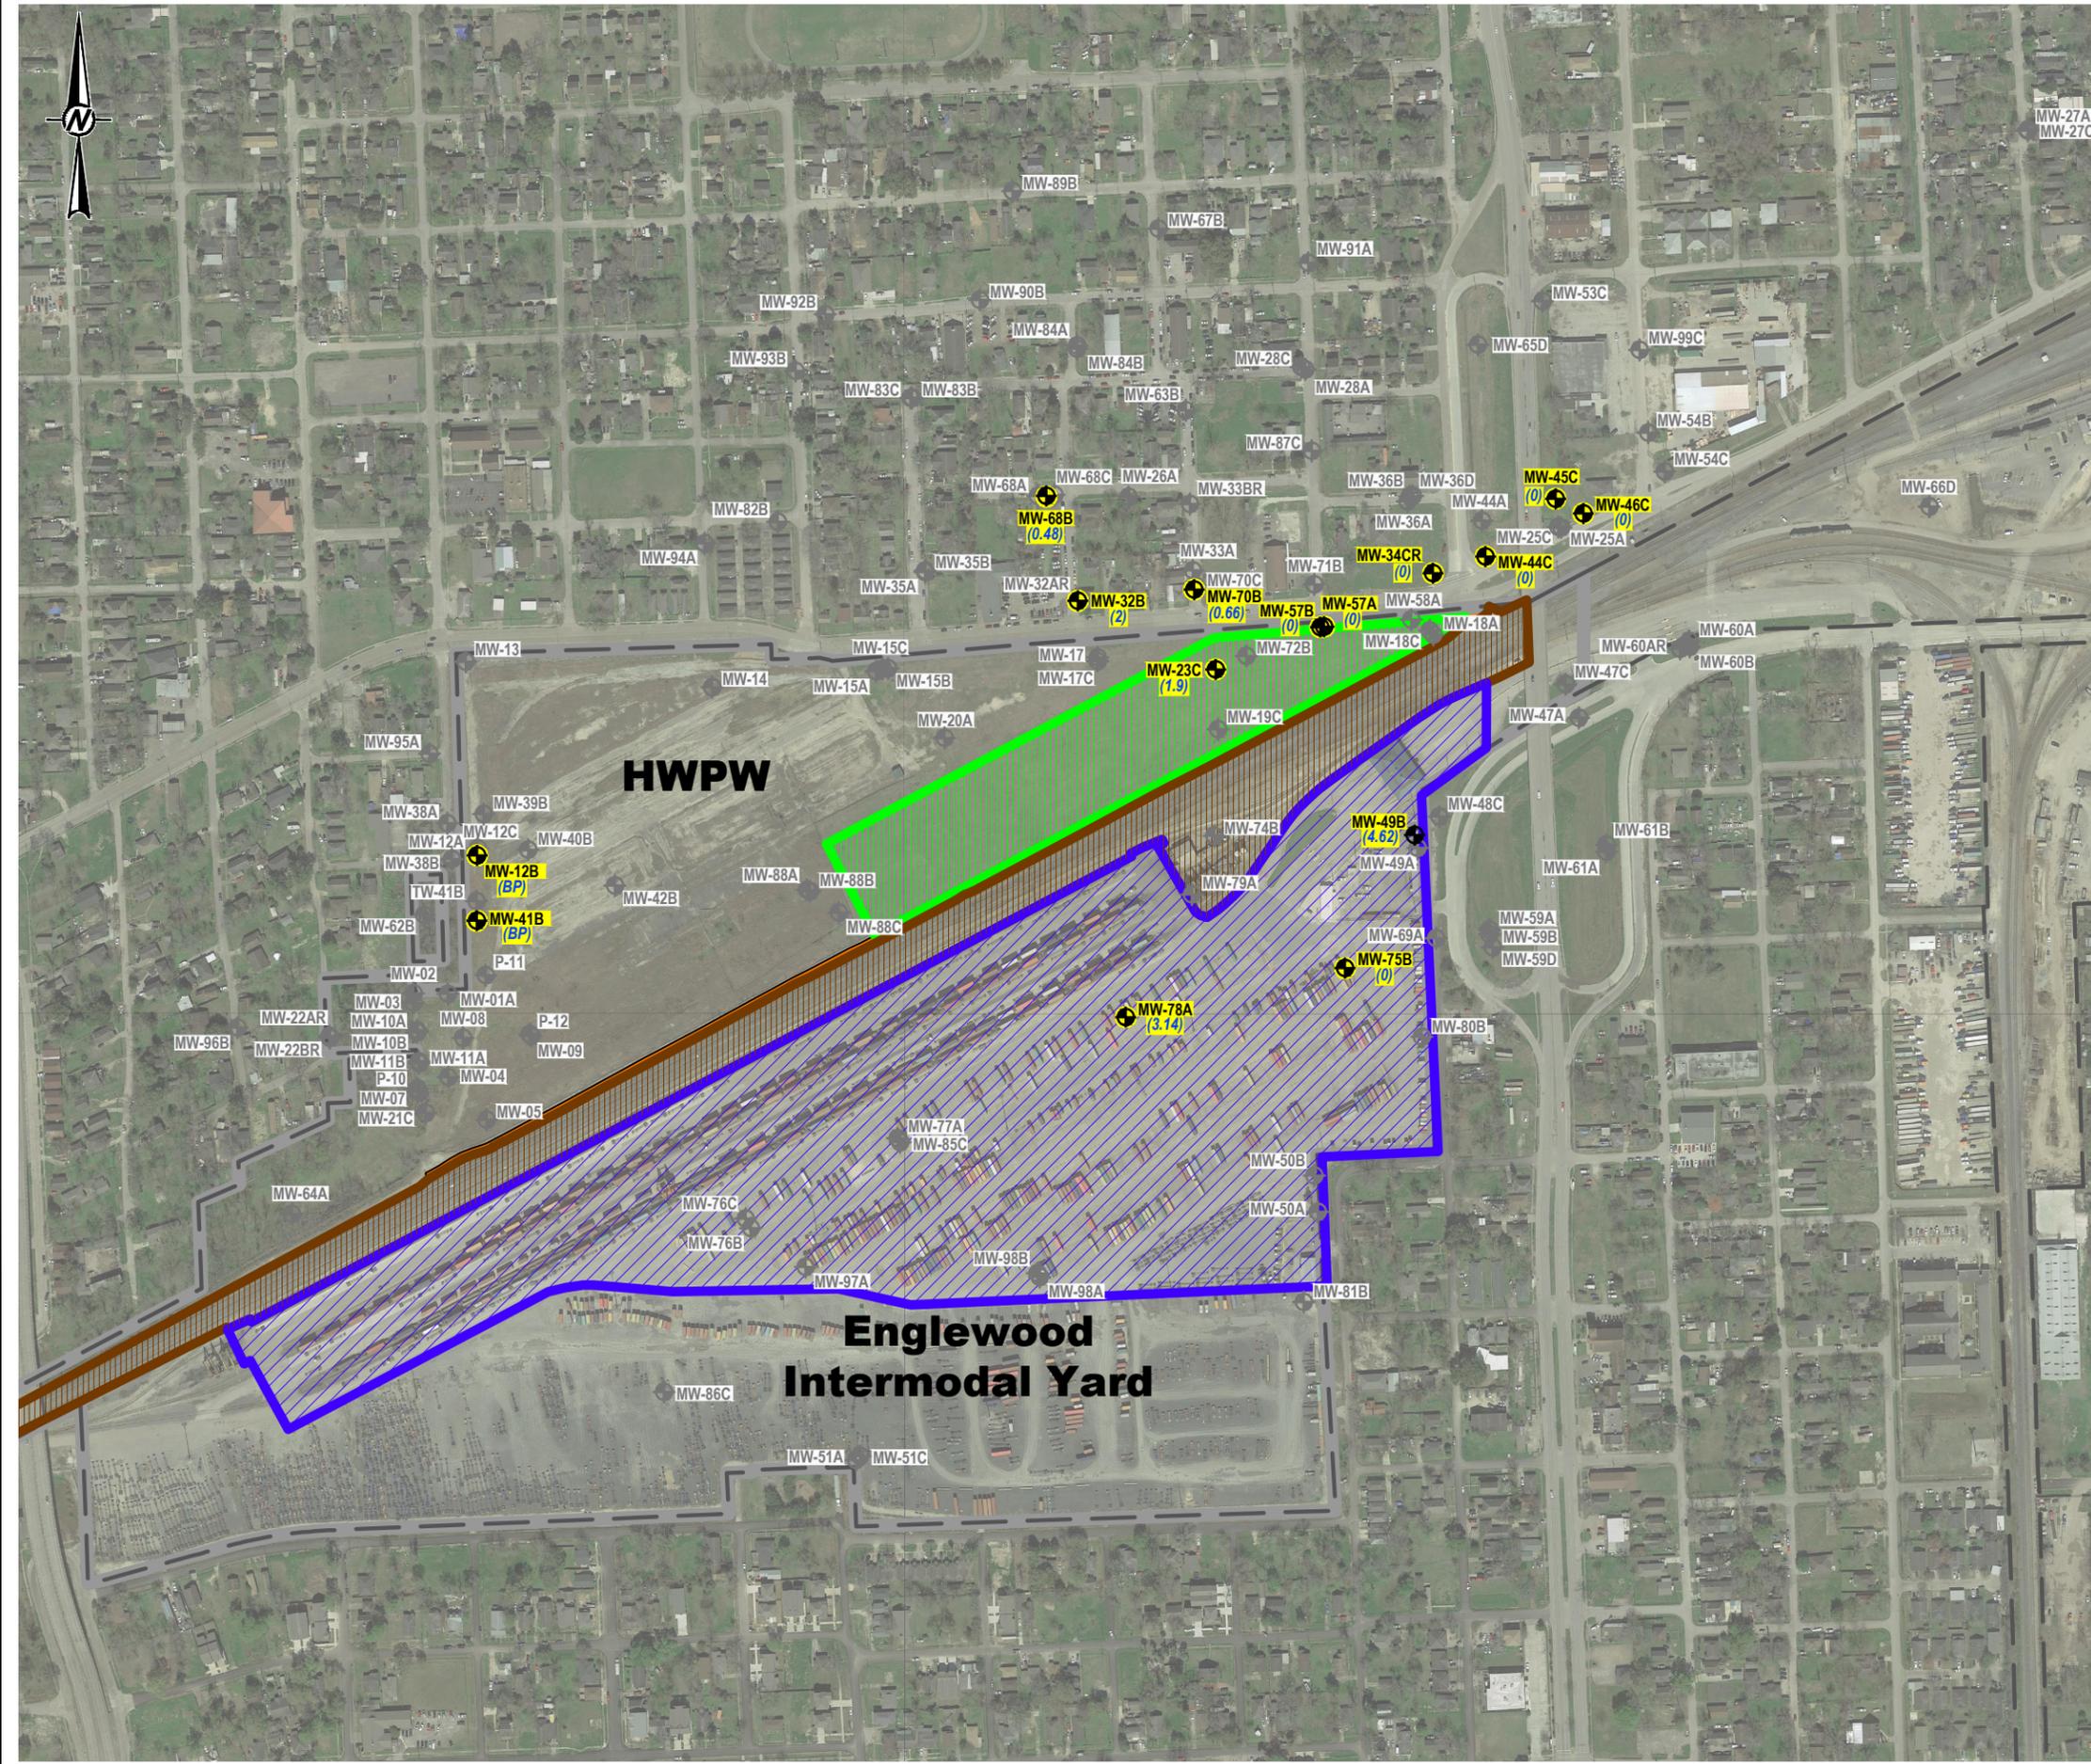
\*Wells MW-49B and MW-68B were added to the list of recovery wells beginning in January 2020. The locations of the DNAPL recovery wells are shown on Figure 1.
