# ***DRAFT 2019 Benthic Macroinvertebrate and Habitat Assessment Results***

## Draft 2019 Benthic Macroinvertebrate and Habitat Assessment Results

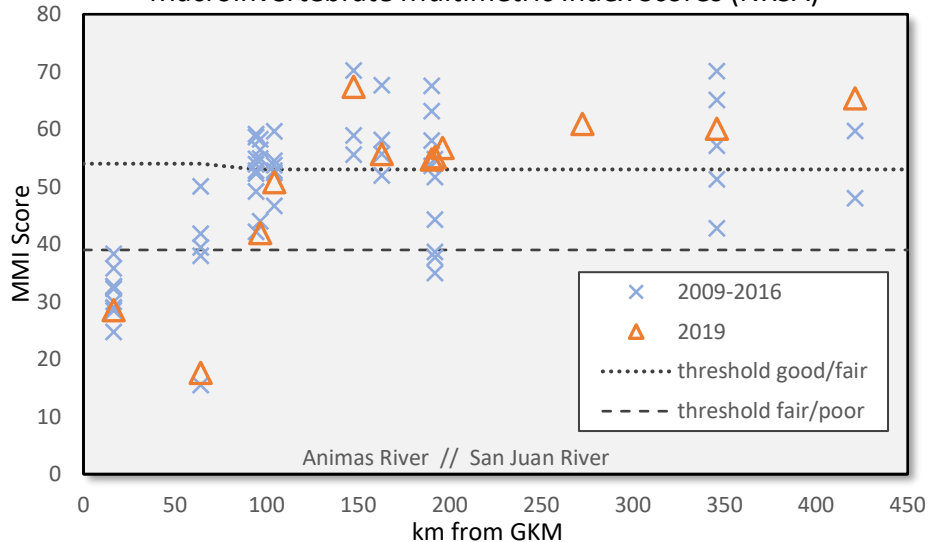
To provide a comparison of 2019 results to historical results, and display longitudinal trends moving downstream, graphs of MMI scores, % EPT, and total taxa for all sites are provided in Figures 2-11. Direct comparisons of Animas River results with those of the San Juan River are discouraged due to the distinctly different substrate characteristics and differences in water quality. Additionally, results for each site have been plotted over time and accompanied by a site location map, habitat results, and photos of high and low flows. These individual site results are represented in Figures 13-52; Photographs 3-22; and Tables 3-12. Note that individual site results are not provided for sites WIIN-14, 28, or 40 as these sites did not have historical data for comparison. However, these sites are represented in Figures 2-11. A map of labeled sites and a crosswalk to site descriptions is found in Figure 53 and Table 13, respectively.

Figure 2. NRSA MMI for all sites, historical and 2019 data.

- Total taxa increase as you move downstream on the Animas River and away from the mining district, as does EPT % and diversity.
- In the Animas River, MMI scores reflect improving water quality conditions as you move downstream from Silverton, CO.
- San Juan River MMI results indicate a more stable condition though habitat is more limiting to EPT taxa (due to natural substrate characteristics).
- Habitat assessments reflect impact of development and roads along the rivers (human disturbance) and is generally higher along the Animas; In-stream habitat complexity and intact riparian vegetation is generally better along the San Juan; and, as expected, relative bed stability is greater in the Animas due to the presence of larger, courser, substrate.

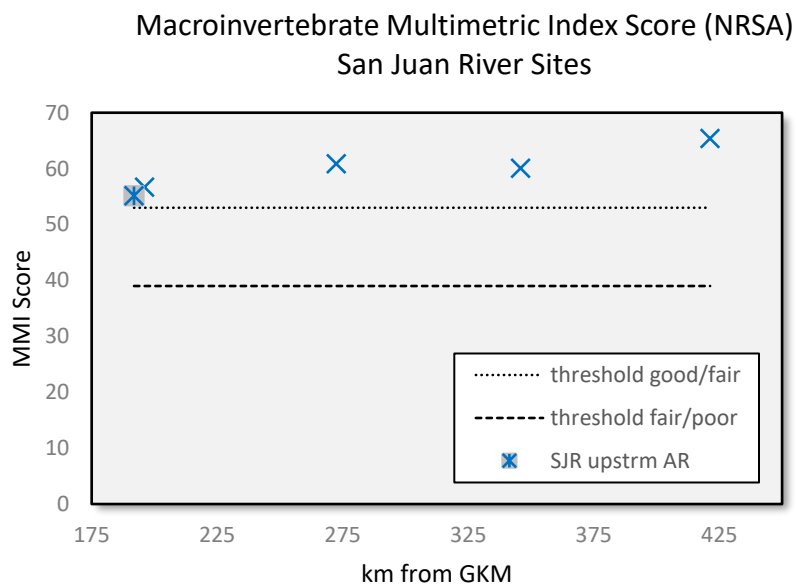
Figure 5. MMI Scores using NRSA MMI, San Juan River, 2019 results.

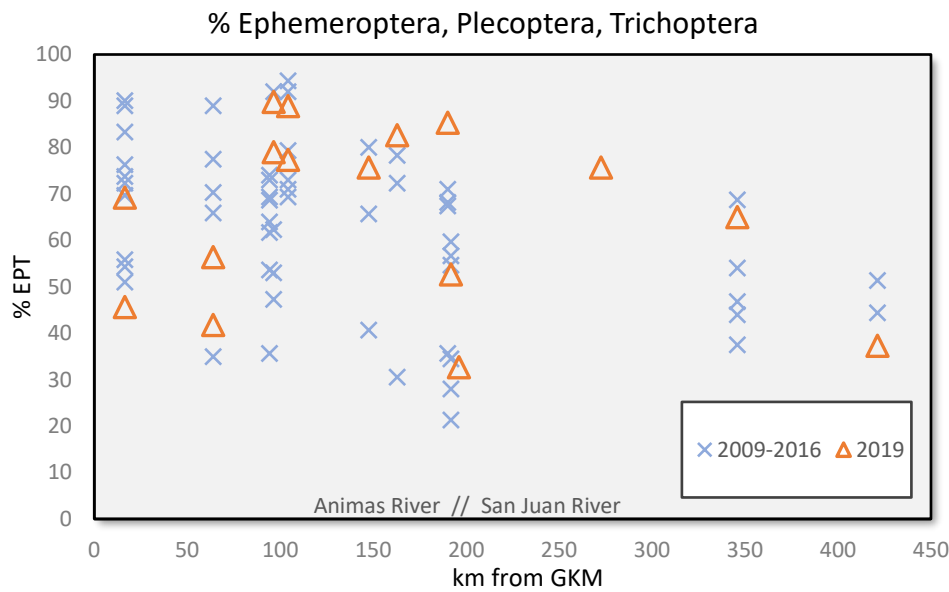
Figures 6-8. Historical and 2019 results for percent sample composition of Orders Ephemeroptera, Plecoptera, Trichoptera.

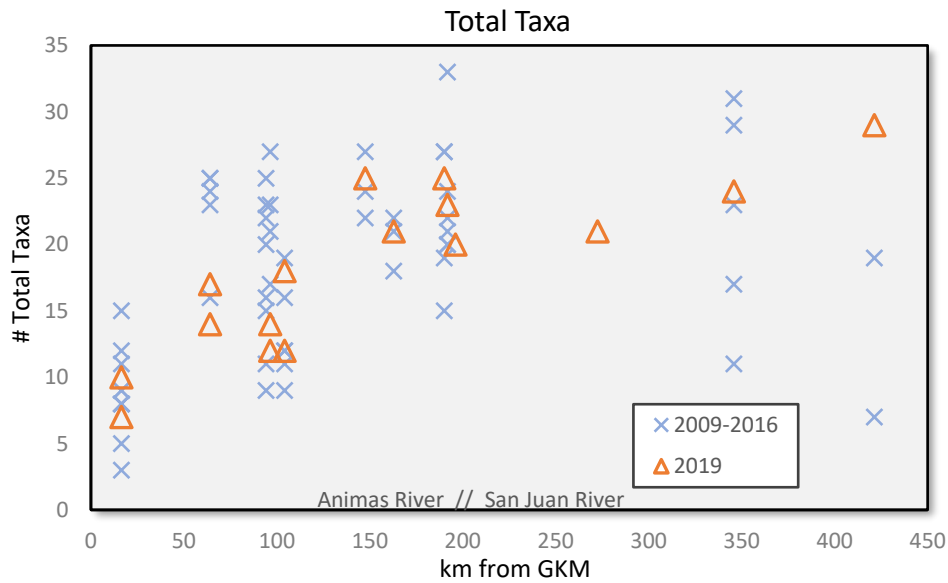
Figure 9. Total taxa collected at each site, historical and 2019 results.

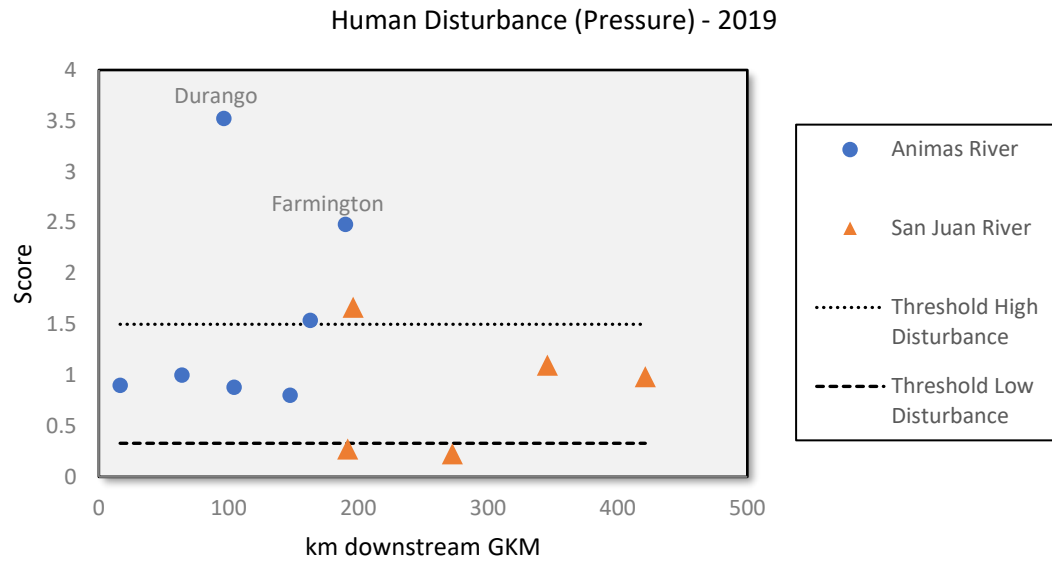
Habitat data were collected concurrent with benthic macroinvertebrate collections. Habitat quality for all sites was assessed using protocols employed by the EPA NRSA. Condition estimates (e.g., *good-fair-poor*) were calculated for four categories: Relative Bed Stability; Riparian Vegetation; Habitat Complexity; and Human Disturbance Pressure. Results of 2019 and historical results, as well as definitions of each of the above categories, can be found in Table 14. One category, Human Disturbance Pressure, a measure of the intensity and extent of human activities along the sample reach, is graphed by site and represented in Figures 12 and Photographs 1-2.

Figure 12. Human disturbance/pressure as measured during habitat assessments, 2019.

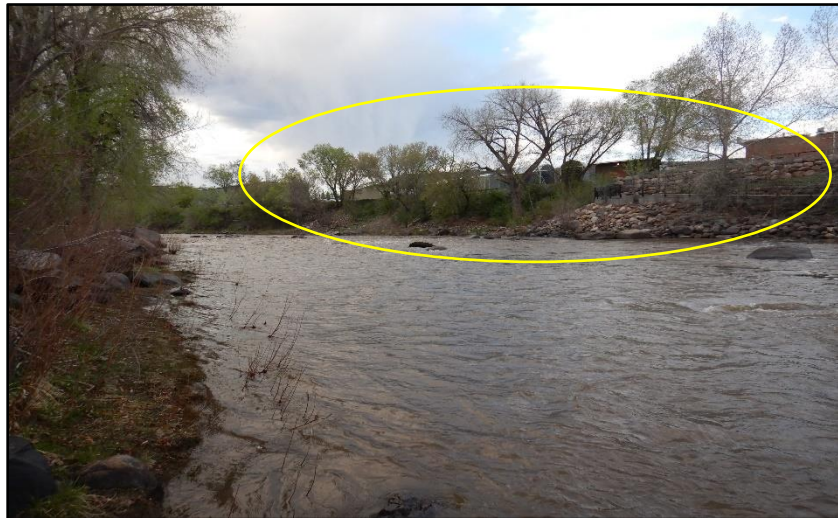
Photograph 1. Example of high human disturbance. Animas River in Durango, CO.

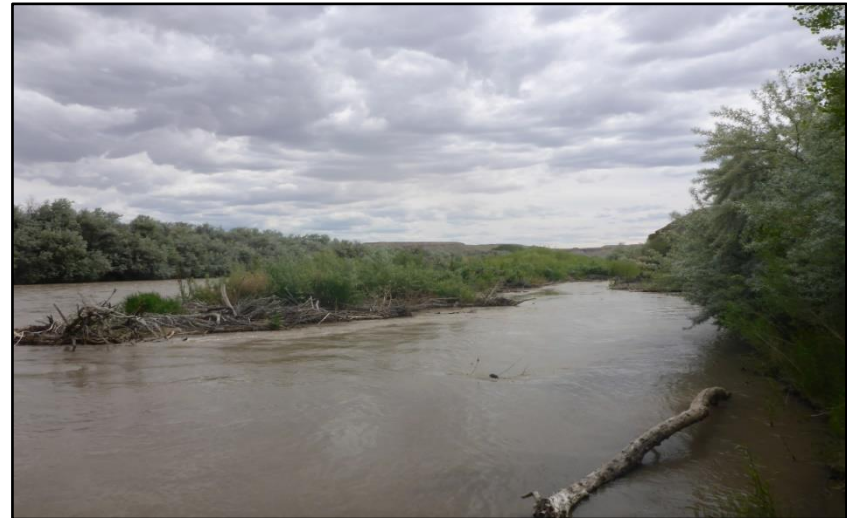
Photograph 2. Example of low human disturbance. San Juan River downstream of Shiprock, NM.

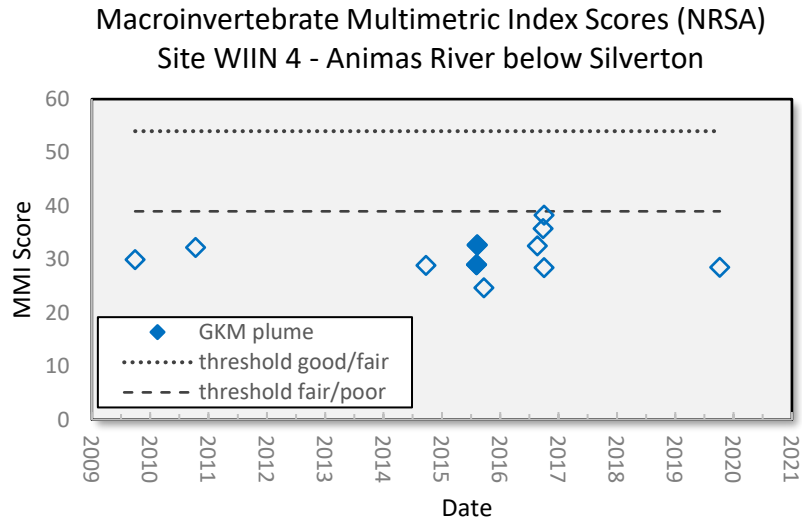
Figure 13. NRSA MMI Score.

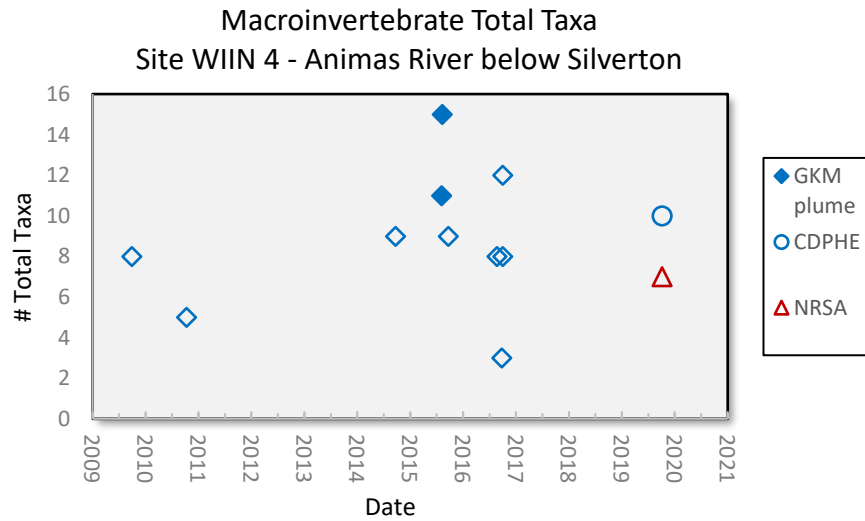
Figure 14. Total taxa.

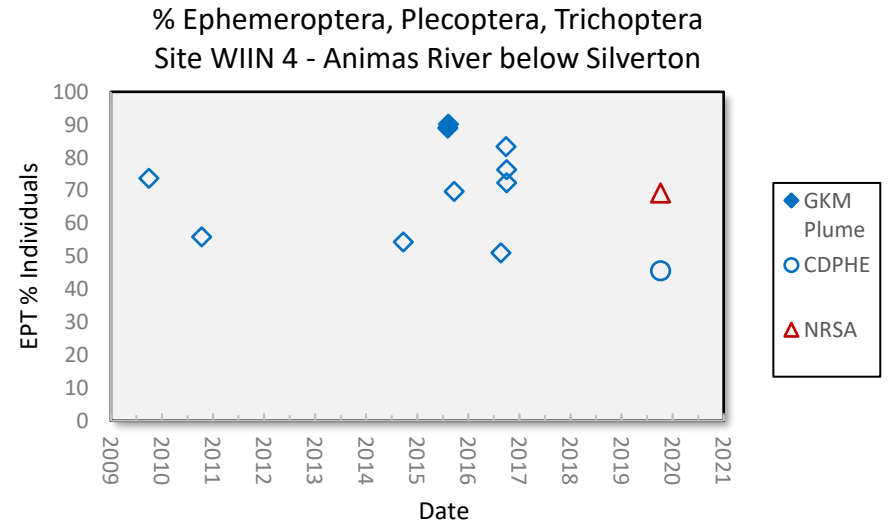
Figure 16. Percent composition EPT taxa.
