Long-Term Stewardship Assessment Report

Chester County Solid Waste Authority Lanchester Landfill

Assessment Date: May 18, 2022

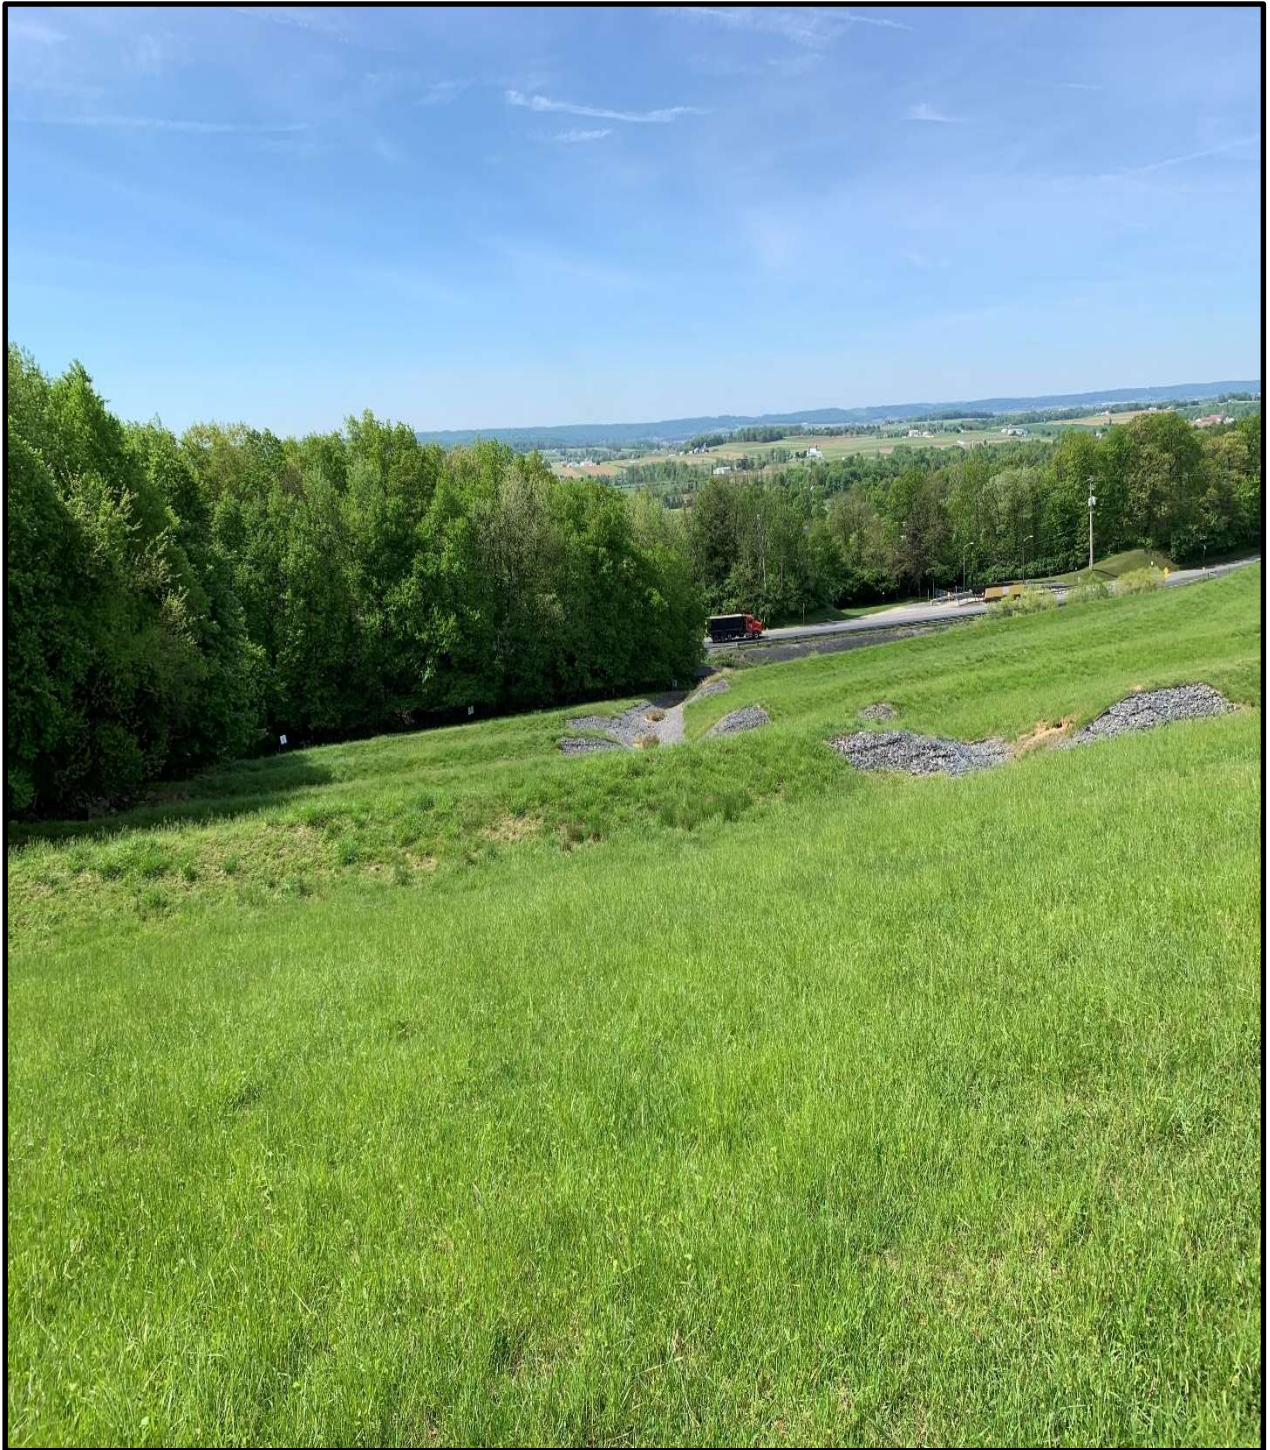
Picture 1: From top of Stabilized Waste Landfill facing south

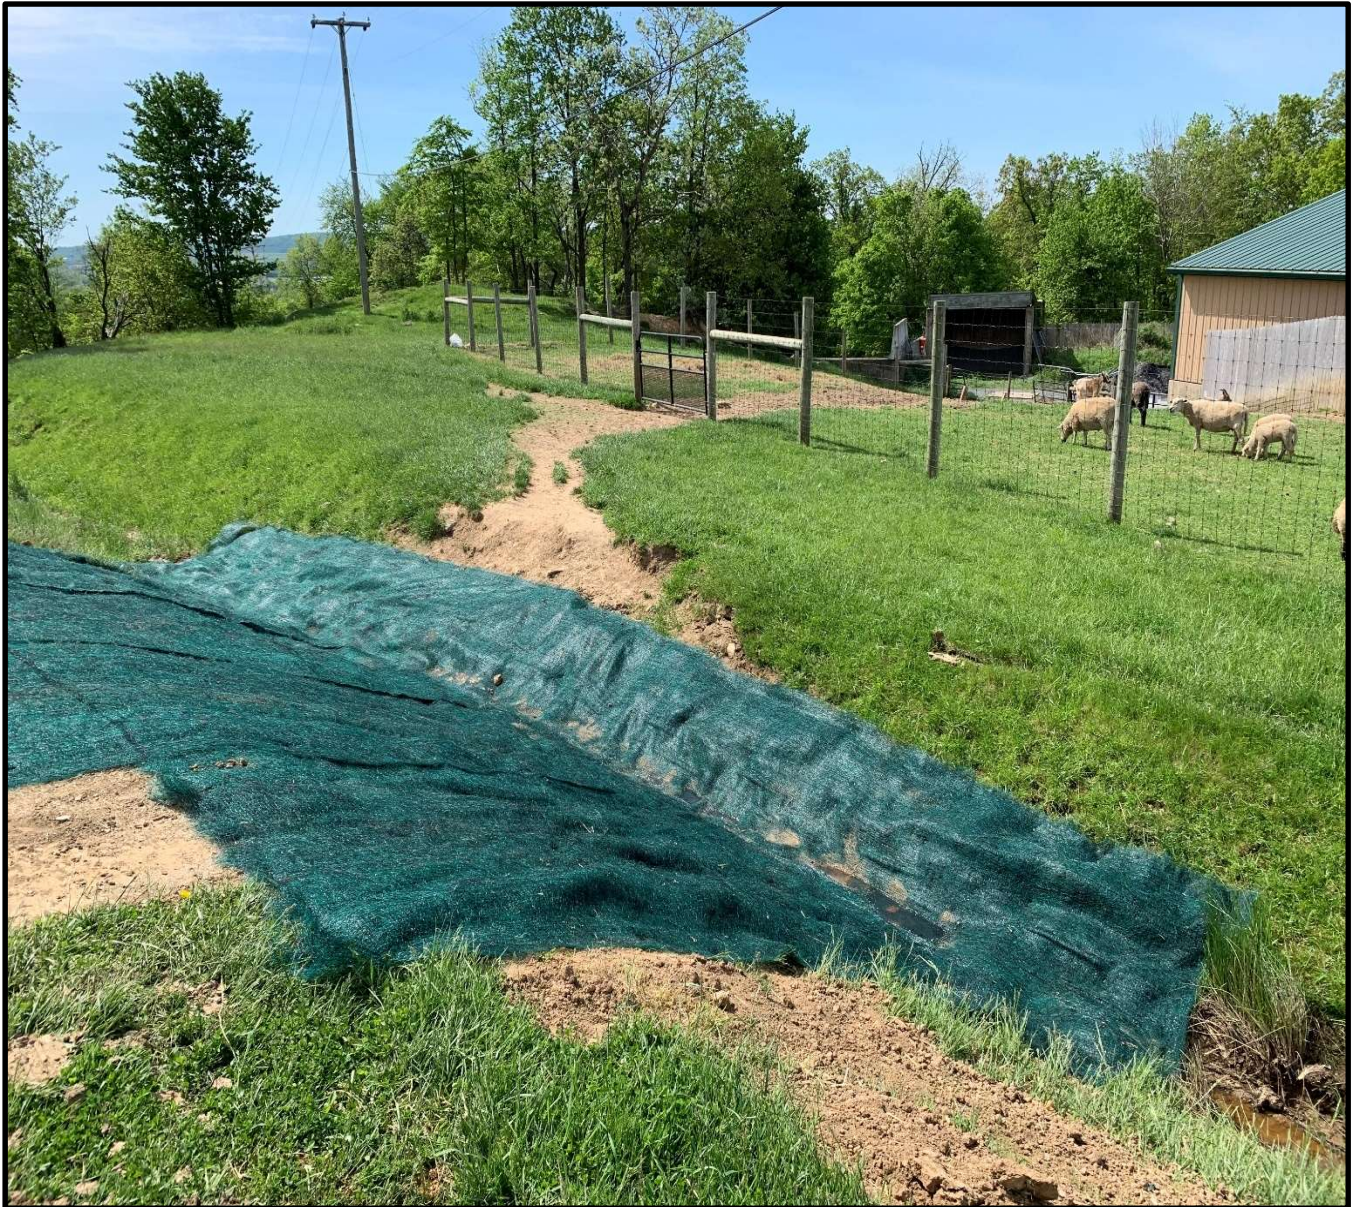
Picture 2: Western area of Stabilized Waste Landfill- erosion control measures in drainage ditch

Conclusions and Recommendations: No EC/IC deficiencies were identified. Some minor areas of erosion were observed on the cover of the Stabilized Waste Landfill. Erosion control measures were being implemented in various areas as shown in Pictures 2 and 3. Continue to monitor and repair areas of erosion as needed. EPA has determined that the remedy institutional and engineering controls have been fully implemented.

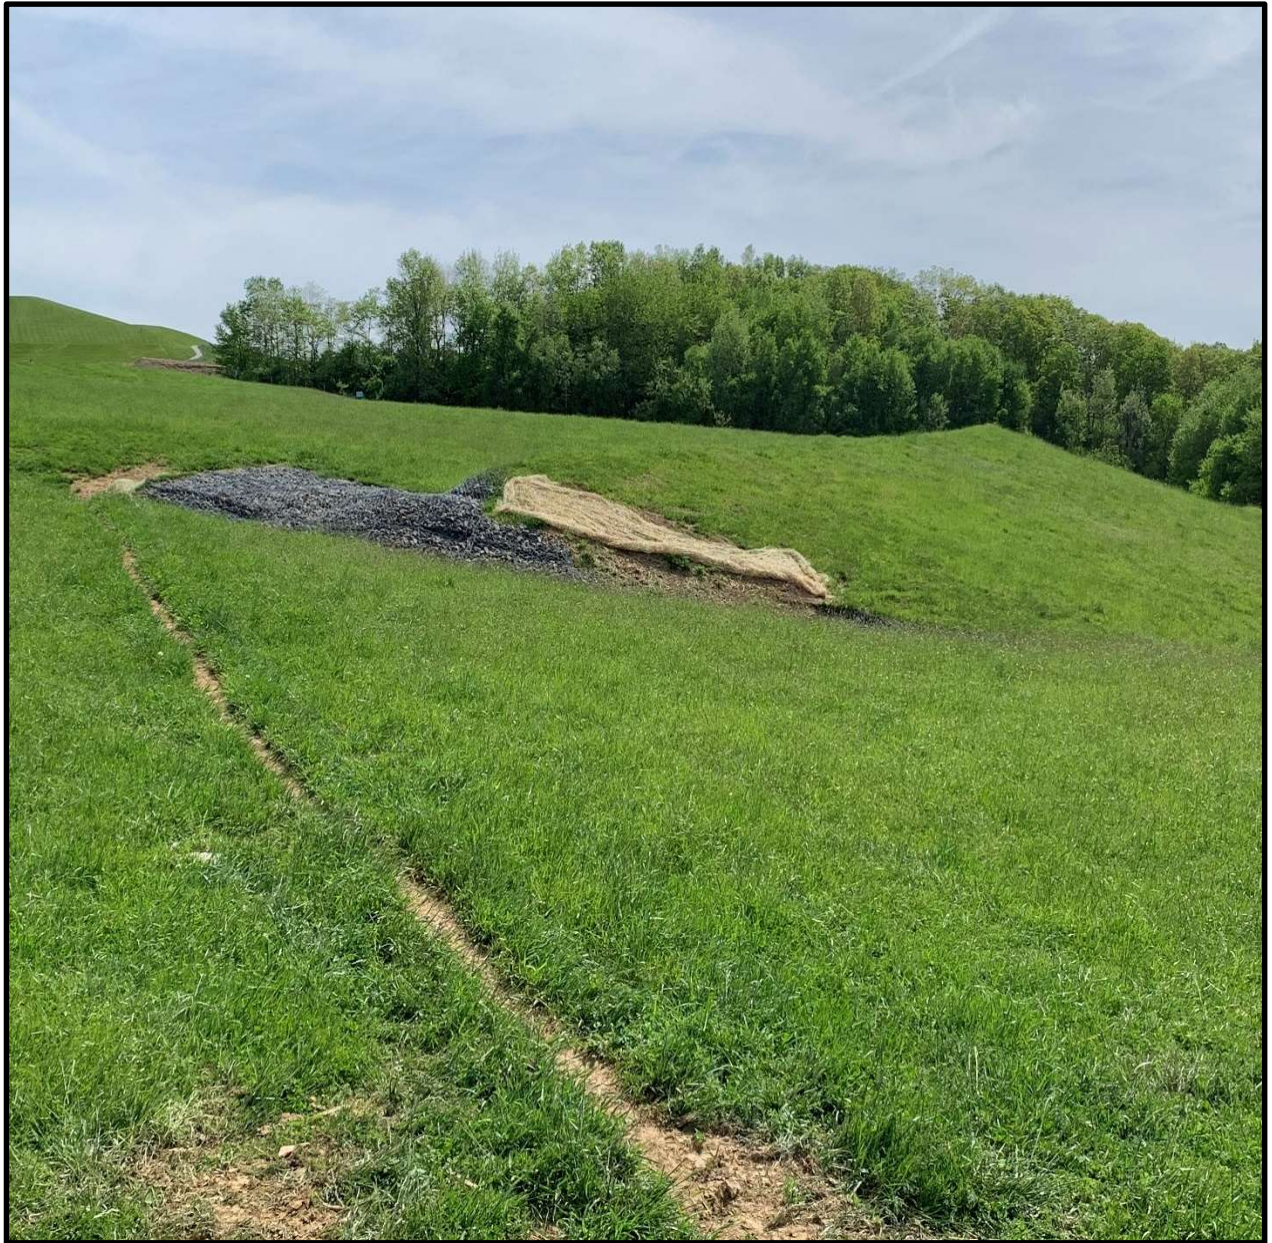
Picture 3: Top of Stabilized Waste Landfill facing north towards Municipal Landfill Areas – area of minor erosion repair

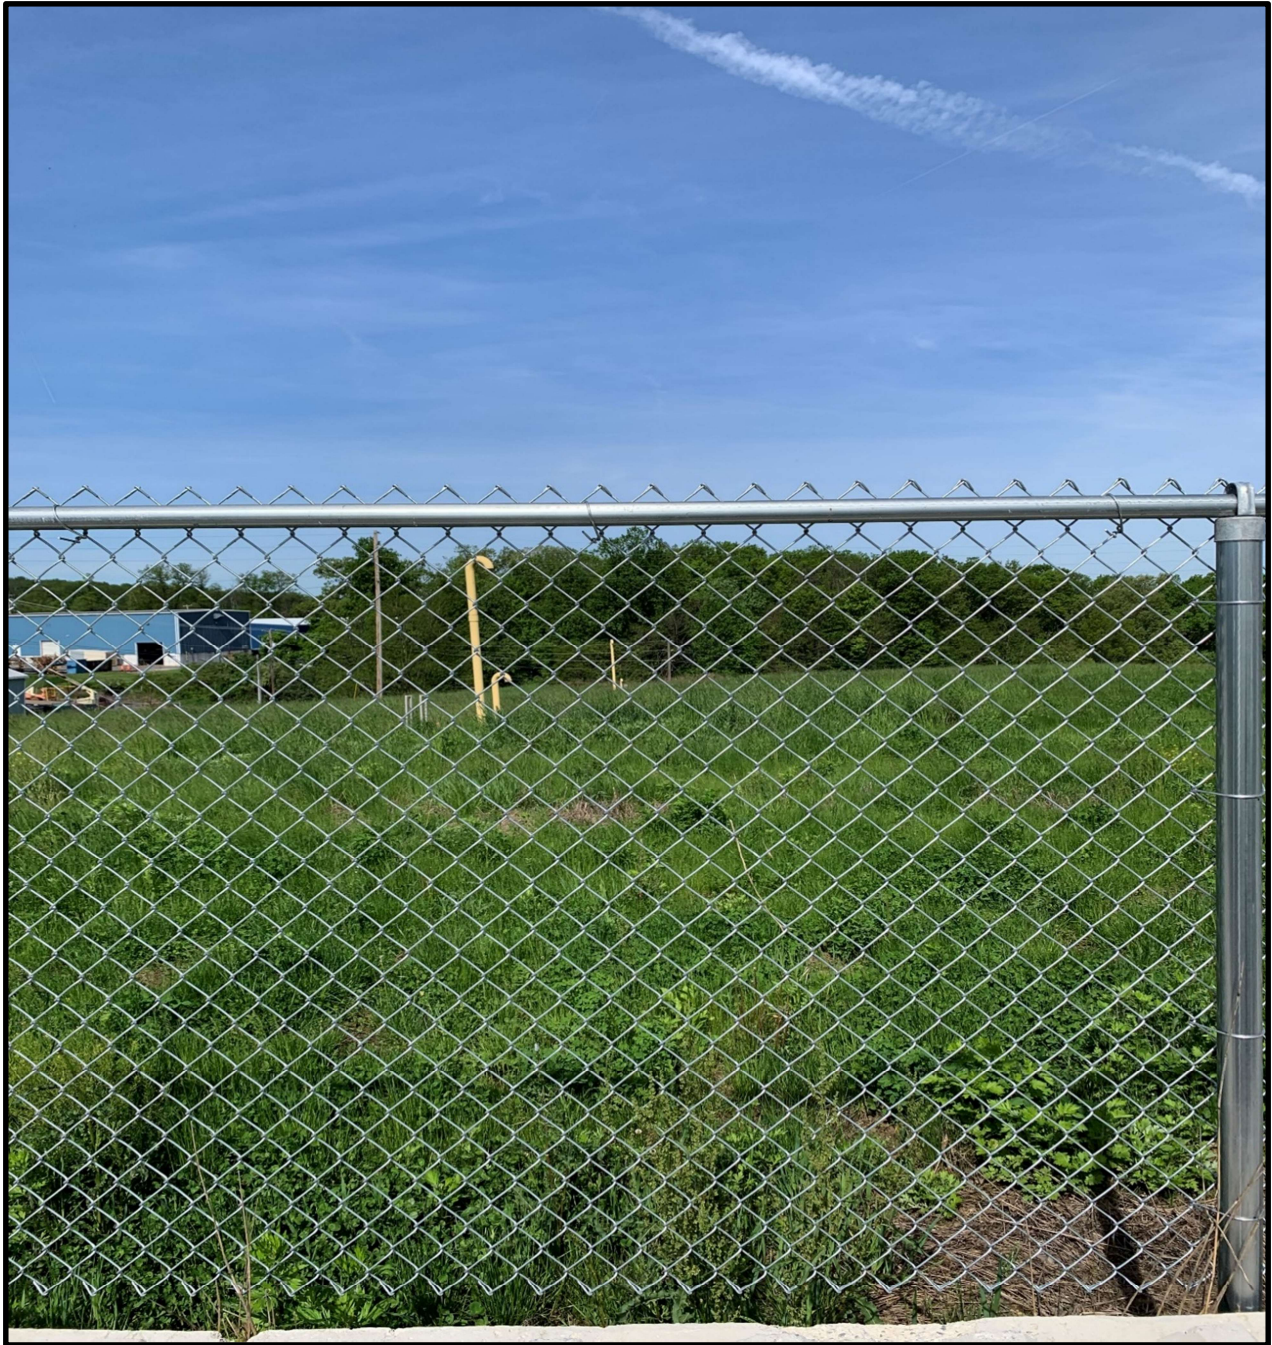
Picture 4: Top of Mountain Top Landfill facing southwest – passive ventilation system

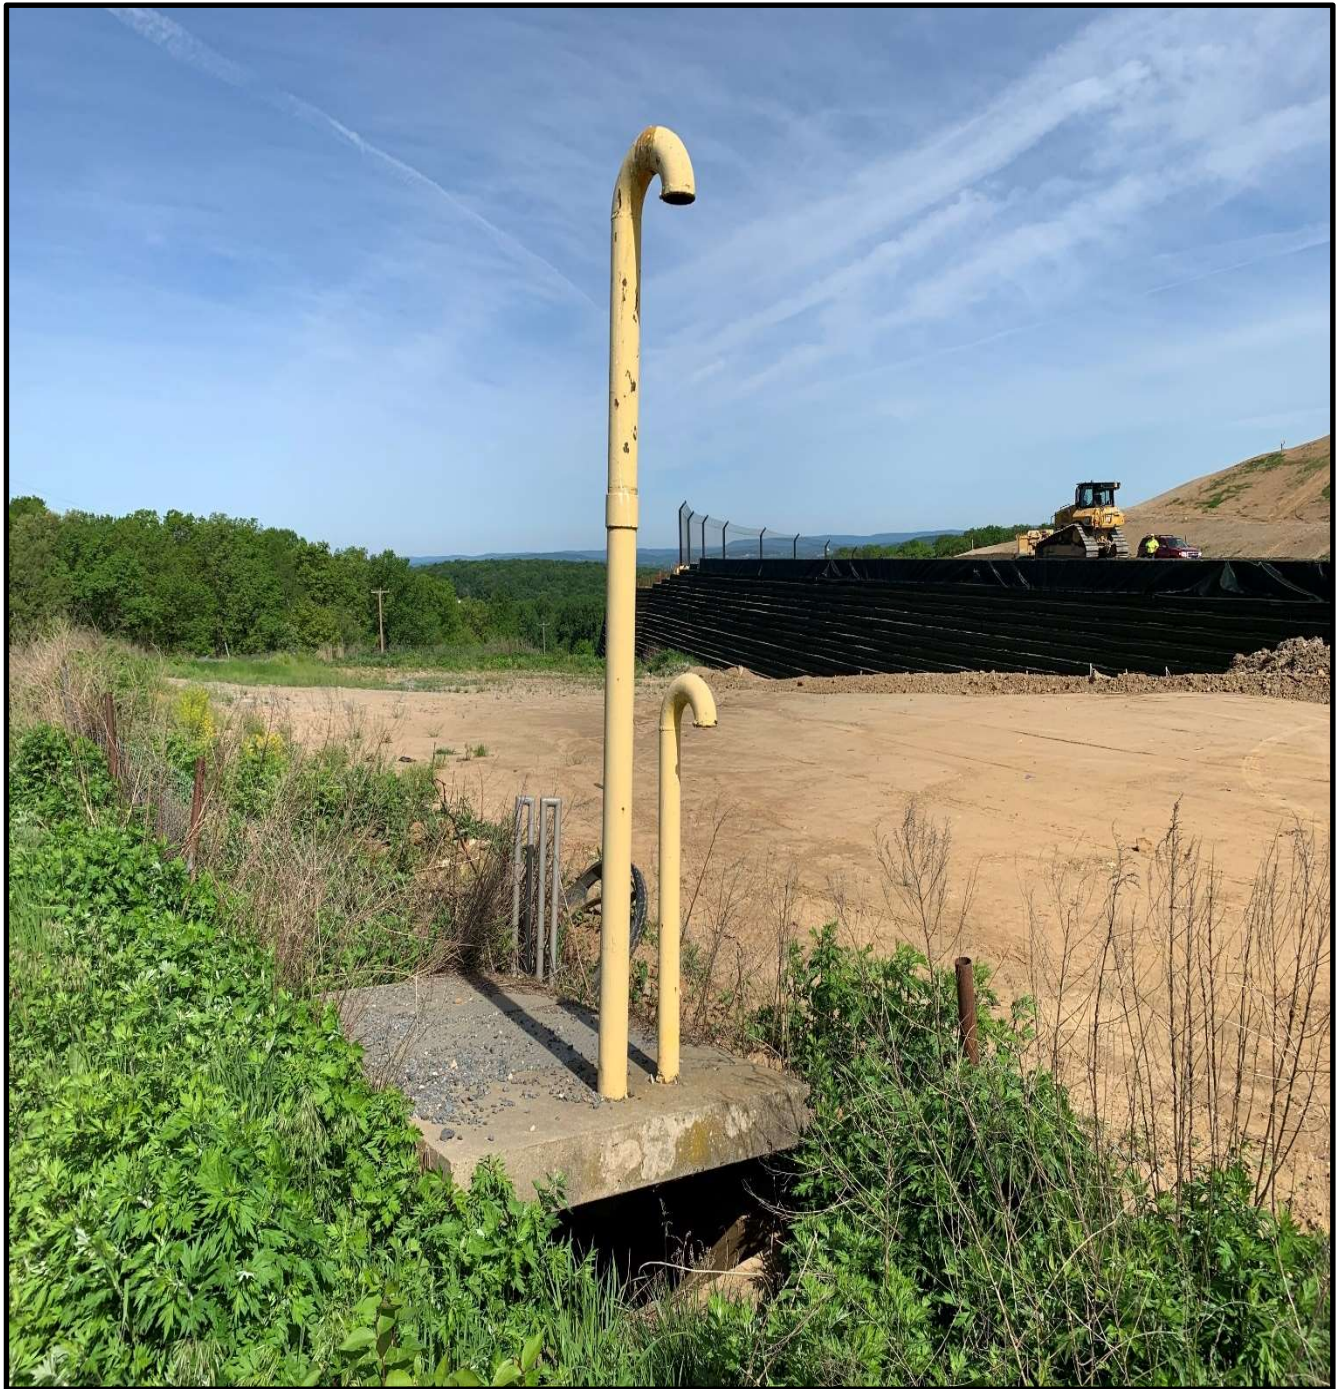
Picture 5: Top of Mountain Top Landfill northern boundary – passive ventilation system

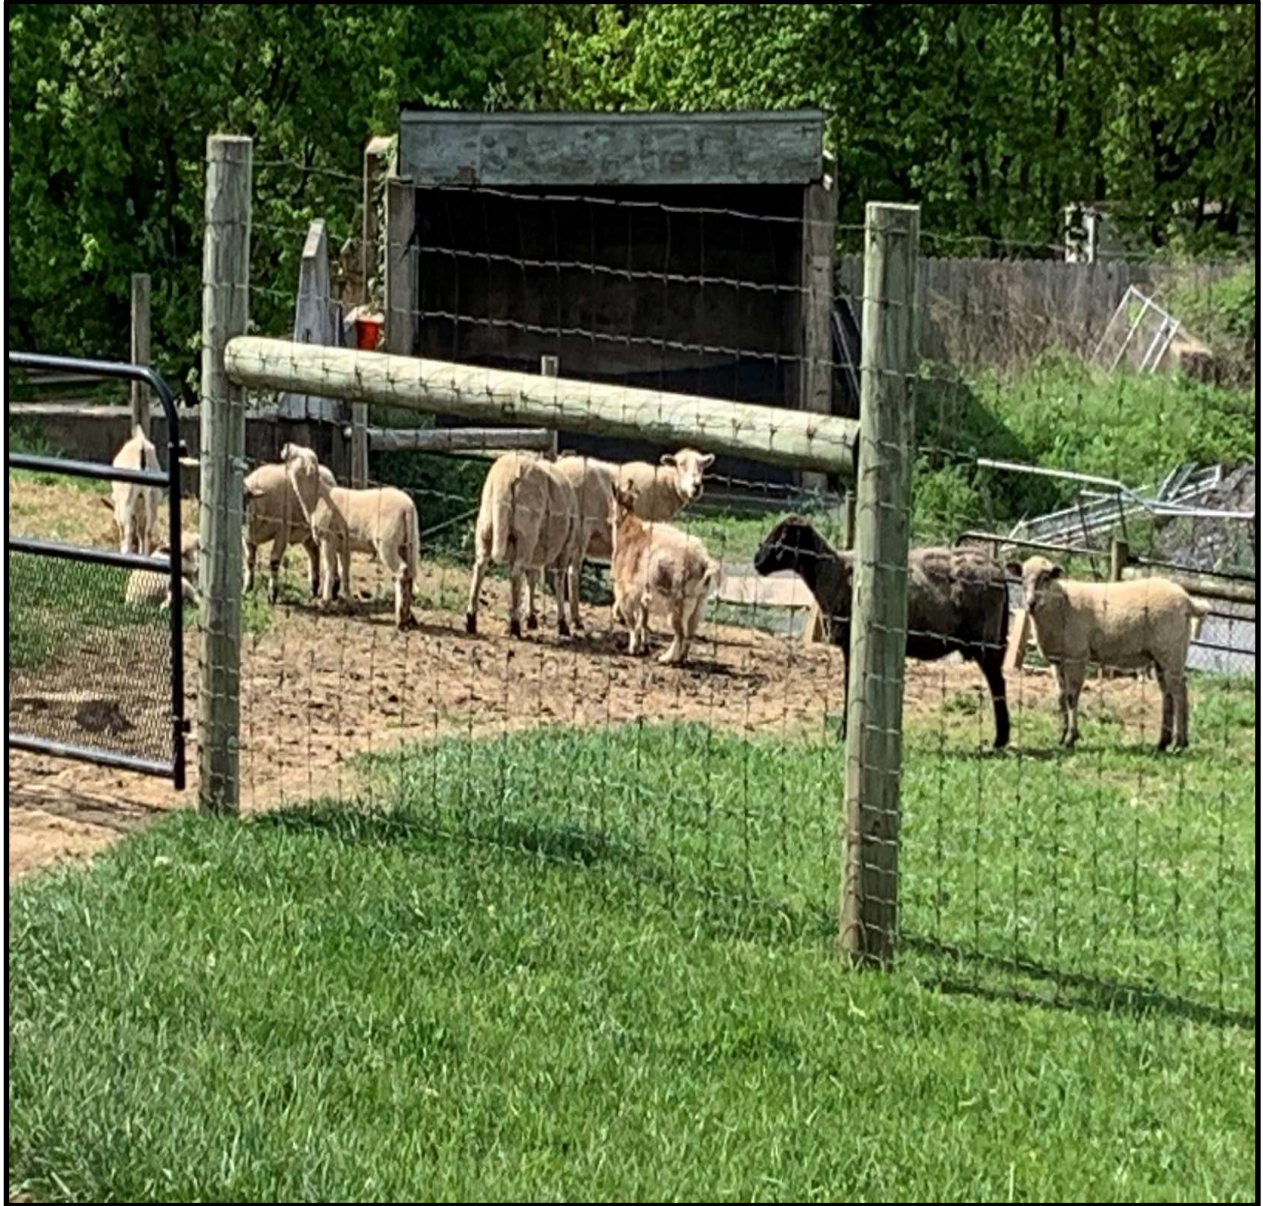
Mountain Top and Stabilized Waste Landfill Caps: CCSWA has maintained the integrity and effectiveness of the landfill caps by mowing approximately twice per year. In addition to mowing, sheep (shown in Picture 8) are used to assist in the maintenance of the approximate 9-acre Stabilized

Picture 8 – Sheep used in conjunction with mowing to maintain vegetative landfill covers

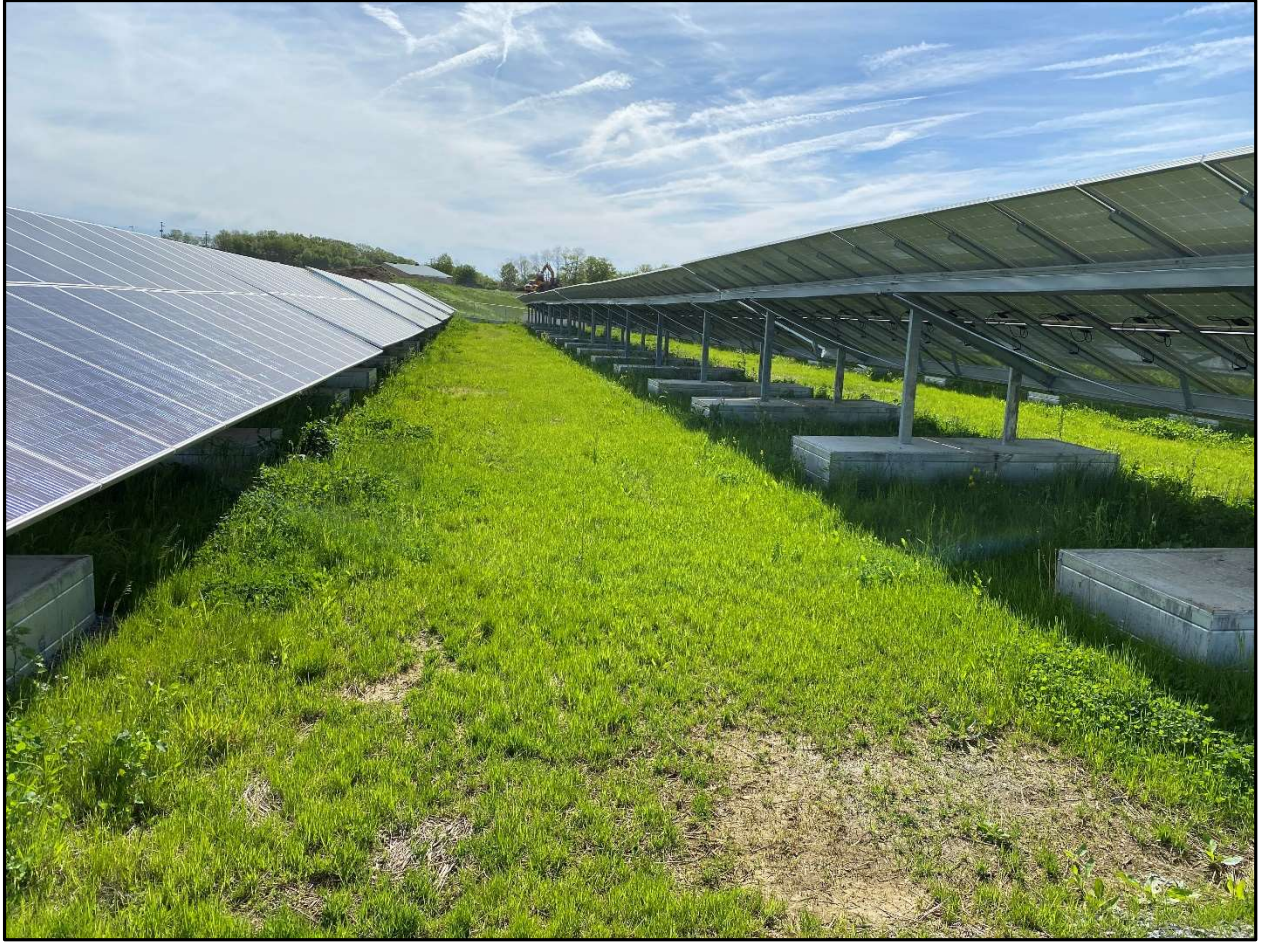
The IU Site is currently being maintained and monitored under a RCRA post-closure permit, Permit No. PAD 980 550 545. While the Mountain Top landfill is not operating under a permit, because of its proximity to the Municipal landfill, groundwater monitoring, inspection and maintenance obligations are required by Municipal Solid Waste Operating Permit No. 100944. No plants with deeply penetrating root systems or signs of significant erosion were observed at either of the capped landfills. Surface water berms and swales were in good condition with no signs of ponding. A solar panel array was recently installed on Mountain Top landfill (Picture 9).

Picture 9 – Solar panels on Mountain Top Landfill
