**ABANDONED MOBILE HOMES TOOLKIT  
BEST MANAGEMENT PRACTICES RESOURCE GUIDE**

**EPA530V12001**

**U.S. Environmental Protection Agency, Region 2  
290 Broadway  
New York, NY 10007-1866**

**April 16, 2012**

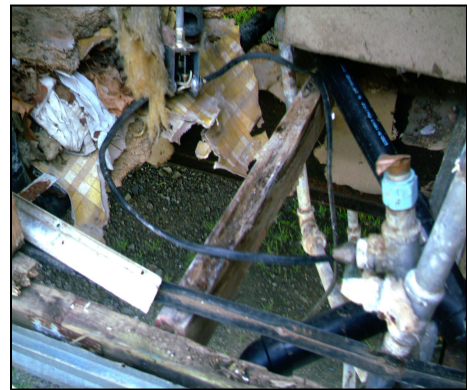
Photograph depicting the rotted floors of MHU2. The floor cavities were exposed raising a safety concern

During the inventory phase, the interior of MHU2 was determined to be unstable. The lower portions of the walls were rotted out and posed a significant safety hazard to the deconstruction team. The deconstruction experts determined that it would be safest to conduct this deconstruction by first removing the roof of the structure; next, deconstruction of the bottom portions of the exterior walls (including removal of the aluminum siding) would take place; finally, deconstruction of the interior would commence. The following observations were made during the inventory phase for this unit:

During the pre-deconstruction assessment, large holes were observed where moisture had rotted the floor and lower walls of MHU2. This was a safety hazard for the deconstruction team. As a result, the strategy for MHU2 involved deconstructing the unit from the exterior portions to the interior, and from the top of the unit to the bottom.

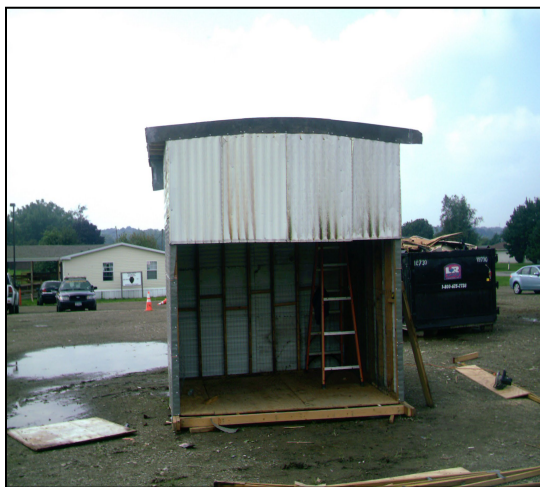
The main reconstruction project, the tool shed; 12 feet high by 6 feet wide.

Reconstruction activities consisted of building four saw horses and a tool shed. The reconstruction project was completed in approximately 18 hours. This included approximately eight hours using manual tools and labor and ten hours using power tools. The reconstruction project used approximately 26 percent of the materials salvaged from MHU1 and MHU2. Five volunteers supported the construction of four saw horses as well as a tool storage shed. The tool shed was constructed using lumber from the floor and wall frames from MHU1, some salvaged roof trusses, and the aluminum siding salvaged from both structures.

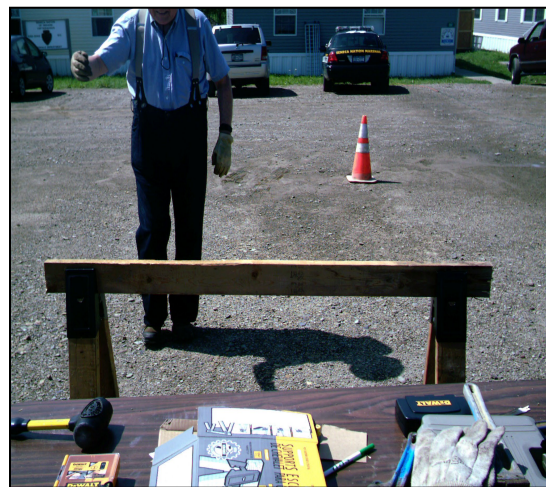
The first reconstruction project; saw horses.

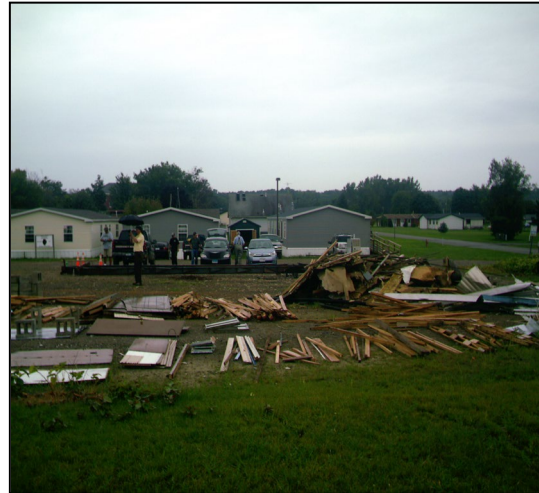
Salvaged material from the deconstruction of the two abandoned manufactured homes.

Approximately 1.75 tons of salvaged material was gathered from MHU1. Of the 1.75 tons, 0.53 tons of salvaged materials were immediately reused on construction of the four saw horses and the tool shed. The majority of this material was comprised of the 2 x 4 lumber that was salvaged and used in constructing the floor and walls of the tool shed.

In comparison, approximately 1.01 tons of materials were salvaged from the deconstruction of MHU2; 0.63 tons of this material was reused as ceiling trusses for constructing the tool shed's roof.

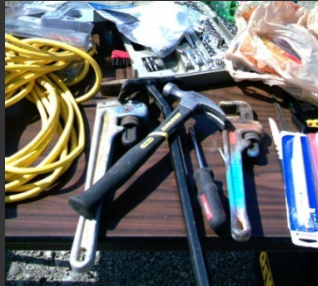
<p><b>Rubber Mallet, Adjustable Wrench, and Socket Wrench (Manual)</b> Used during the reconstruction phase. The hammer was used to beat the salvaged aluminum siding around the corners of the storage shed.</p>
