**RE: Long-Term Stewardship Report
Emporia Foundry, Inc.
EPA ID VAD023720105**

Long-Term Stewardship Assessment Report
Emporia Foundry, Inc.
EPA ID VAD023720105

DEQ Long-Term Stewardship Facility Geospatial PDF
Emporia Foundry – Emporia, Virginia

Select Site Photos
Photos by: Tara Mason
September 16, 2022

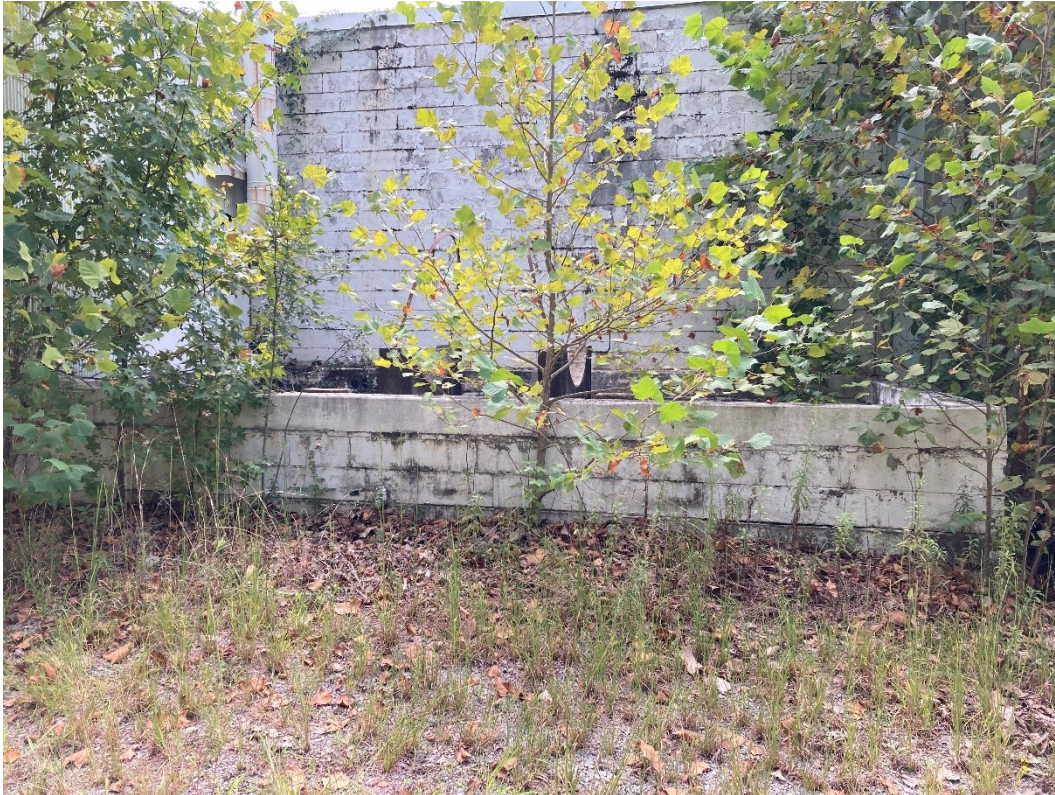
Restriction Area I

Conclusion: The engineering and institutional controls selected are implemented and remain intact and undamaged. No EC/IC deficiencies have been identified.
