# NONPOINT SOURCE SUCCESS STORY

## New Hampshire

### McQuesten Brook Restoration Protects Native Brook Trout

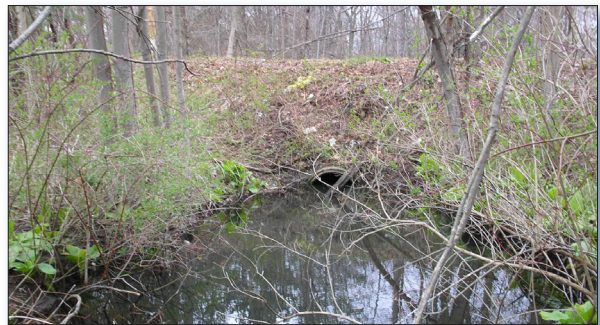
Figure 1. Culverts like this one on Eastman Avenue blocked fish passage and contributed to low DO.

In 2010, NHDES listed a segment of McQuesten Brook (assessment unit NHRIV700060803-16), a tributary to the Merrimack River, located in Bedford and Manchester, New Hampshire, for failure to support aquatic life integrity due to insufficient DO concentration. The brook did not meet the state standard of 5.0 milligrams per liter (mg/L). A sequence of open and closed channels and four fish passage barriers restricted the movement of brook trout and contributed to the DO impairment in this highly urbanized, 564-acre watershed (Figure 1).

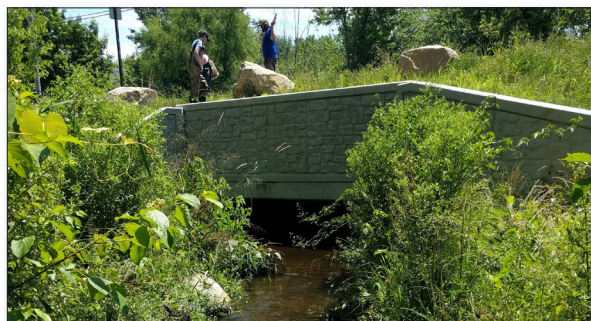
Figure 2. A new bridge crosses Eastman Avenue.

Upstream and one block north of Wathen Road, where the brook was constricted, the Town of Bedford replaced an undersized 36-inch culvert at Eastman Avenue with a 15-foot open-bottom bridge. This structure is sized appropriately for aquatic organism passage and conveyance of flood flows up to one and a half times bankfull width (Figure 2).

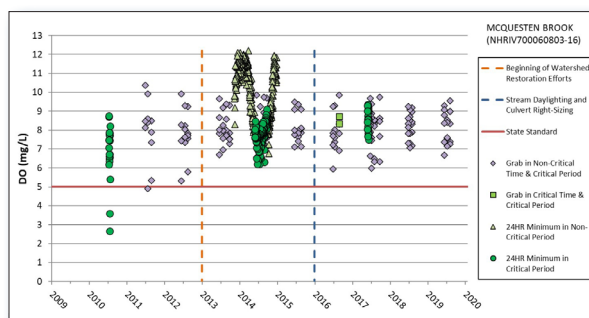
Figure 3. DO levels in McQuesten Brook (2009–2020).

Addressing these three fish passage impediments in 2016 re-established a more natural flow regime in this segment of McQuesten Brook, resulting in improved DO levels and lower water temperatures, which created a healthier and more valuable habitat for eastern brook trout and other aquatic organisms. After restoration work, the DO threshold of 5.0 mg/L was met during a wide range of temperatures and conditions similar to those present while the brook was impaired (Figure 3). In 2018, NHDES removed this river assessment unit from the CWA section 303(d) list for its DO impairment.
