**Region 6 - Enforcement & Compliance Assurance Division**  
**INSPECTION REPORT**

Inspection Date(s):	04/20/2022	
Media Program:	Air	
Regulatory Program(s)	Title V	
Company Name:	<b>MPLX/Pin Oak Terminal LLC</b>	
Facility Name:	<b>Mt. Airy Terminal LLC</b>	
Facility Physical Location:	4006 LA-44	
(city, state, zip code)	Mt. Airy, LA 70076	
Mailing address:	539 South Main Street	
(city, state, zip code)	Findlay, OH 45840	
County/Parish:	St. John the Baptist	
Facility Phone Number	504-533-8783	
Facility Contact:	Tina Harper	Environmental Professional
	KKHarper@marathonpetroleum.com	
FRS Number:	110027225198	
Identification/Permit Number:	AI 144688/2580-00051-V1	
Media Identifier Number:	AFS 22-095-00051	
NAICS:	424710	
SIC:	5171	
Personnel participating in inspection:		
Sarah Frey	EPA ECD-AT	Inspector
Chris Williams	EPA OECA-AED	Chemical Engineer
Richard Helmich	EPA NEIC	Chemist
David Mahoney	EPA NEIC	Technical Coordinator
Ali Gitipour	EPA ORD	Engineer
Brandon Saunier	LDEQ	Environmental Scientist

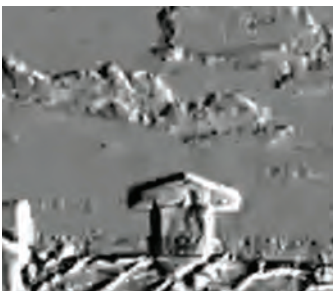
Downwind of Tank 110-20, Volatile Organic Carbon (“VOC”) emissions were detected intermittently between 200 and 300 parts per billion (“ppb”). Mr. Neal identified the contents of the tank as Vacuum Gas Oil and confirmed the tank was static, not being loaded or unloaded. Mr. Williams recorded two videos using an Optical Gas Imaging (“OGI”) camera. The videos show intermittent hydrocarbon emissions exiting the fixed roof tank from the center conservation vent. See Videos 1 and 2.

File Name: MOV\_176.mp4  
Date taken: 04/20/2022  
Time taken: 2:31 pm  
Videographer: Chris Williams  
Description: Intermittent hydrocarbon emissions exiting the fixed roof Tank 110-20 from the center conservation vent

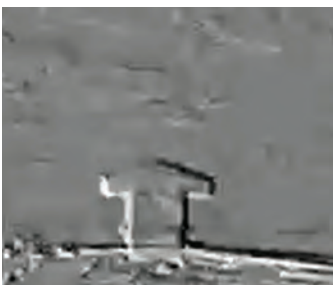
File Name: MOV\_177.mp4  
Date taken: 04/20/2022  
Time taken: 2:32 pm  
Videographer: Chris Williams  
Description: Intermittent hydrocarbon emissions exiting the fixed roof Tank 110-20 from the center conservation vent
