**Region 6 - Enforcement & Compliance Assurance Division**  
**INSPECTION REPORT**

Inspection Date(s):	04/13/2022	
Media Program:	Air	
Regulatory Program(s)	Title V	
Company Name:	<b>Eagle US 2 LLC, a Westlake Chemical Company</b>	
Facility Name:	<b>Lake Charles South - Eagle</b>	
Facility Physical Location:	1300 PPG Drive	
(city, state, zip code)	Westlake, Louisiana 70669	
Mailing address:	1300 PPG Drive	
(city, state, zip code)	Westlake, Louisiana 70669	
County/Parish:	Calcasieu Parish	
Facility Phone Number	337-708-4688	
Facility Contact:	Paula McCain	Environmental Manager
	pmccain@westlake.com	
FRS Number:	110000494894	
Identification/Permit Number:	AI No. 1255/2040-V9	
Media Identifier Number:	LA0000002201900004	
NAICS:	325181, 325199	
SIC:	2869	
Personnel participating in inspection:		
Nicholas Bobbs	EPA/OECA/OCE/AED	Inspector
Richard Helmich	EPA/OECA/OCEFT/NEIC	Chemist
Agustin Martinez	EPA/OECA/OCEFT/NEIC	Technician
Ali Gitipour	EPA/ORD/CEMM/AMCD	Physical Scientist
Elena Mayard	LDEQ/OEC/SD	Inspector

## **Section I – INTRODUCTION**

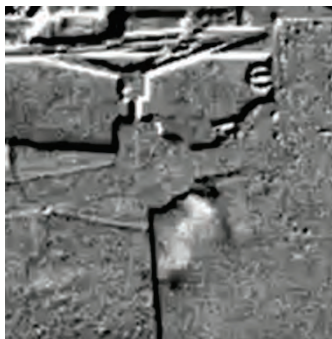
The GMAP detected elevated concentrations of methane downwind of the natural gas breakout south of Plant C. I recorded FLIR videos MOV\_0153, MOV\_0154, MOV\_0155 and MOV\_0156 at around 4:10 pm. Mr. Helmich recorded FLIR videos MOV\_0187 and MOV\_0188 at the same time. We observed several leaks using the FLIR GF320 cameras in the natural gas breakout, including leaks from wheel valves, pilot valves, and gages. [AOC 3] We identified the leaking components to the facility personnel.

File Name: MOV\_153.mp4  
 Date taken: 04/13/2022  
 Time taken: 4:10 pm  
 Videographer: Nicolas Bobbs  
 Description: OGI video of emissions from leaking components in Plant C

The GMAP detected elevated methane downwind of the natural gas pipeline breakout on the south end of Plant C. We observed several leaks with OGI from various valves in the breakout area. We identified the leaking components to the facility personnel and they started taking action to fix the leaking components.

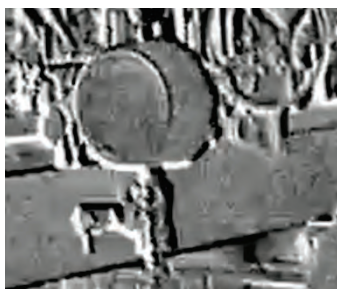
File Name: MOV\_154.mp4  
 Date taken: 04/13/2022  
 Time taken: 4:10 pm  
 Videographer: Nicholas Bobbs  
 Description: OGI video of emissions from leaking components in Plant C

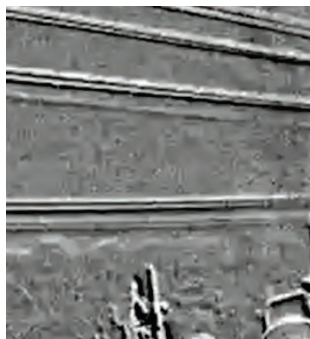
File Name: MOV\_155.mp4  
 Date taken: 04/13/2022  
 Time taken: 4:10 pm  
 Videographer: Nicholas Bobbs  
 Description: OGI video of emissions from leaking components in Plant C

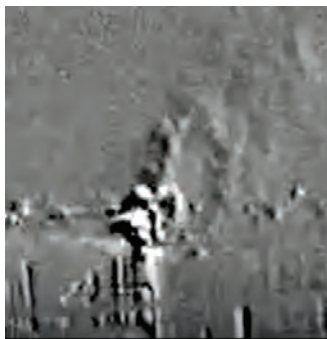
File Name: MOV\_157.mp4

The GMAP detected elevated VOCs near the halogenated hydrocarbon tank farm. [AOC 1] I recorded FLIR video MOV\_0157 of VOC emissions coming from the area of the tank farm. I recorded FLIR video MOV\_0158 of VOC emissions coming from the stack of the Plant A Powerhouse. It is unknown if the GMAP detections were due to emissions from the Plant A Powerhouse or a source in the halogenated hydrocarbon tank farm.

The GMAP detected elevated VOCs downwind of Powerhouse A and the halogenated hydrocarbons tank farm. OGI showed a significant VOC plume from the Powerhouse A stack. There may also be a source within the halogenated hydrocarbon tank farm that contributed to the GMAP detection.

Date taken: 04/13/2022  
 Time taken: 9:00 am  
 Videographer: Nicolas Bobbs  
 Description: OGI video of emissions from area of the tank farm

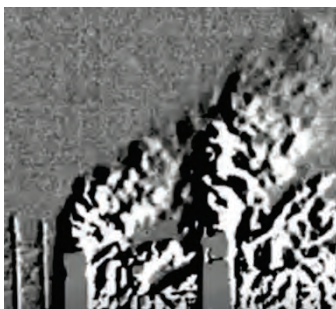
File Name: MOV\_158.mp4  
 Date taken: 04/13/2022  
 Time taken: 9:30 am  
 Videographer: Nicholas Bobbs  
 Description: OGI video of emissions from the stack of power house A

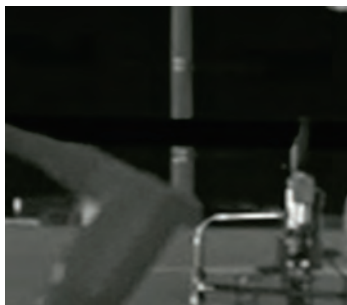
File Name: MOV\_187.mp4  
 Date taken: 04/13/2022  
 Time taken: 4:10 pm  
 Videographer: Nicholas Bobbs  
 Description: OGI video of emissions from leaking components in Plant C

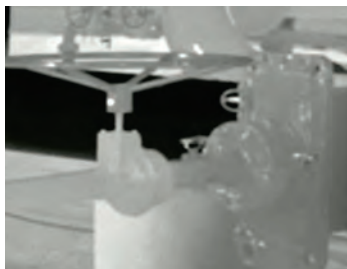
File Name: MOV\_188.mp4  
 Date taken: 04/13/2022  
 Time taken: 4:10 pm  
 Videographer: Nicholas Bobbs  
 Description: OGI video of emissions from leaking components in Plant C
