Subject: July 25-26, 2022, SSO Inspection Trip Report for City of Cahokia

Purpose: NPDES SSO Inspection Trip Report

Facility: City of Cahokia Heights, Illinois

Appendix A - Photo Log
EPA Inspection, Cahokia Heights, July 25-26, 2022
All photos taken by Dean Maraldo (unless indicated otherwise), Inspector, U.S. EPA
Camera: Ricoh WG-4

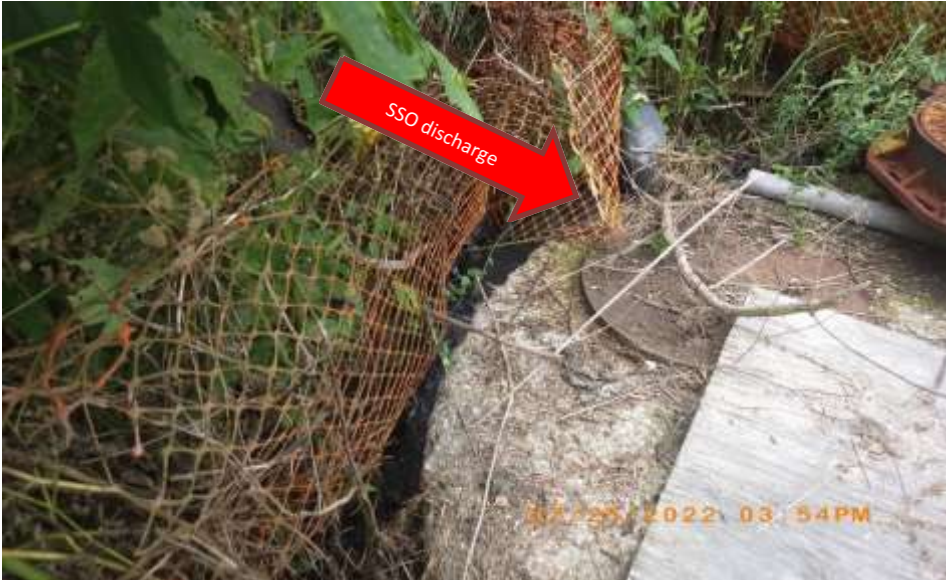
1: CCHM012

Description: The lift station was overflowing into the adjacent wetland when the pumps cycled on, approximately every 5 minutes. Red arrow denotes SSO discharge location.

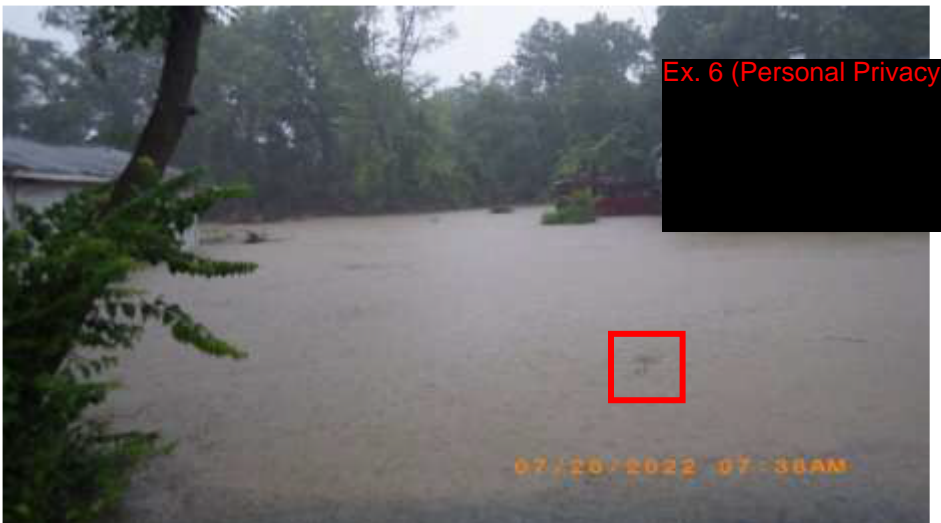
2: CHWW0027

Description: The cleanout (outlined in red) was overflowing. The ditch leading from the cleanout was inundated and yards in the area were flooded.

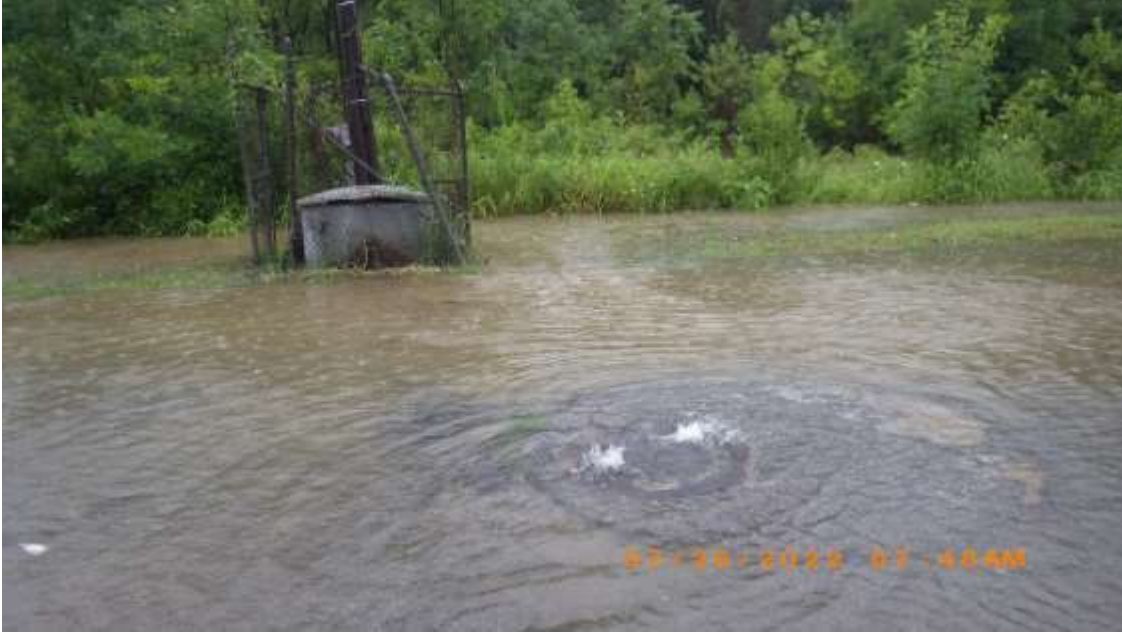
3: CHWW0030

Description: The roadside ditches along the street were inundated with floodwater, along with sanitary sewage discharging from the manhole.

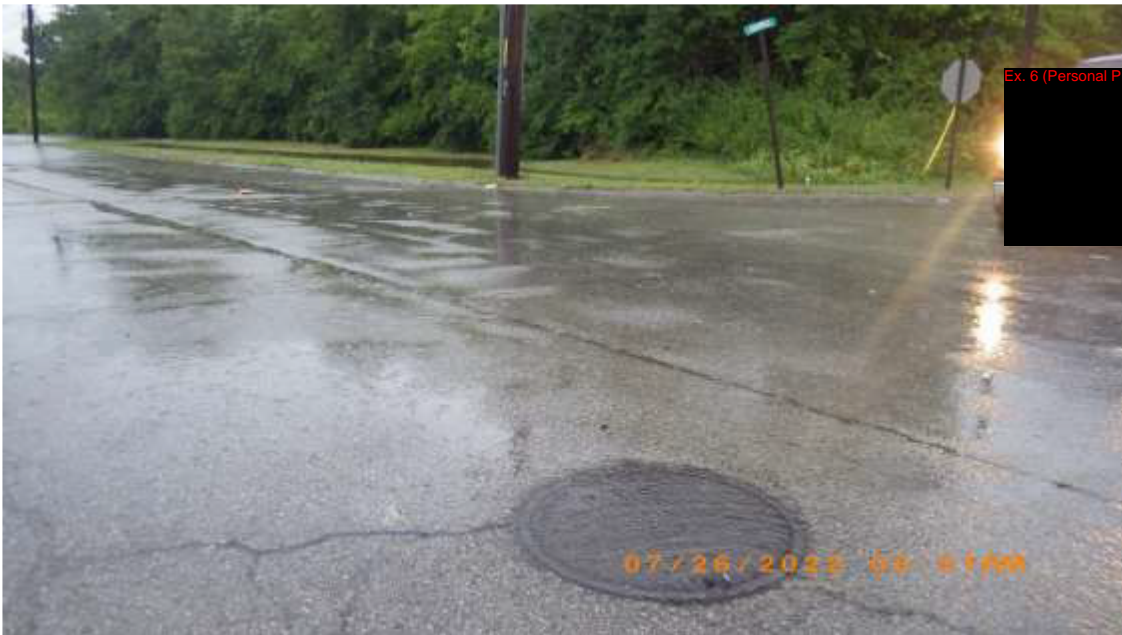
4: CHWW0034

Description: Sanitary sewage discharging from the manhole.

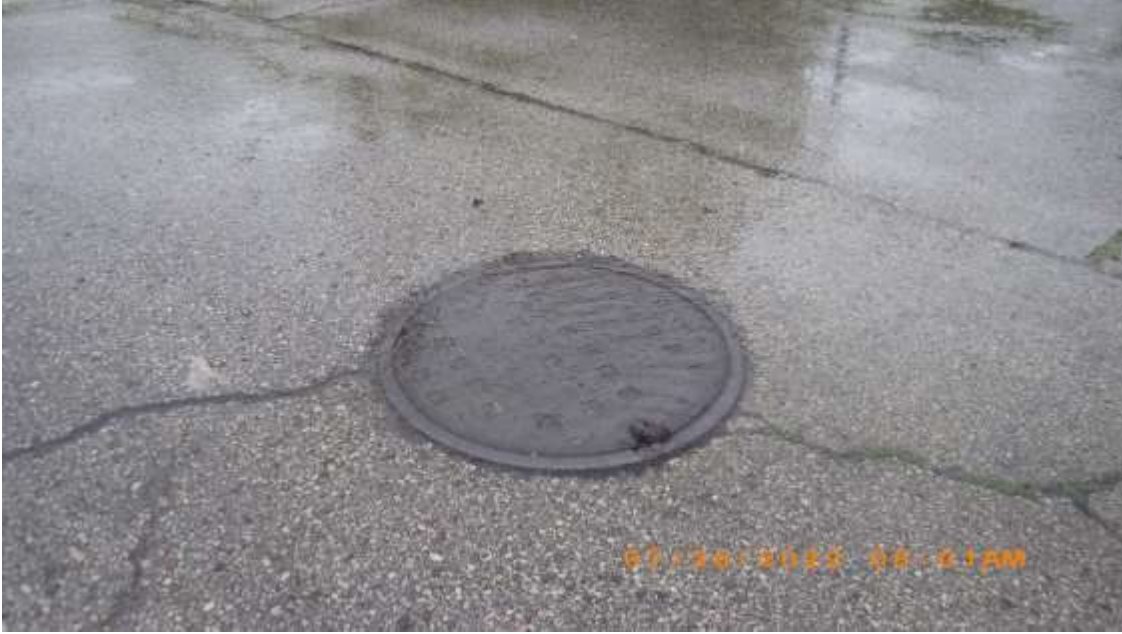
5: CHWW0037

Description: Sanitary sewage discharging from the manhole.

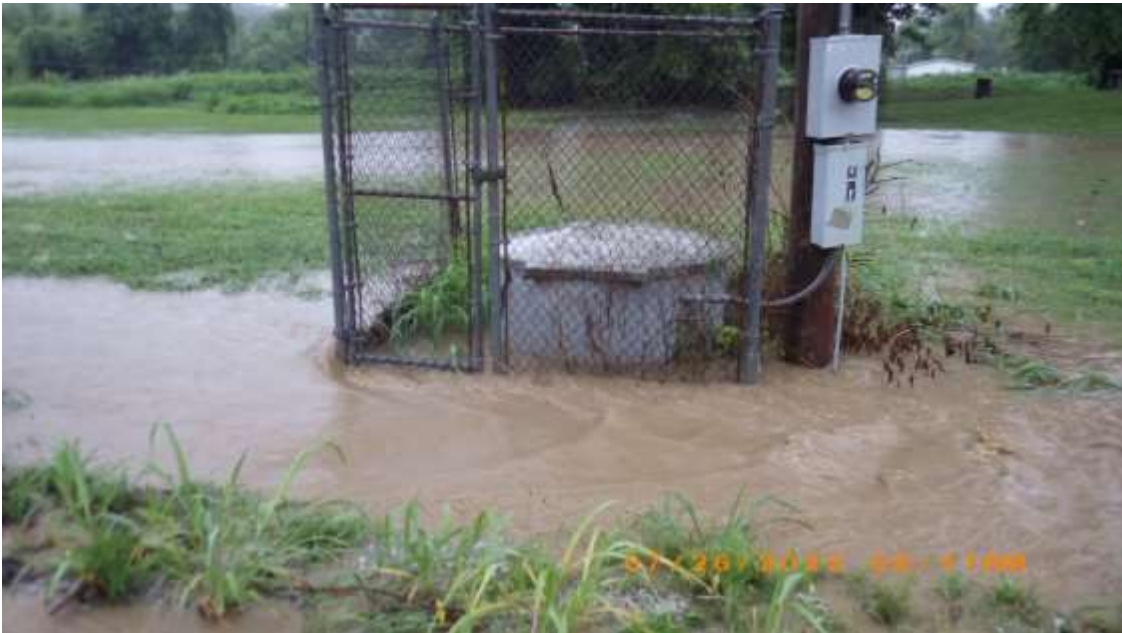
6: CHWW0038

Description: Inundated roadside ditches and a partially submerged lift station structure on Belleview Ave.

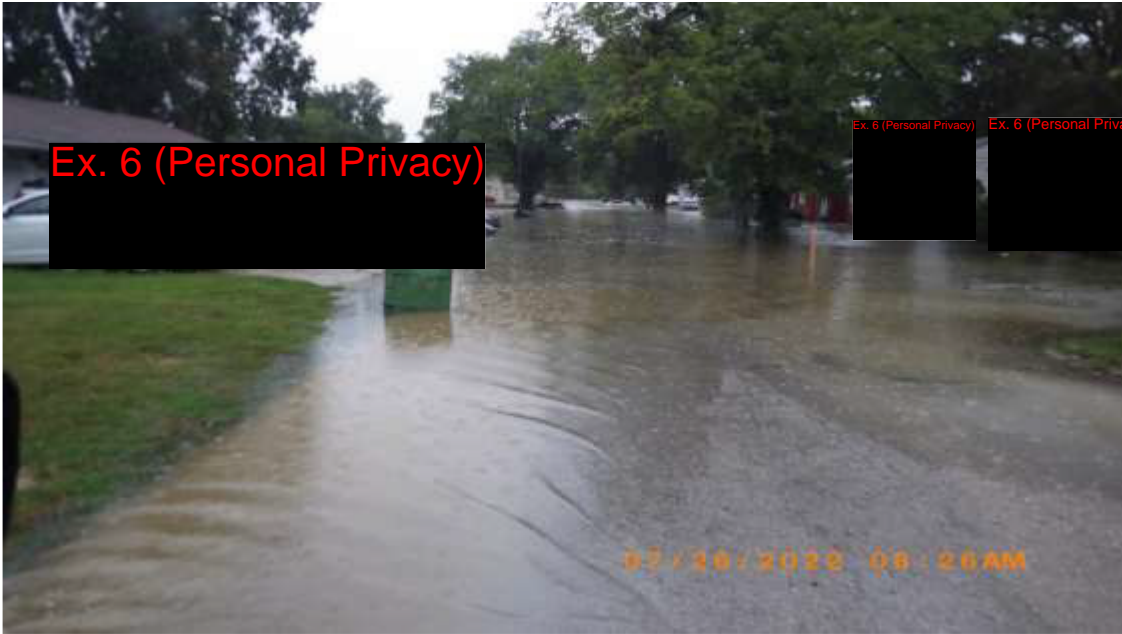
7: CHWW0040

Description: Steet flooding.

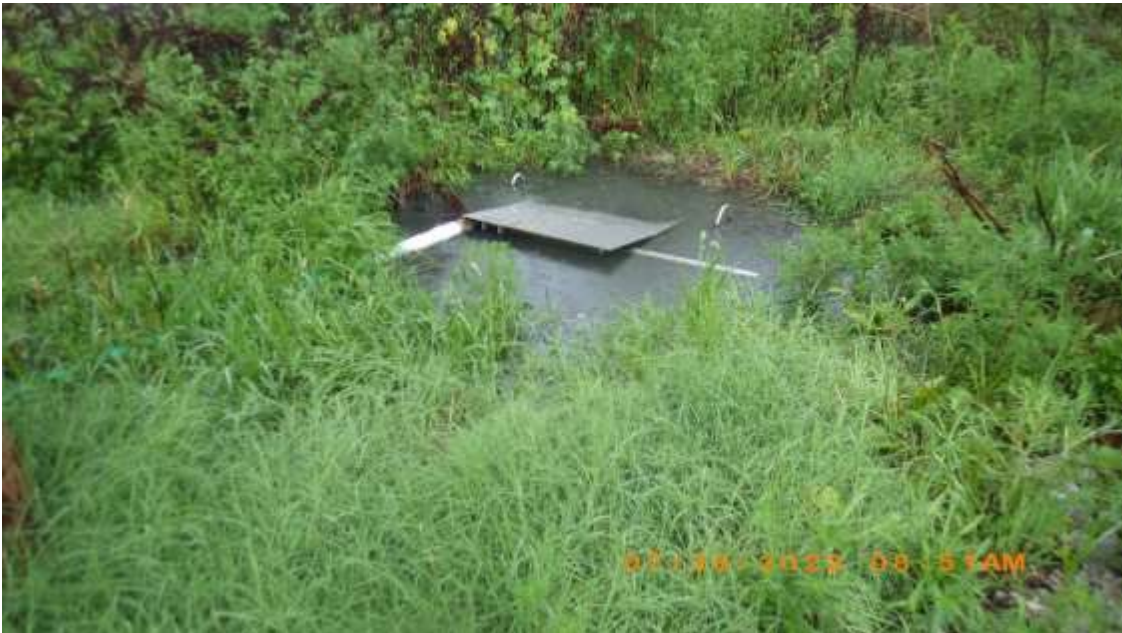
8: CHWW0041

Description: Lift station submerged.

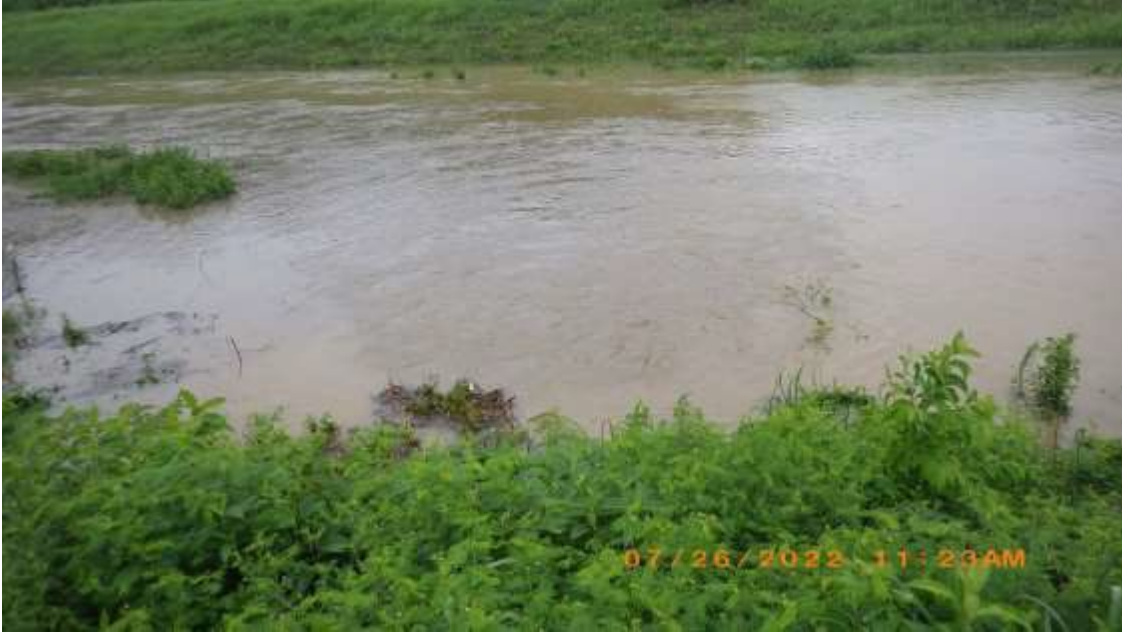
9: CHWW0047

Description: Discharge to Canal #1. The stormwater discharges through a pair of culverts under North 80th Street. The stormwater collects from roadside ditches throughout the area and includes discharge from a sanitary sewer overflow location on North 82nd Street.

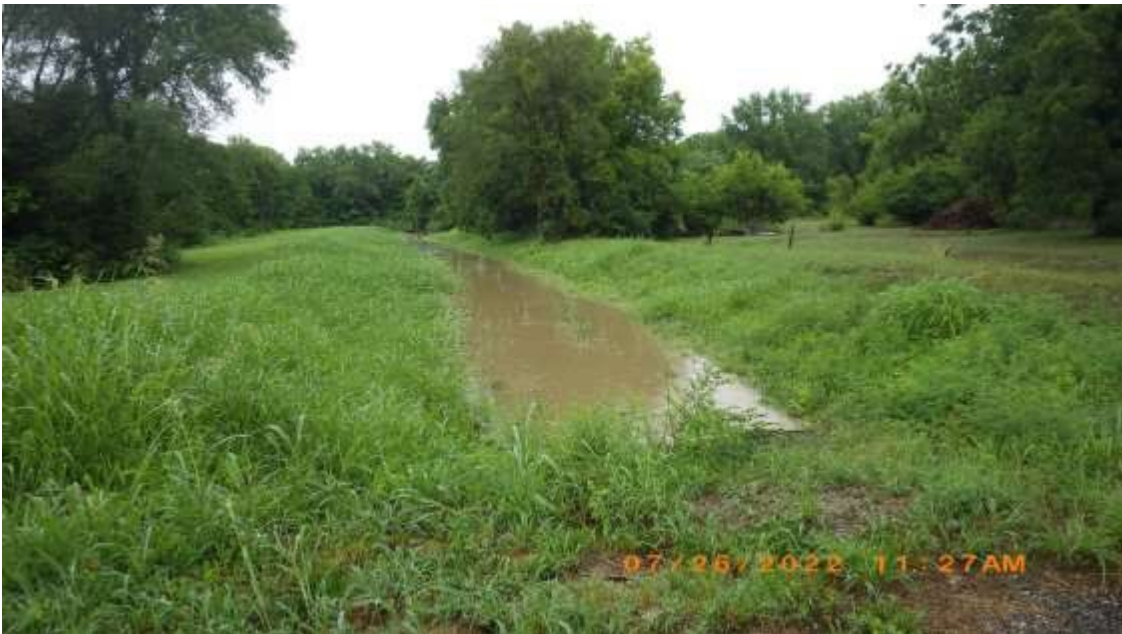
10: CHWW0049

Description: Water flowing in ditch towards Canal #1.

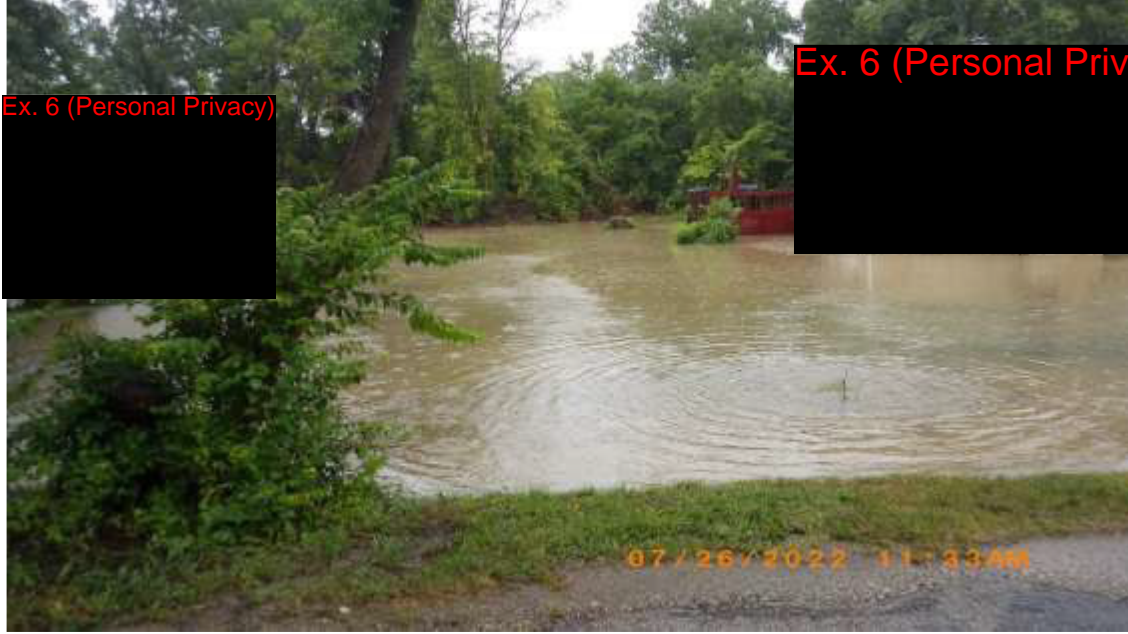
11: CHWW0053

Description: The cleanout was overflowing. The ditch leading from the cleanout was inundated and yards in the area were flooded.

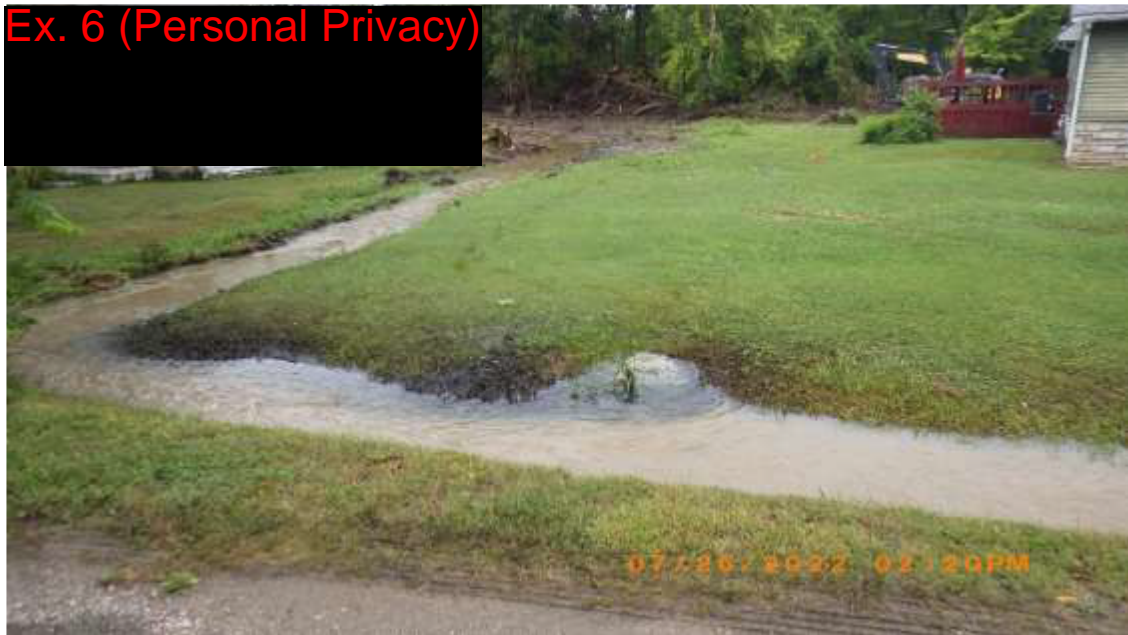
12: CHWW0055

Description: The cleanout was overflowing. The ditch leading from the cleanout was full and flowing. Yard flooding had subsided since the 11:33 A.M. observation at this location.
