## **2022 Nonpoint Source Success Story Recap**

Over 12,500 miles of rivers and streams restored.

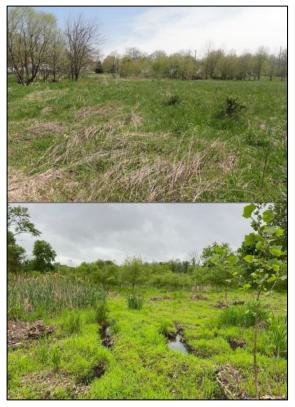
*Typical floodplain conditions before (top, 2011) and after (bottom, 2020) restoration.*

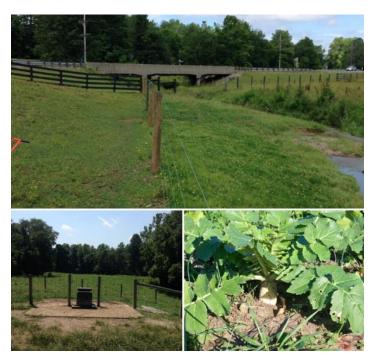
Multiple BMPs were implemented to improve water quality in the watershed, including fencing to keep livestock out of streams (top), a watering facility installed on a concrete heavy use protection area pad (bottom left), and cover crops (bottom right).
