NONPOINT SOURCE SUCCESS STORY

New Mexico

Cleaning Up Cold Springs Creek

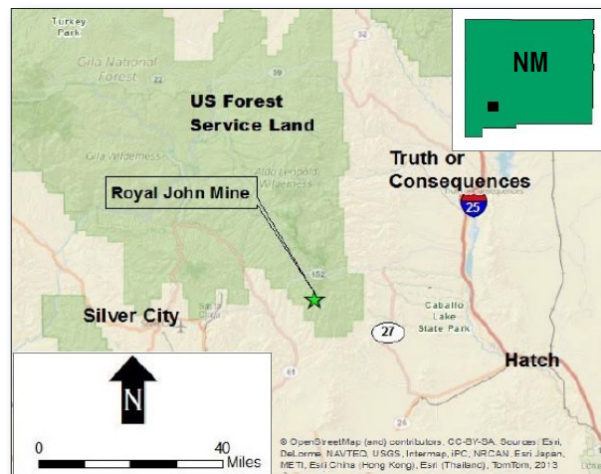
Figure 1. The historical Royal John Mine affected Cold Springs Creek in southern New Mexico.

Mining activities dating from 1916 to 1969 at the Royal John Mine and Mill site in southern New Mexico polluted Cold Springs Creek, a tributary to Hot Springs Creek and the Mimbres River (Figure 1). The approximately 2,000-acre mine site contained numerous adits, cuts, and waste rock piles from the historical mining operations. Mine tailings were piled on both the banks and the channel of the creek, at the on-site mill, and at a depository about a half mile downstream. Water quality samples collected in 2009 detected elevated levels of lead and cadmium. NMED listed Cold Springs Creek as impaired on the 2012 Integrated Report due to these metals interfering with the Cold Water Aquatic Life designated use. Portions of the upper watershed burned during the 2013 Silver Fire, which exacerbated erosion during intense summer rains. Site investigation by the U.S. Forest Service in 2014 and consultants in 2016 included conducting soil, sediment, and waste rock sampling, which showed elevated levels of lead and other heavy metals (aluminum, arsenic, cadmium, copper, iron, manganese, and zinc). These pollutants posed a significant threat to aquatic life and human health based on NMED soil screening levels and the potential for transport from the site via surface water runoff.

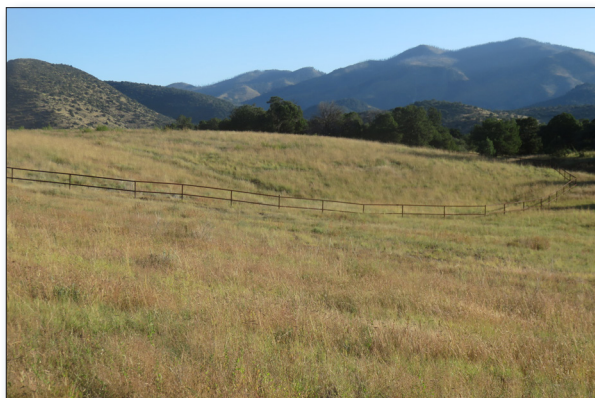
Figure 2. Mine waste was buried under a vegetated earthen cap at the Cowboy Flat Repository.

Crews moved the waste rock and tailings into an on-site consolidation cell on Forest Service land called the Cowboy Flat Repository. The Forest Service aimed to meet the NMED Industrial Soil Screening Levels rather than the more stringent residential levels, given that the site had background levels of naturally occurring lead and was not planned for residential uses. On-the-ground cleanup activities began in earnest in March 2019. The first steps included clearing access roads at the mine and clearing and stockpiling the topsoil at the repository. The crews constructed silt fences to prevent the tailings from washing into the creek during construction. A new temporary road was constructed to access the tailings that had been piped downstream in the 1920s. Heavy equipment transported the mine and mill waste to the repository,

where it was buried under an earthen cap with a silty clay layer and the topsoil to support native plants. This cap was designed to keep the underlying waste material mostly dry and minimize contaminant transport. A total of 24,476 cubic yards of contaminated mill tailings were removed from the banks of Cold Springs Creek. An additional 22,070 cubic yards of waste rock with elevated lead levels were removed from other areas of the mine. The waste materials were buried safely in Cowboy Flat Repository, thus greatly reducing the risk of exposure to hazardous materials (Figure 2). Some of the mine adits were sealed off completely; other adits were identified as important habitat for bats and were closed off with bat-friendly grates.

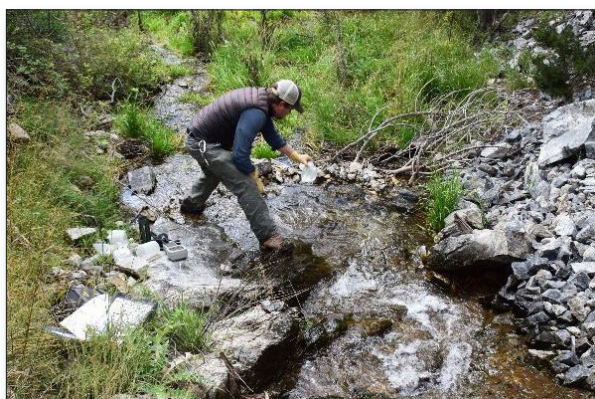
Figure 3. An NMED staff member collects samples from Cold Springs Creek, after reclamation.

NMED staff sampled Cold Springs Creek for metals downstream of the Royal John Mine before and after reclamation (Figure 3; Table 1). After reclamation, samples from 2019 and 2020 showed a decrease in lead, and no cadmium was detected. In 2021, both cadmium and lead levels were below detection. Therefore, the NMED Surface Water Quality Bureau (SWQB) removed cadmium as a cause of water quality impairment in the 2022–2024 Integrated Report. Based on current data trends, it appears likely that the lead impairment could also be removed in the next reporting cycle.
