East Palestine Train Derailment - TAGA Route Map - May 10, 2023

Prepared For: U.S. EPA Prepared By: U.S. EPA GIS Unit

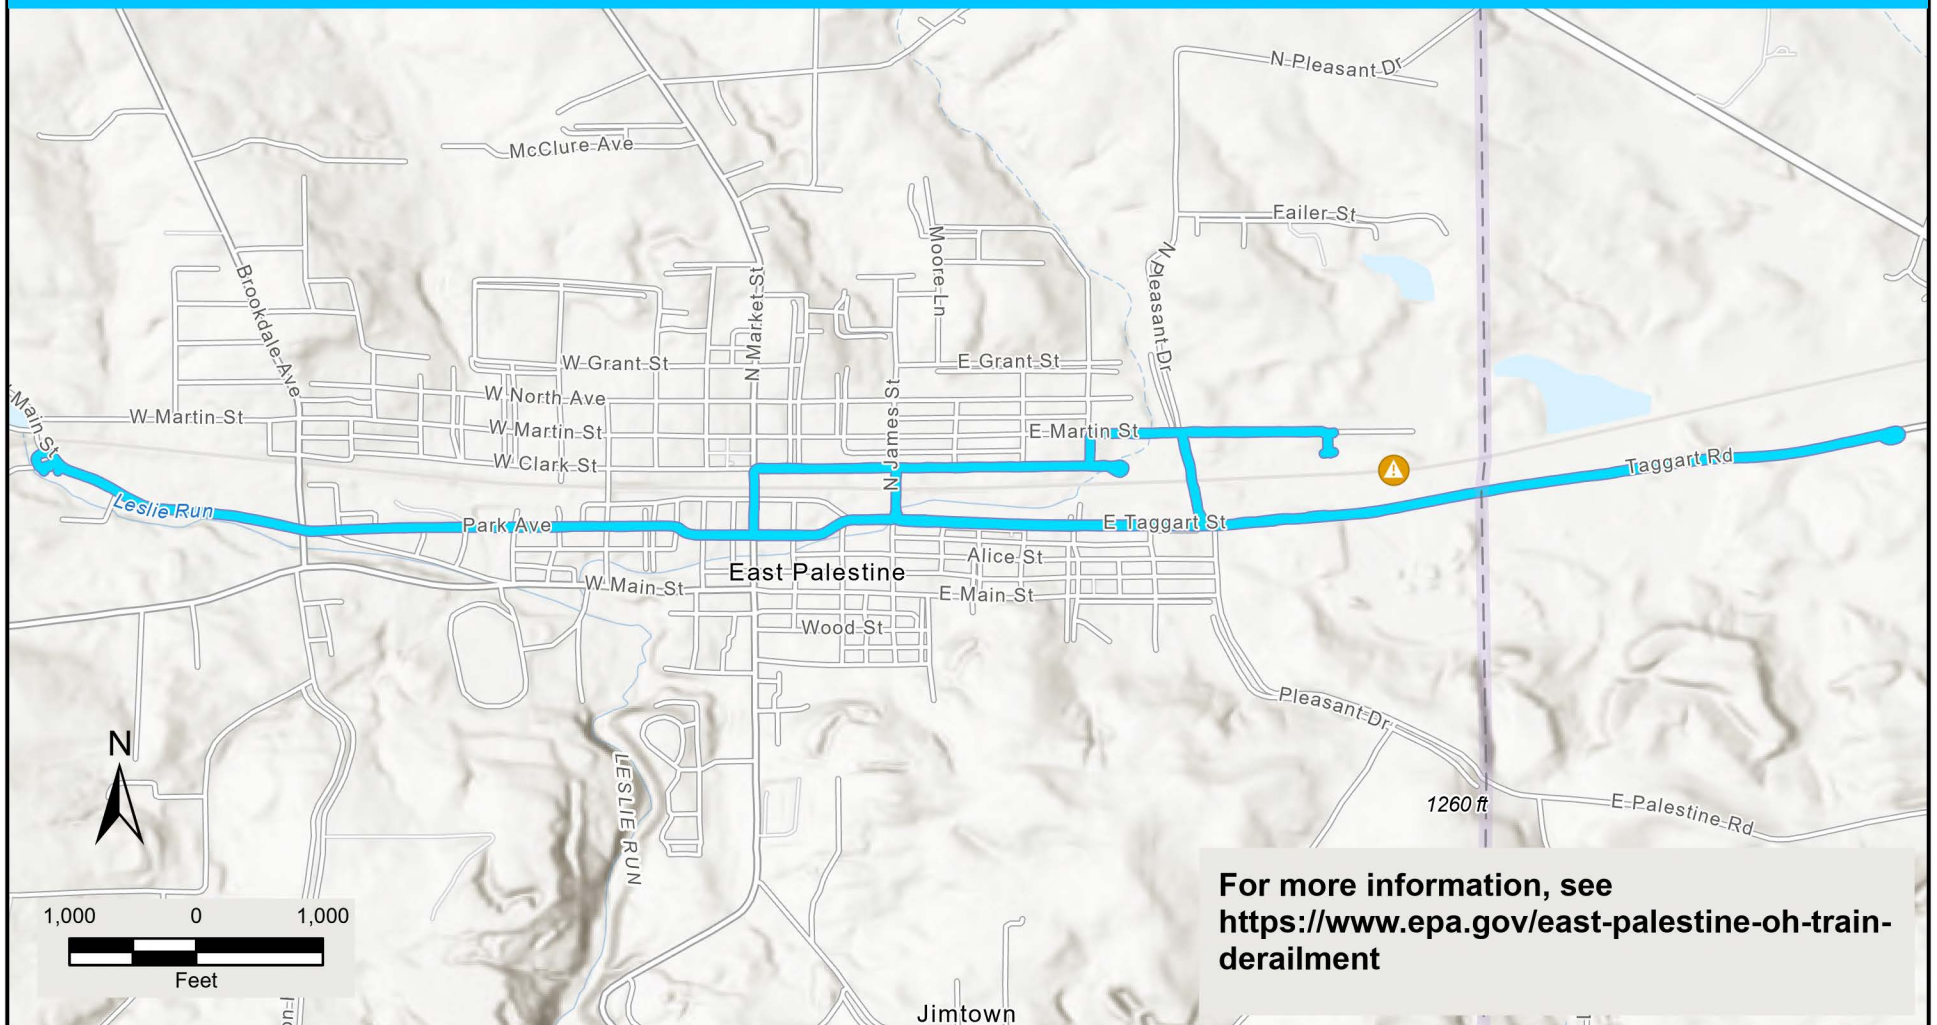
On May 10, 2023 EPA's Trace Atmospheric Gas Analyzer (TAGA) bus performed air monitoring around the East Palestine Derailment Location, monitoring for n-Butyl Acrylate.

Of the 31,698 real-time readings taken during the day, 100% of the readings were below site-specific mobile thresholds.
