SUBJECT: Long-Term Stewardship Assessment
Electroplaters of York Inc.
EPA ID: PAD015139470
209 E. Willow Street
Wrightsville, PA 17368

DATE: August 22, 2023

Remedy Assessment Summary:

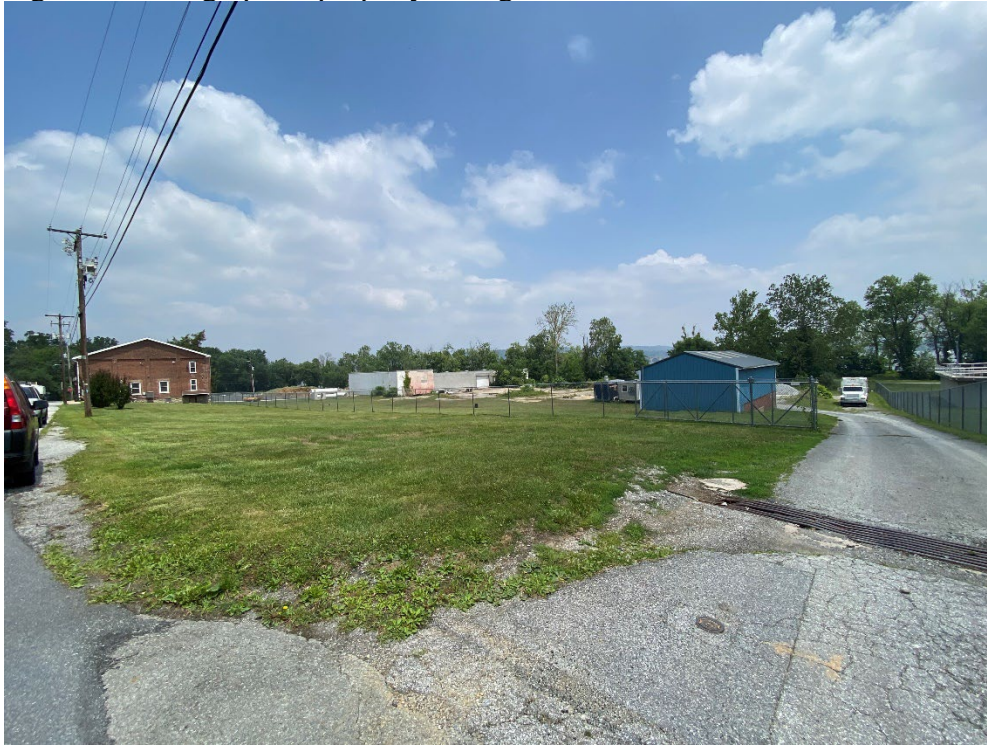
Figure 3. Photograph of property facing North, at the corner of Water Street and Willow Street.

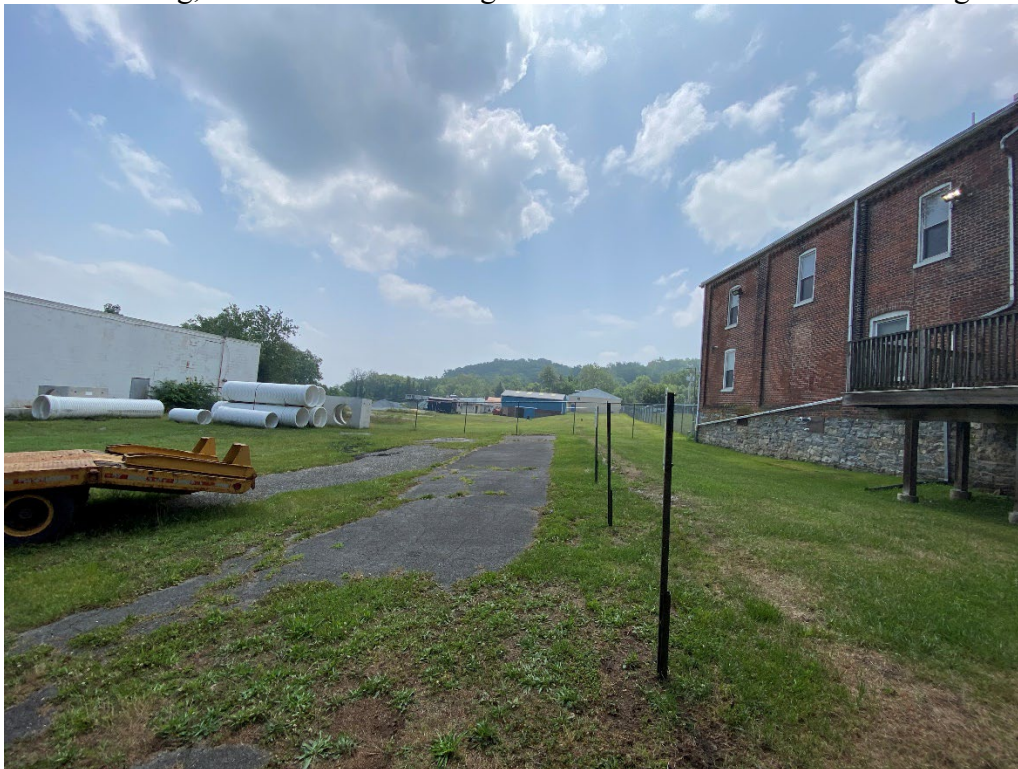
Figure 4. Photograph of property facing South. The brick building on the right is the occupied office building, and the white building on the left is the warehouse building.
