UNITED STATES ENVIRONMENTAL PROTECTION AGENCY
New England Regional Laboratory
Laboratory Services and Applied Sciences Division
11 Technology Drive
North Chelmsford, MA 01863-2431

Subject: Reconnaissance and Sampling Inspection Report
Clean Water Act – National Pollutant Discharge Elimination System
Hartford, Connecticut

- A. Facility Name: City of Hartford, CT*
- B. Facility Location: Hartford, CT*
- C. Facility Contact: Scott W. Jellison (The Metropolitan District), and Michael Looney (Department of Public Works, Hartford, CT)*
- D. NPDES Permit ID: CTR030062 (MS4)*

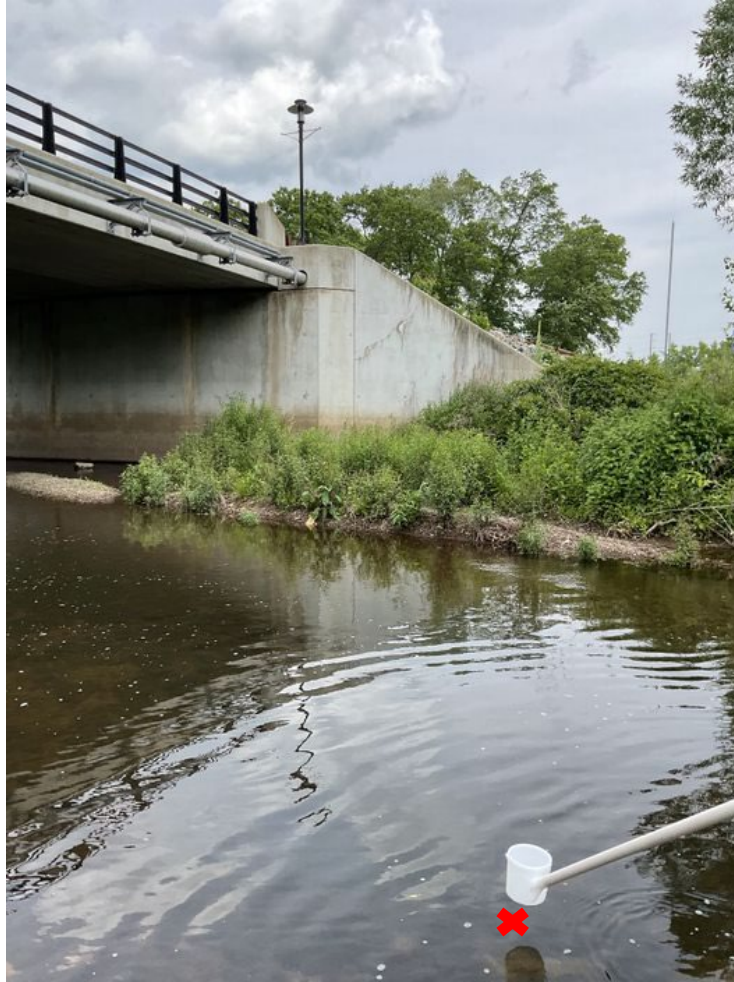
- **HartSW-A:** In-stream sample of North Branch Park River, collected by the northern end of Lot D, at the University of Hartford, approx. 25 ft downstream of the adjacent bridge and 4 feet from the bank of the stream. No odor was observed. Color and turbidity were clear. Some suds were observed on the surface of the stream. Some green filamentous algae growth was observed on the streambed. No bacteria samples were collected due to holding time constraints.

Photo 1: HartSW-A (photo taken 06/14/2023 at approx. 11:25) Surface water sample of North Branch Park River near 200 Bloomfield Ave. Sample points are indicated by a red X.

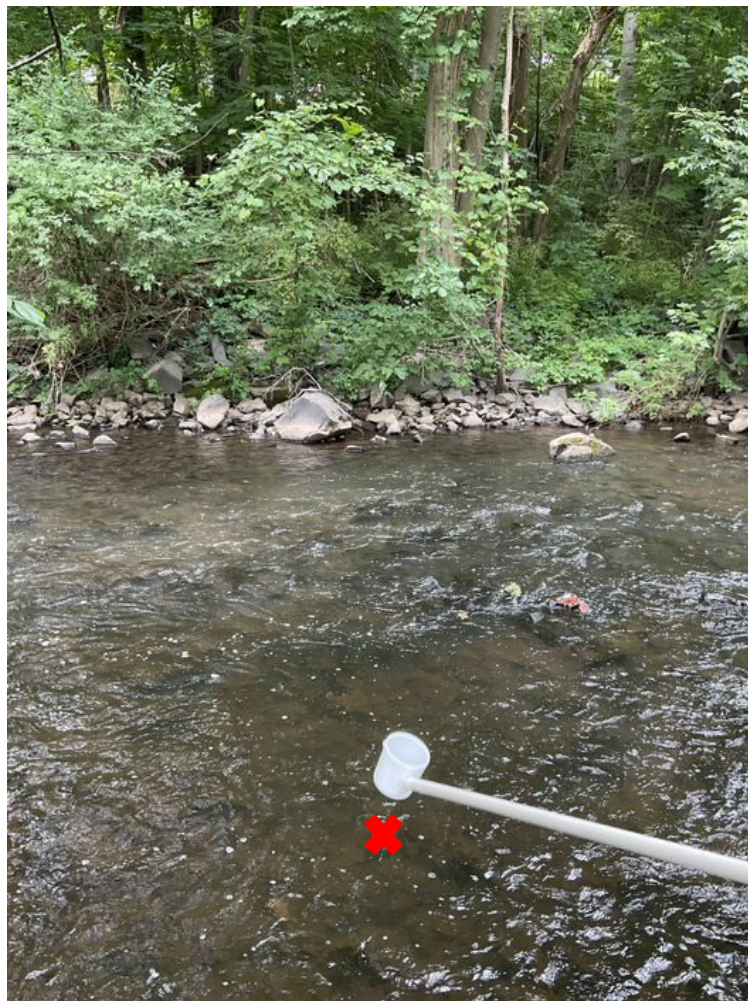
- **HartSW-B:** In-stream sample of North Branch Park River, collected at the end of the rip rap swale connected to eastern edge of the parking lot behind 19 Woodland Street and 4 feet from the bank of the stream. No odor was observed. The color of the flow was slightly yellow, and turbidity was clear. Some suds were observed on the surface of the stream. Trash and litter debris were observed in the stream. Algae growth was observed on the rocks covering the streambed.

Photo 2: HartSW-B (photo taken 06/14/2023 at approx. 12:06) Surface water sample of North Branch Park River near 404 Farmington Ave. Sample points are indicated by a red X.

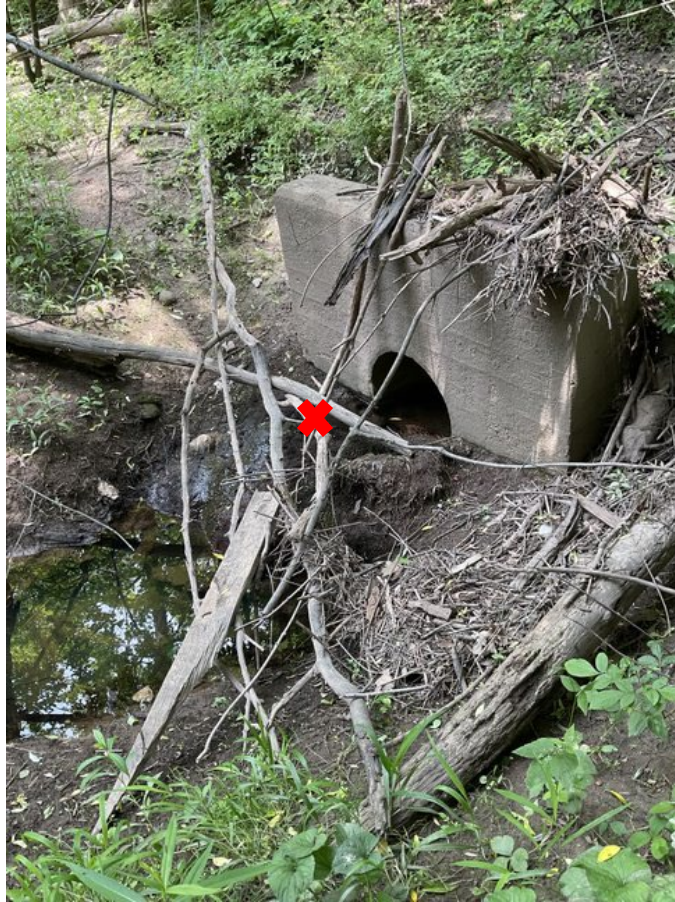
- **Hart09**: a single concrete, circular outfall, approximately 18 inches in diameter, located at 126 Mark Twain Drive. Discharge flow was approximately less than 5 gallons per minute (gpm) into North Branch Park River. Sample was collected 6 inches downstream of the mouth of the outfall. No odor was observed. Color and turbidity were clear. No floatables were observed. Some sediment build up was observed on the interior of the pipe. Algae growth was also observed inside the pipe.

Photo 3: Hart09 (photo taken 06/15/2023 at approx. 08:19) Outfall located near 126 Mark Twain Drive, discharging into the North Branch Park River. Sample points are indicated by a red X.

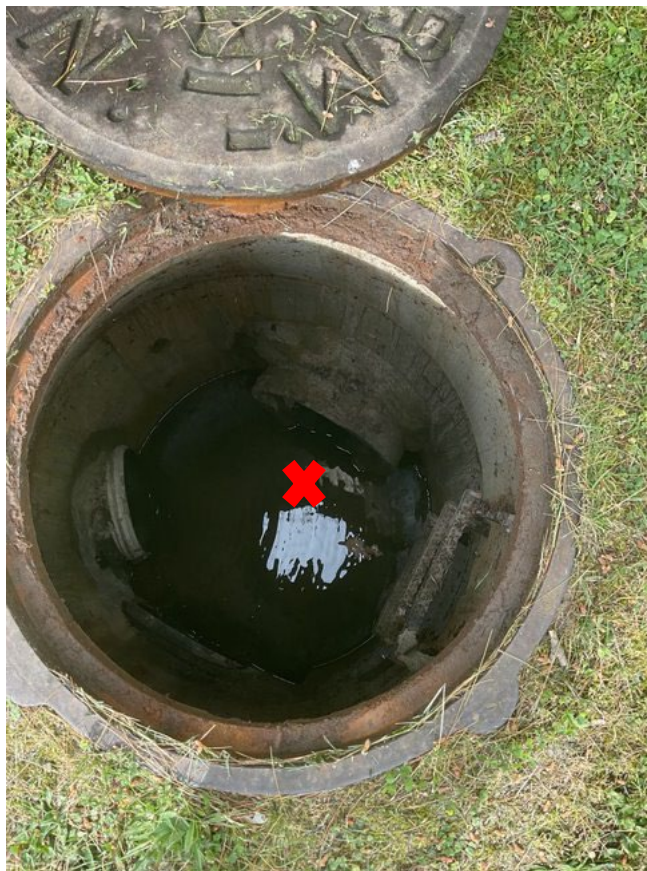
- **Hart01D**: a single plastic, circular pipe, in a manhole, approximately 24 inches in diameter, located near 353 Granby Street. Discharge flow was approximately 5 gpm into the underground stormwater piping which flows to North Branch Park River. Sample was collected at the mouth of the outfall. No odor was detected. Color and turbidity were clear. No floatables were observed. Orange precipitate was observed immediately downstream of the pipe.

Photo 4: Hart01D (photo taken 06/15/2023 at approx. 09:28) Outfall located near 353 Granby Street, discharging into the North Branch Park River. Sample points are indicated by a red X.

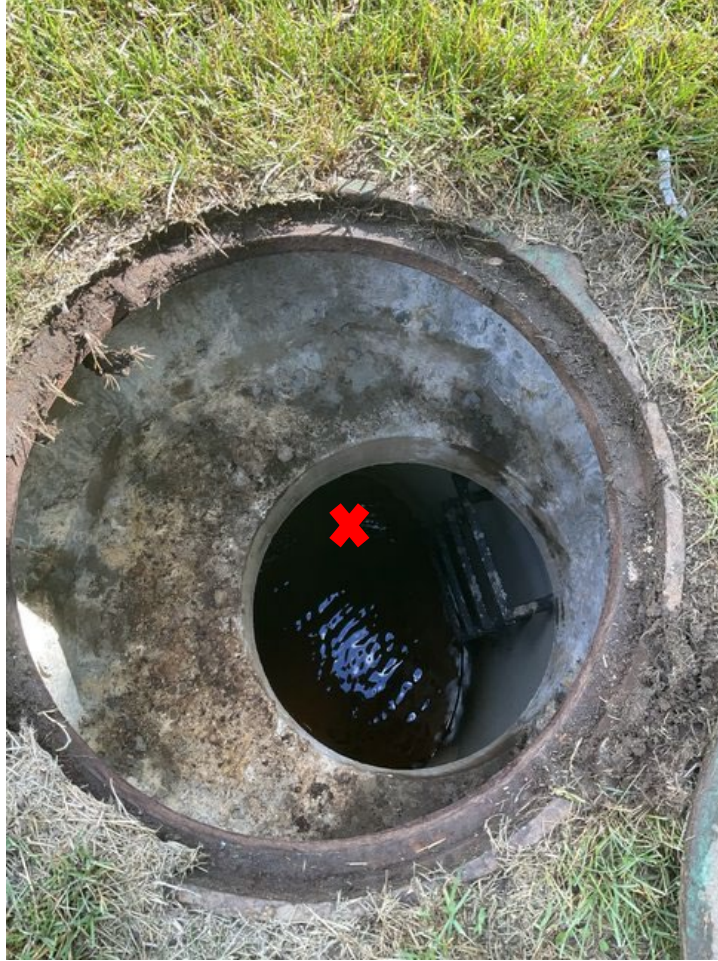
- **Hart01AG**: a single, concrete, circular outfall, in a manhole, conveying flow from the east, approximately 42 inches in diameter, located near 353 Granby Street. Discharge flow was approximately less than 5 gpm into the underground stormwater piping which flows to North Branch Park River. Sample was collected at the mouth of the outfall. No odor was detected. Color and turbidity were clear. No floatables were observed.

Photo 5: Hart01AG (photo taken 06/15/2023 at approx. 09:50) Outfall located near 353 Granby Street, discharging into the North Branch Park River. Sample points are indicated by a red X.

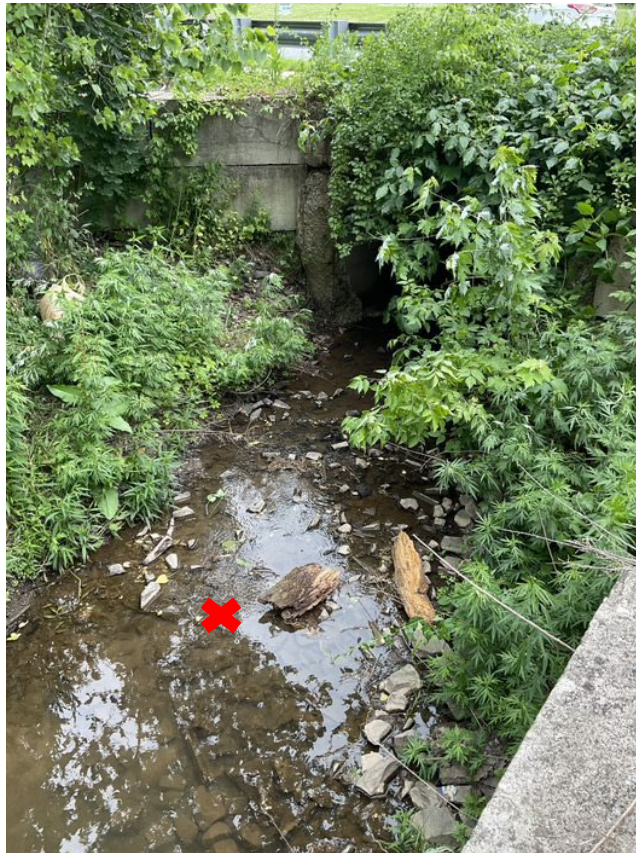
- **Hart01C**: In-stream sample of an unnamed brook, collected on the north side of the bridge on Burnham Steet, on the east bank of the brook. Sample was collected approximately 10 feet upstream of the inlet culvert. A musty odor was observed. Color was brown and fine particulate was observed. Floatables observed were weeds and vegetation debris. Patches of grey and brown murky water observed in the stream. Filamentous algae growth was observed on the rocks of the stream bed.

Photo 6: Hart01C (photo taken 06/15/2023 at approx. 10:30) Surface water sample of North Branch Park River near 500 Granby Street. Sample points are indicated by a red X.

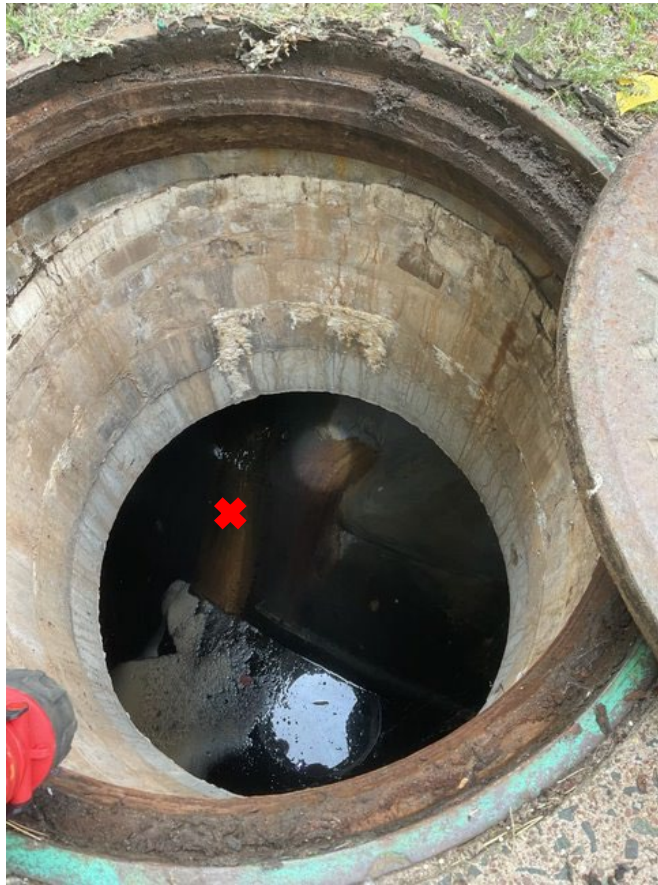
- **Hart10A**: a single concrete, circular, outfall, in a manhole, conveying flow from the south, approximately 42 inches in diameter, located at 602 Tower Ave. Discharge flow was approximately 5 gpm into the underground stormwater piping to Gully Brook. Sample was collected approximately 6 inches below mouth of outfall. No odor was detected. Color and turbidity were clear. Foam was observed on the surface of the flow. Orange precipitate was observed immediately downstream of the outfall. Dup01 was collected here.

Photo 7: Hart10A (photo taken 06/15/2023 at approx. 11:00) Outfall located near 602 Tower Ave, discharging into the North Branch Park River. Sample points are indicated by a red X.

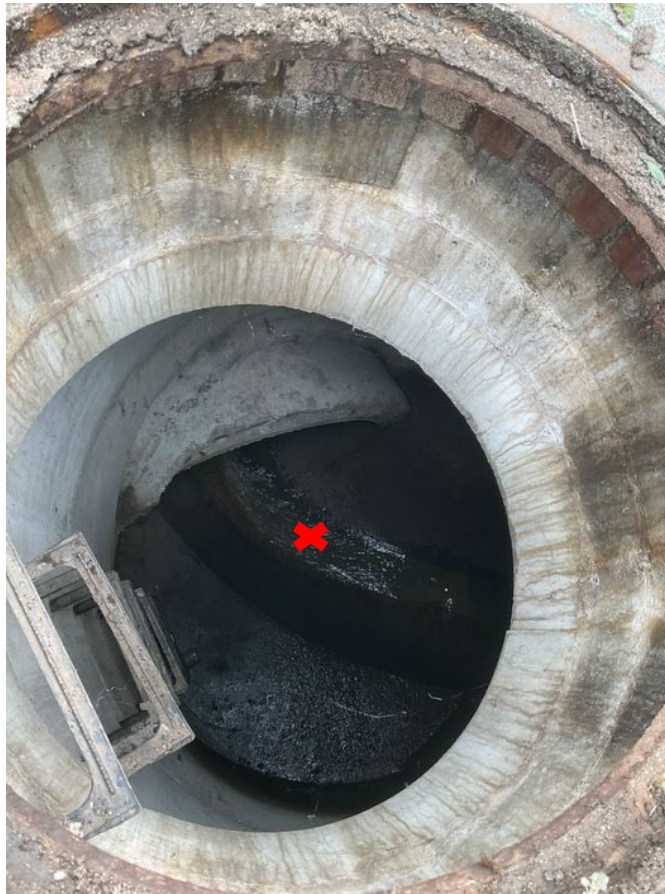
- **Hart12F**: a single, concrete, circular, outfall, in a manhole, approximately 36 inches in diameter, located at 101 Tower Ave. Discharge flow was approximately less than 5 gpm into the underground stormwater piping to the North Meadows Storage Pond. Sample was collected in the channel of the manhole at the mouth of the outfall. A musty odor was observed. No color, turbidity or floatables were observed. No YSI readings were collected due to low volume of flow and accessibility. No PPCP samples were collected.

Photo 8: Hart12F (photo taken 06/15/2023 at approx. 11:50) Outfall located near 101 Tower Ave, discharging into the North Branch Park River. Sample points are indicated by a red X.
