NONPOINT SOURCE SUCCESS STORY

Culvert Replacement Improves Channel Stability and Fish Passage for a Little Delaware River Tributary

EPA 841-F-23-001L
October 2023

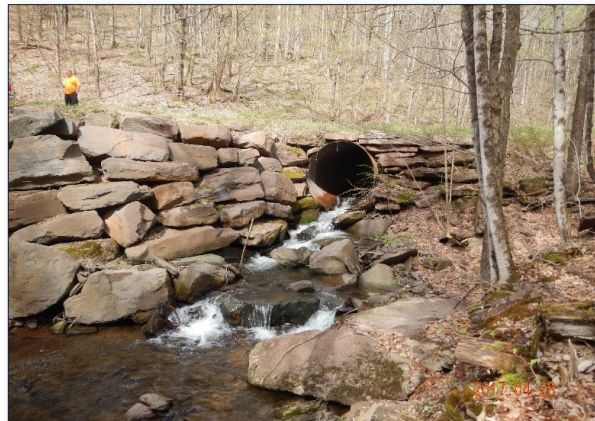
Figure 2. Looking upstream at the old deteriorating metal culvert outlet pipe and constructed outfall protection.

This box culvert addresses stream scouring of the road above the culvert and along the upstream and downstream stream embankments. This improvement also provides safe fish passage through the structure. After the new box culvert was installed, an aquatic passability score of 0.88 was assessed using the North Atlantic Aquatic Connectivity Collaborative (NAACC) aquatic passability protocol. A score of 0.80 to 0.99 (Table 1) is deemed an insignificant barrier to actual passability for fish and other aquatic organisms. Although the NAACC score was not assessed before construction, the old culvert and plunge pool represented a significant barrier to the aquatic passage, as was visually evident (see Figure 2).

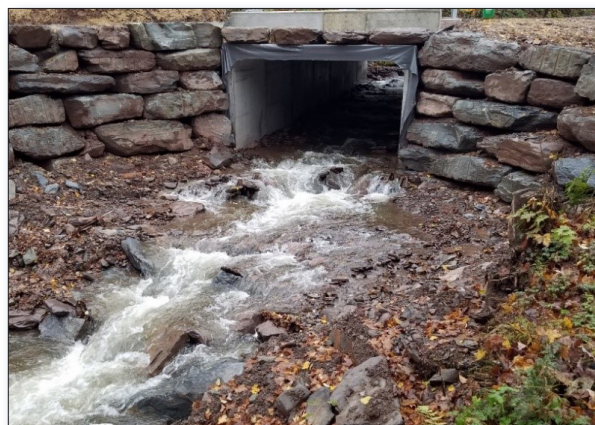
Figure 3. Looking upstream at the newly installed box culvert outlet and the stream grade control structure.

To create a natural stream channel bottom, allow for additional flow, and reduce streambank erosion, the project partners installed a concrete box culvert (9 feet by 13 feet) to replace the failing undersized (7-foot diameter) metal culvert (Figure 3). The box culvert was designed to withstand a 100-year storm event. Delaware County Soil and Water Conservation
