Lame Deer Creek Watershed Nine Element Plan

Northern Cheyenne Tribe
Rosebud County, Montana

January 2024
Project 350.00804.000

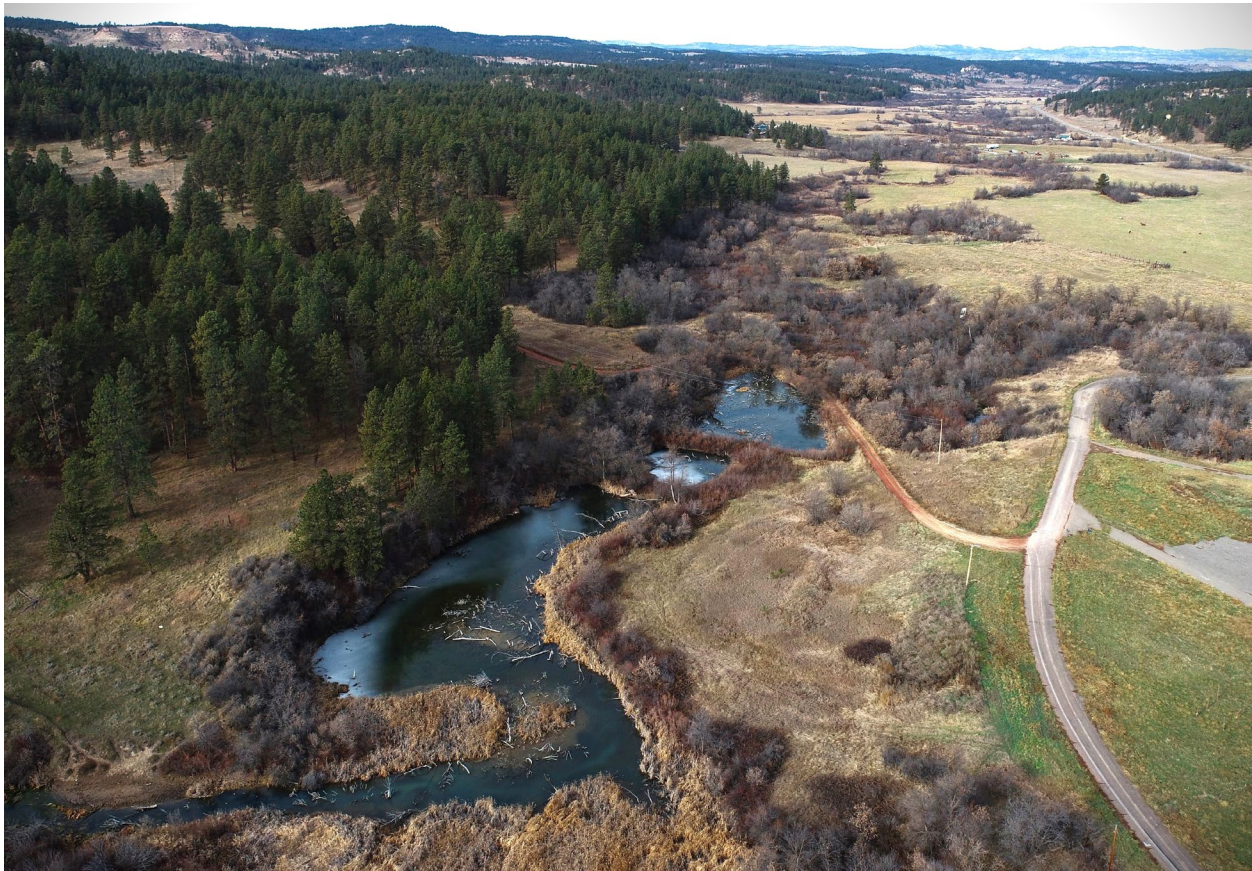
Photograph 1. Reach 1 – Headwaters of Lame Deer Creek

The ponded waters of the South Fork of Lame Deer Creek have disrupted an ecological process that historically supported populations of cold-water trout. In 2021, tribal elder, Jules Spang, Sr. described the Lame Deer Creek watershed as a stream system that supported a functional fishery when he was a child (NCT, 2022b). Prior to 1940, natural springs fed Lame Deer Creek at a rate sufficient to support a cold-water fishery from the headwaters to the confluence with Rosebud Creek. Tribal elders recall an intact riparian area without stream bank erosion (NCT, 2022b).

The conditions at the headwaters reach do not meet the basic requirements to support a Class 1 Cold Water Fishery as they once did. Headwater wetlands provide critical functions for the maintenance of aquatic systems, including water storage/groundwater connections support for the hydrodynamic balance and habitat for a diverse assemblage of native species. The crushed culverts currently act as a barrier for fish passage negating the possibility of fish to migrate up and downstream.

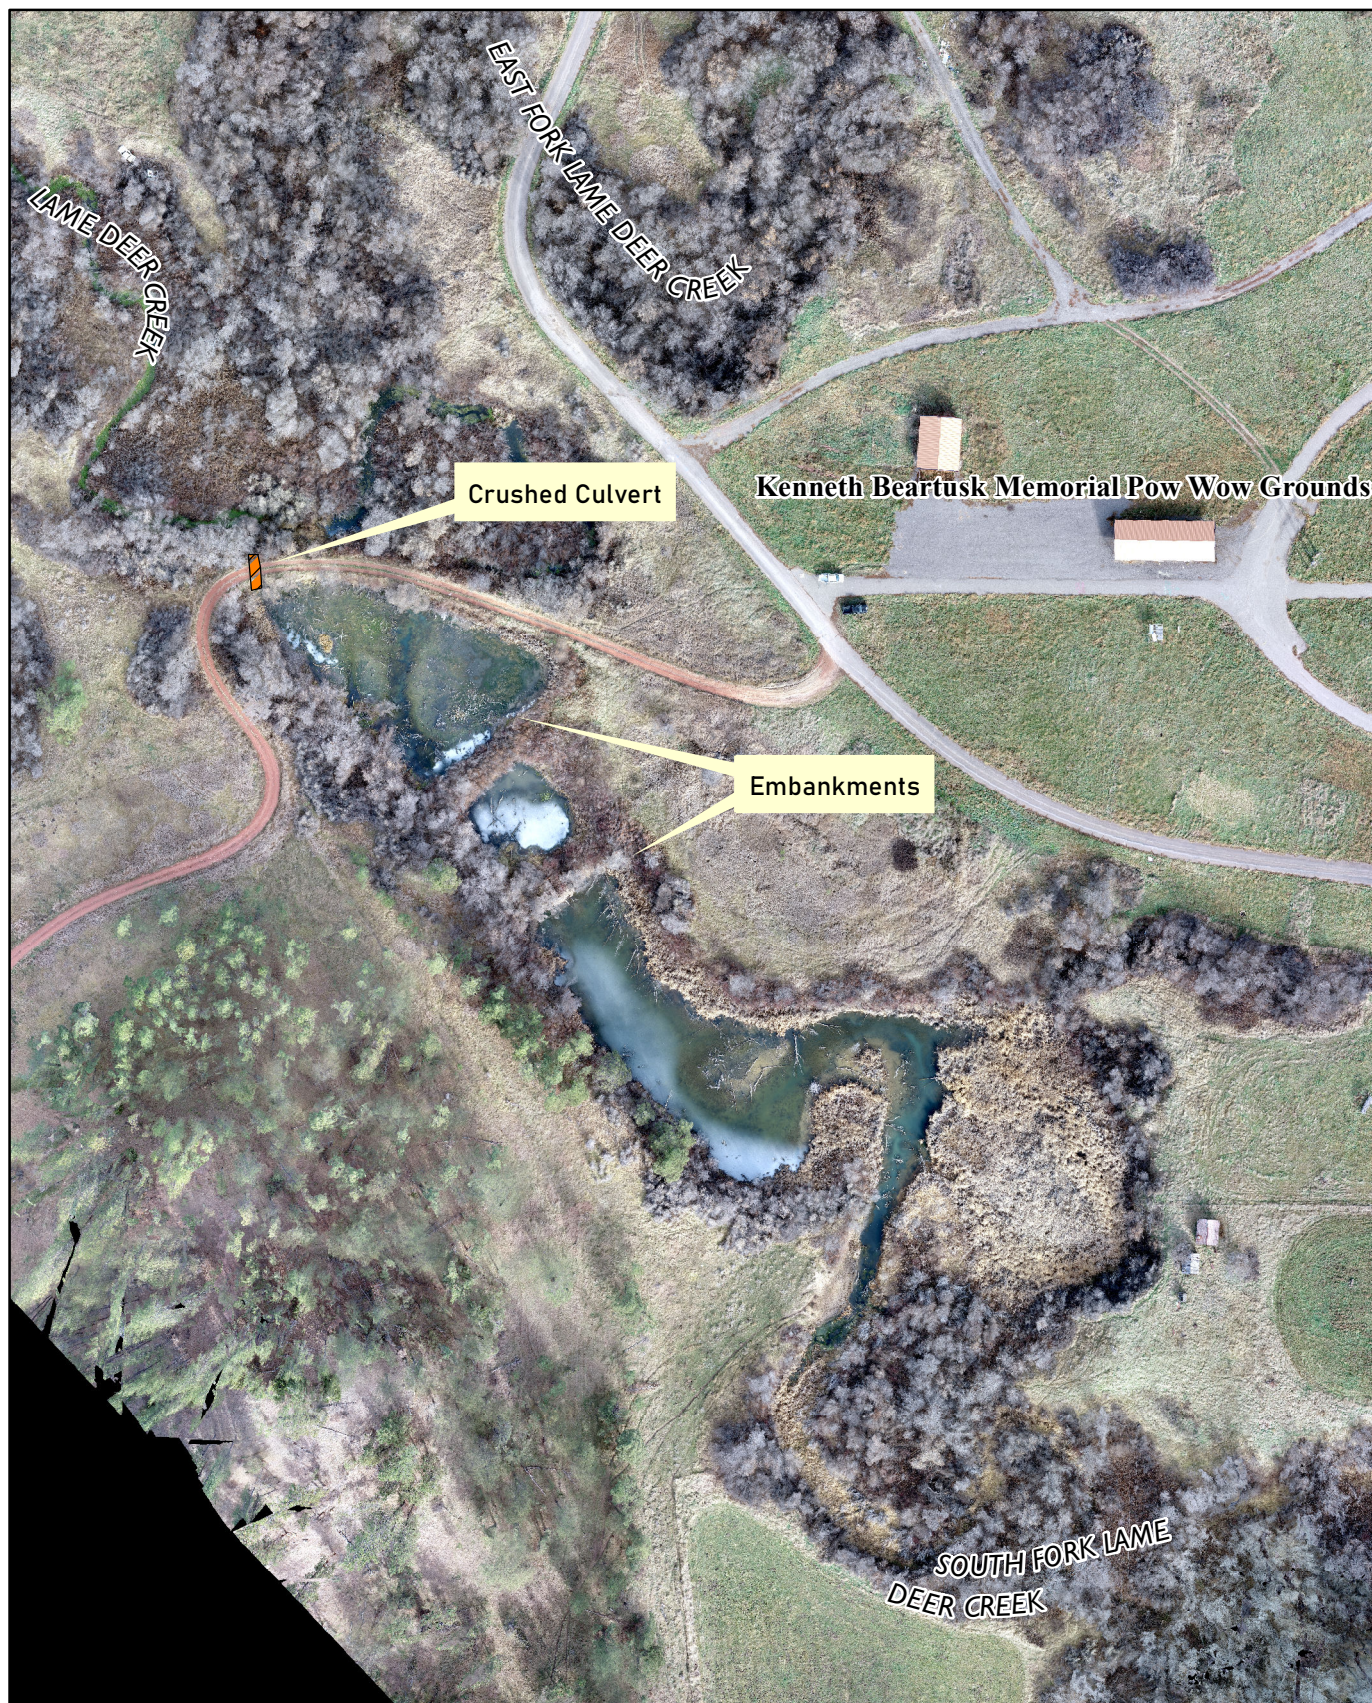
FIGURE 9

Headwaters Reach
Lame Deer Creek Watershed
Restoration Plan Lame Deer, MT

1. Restore 600 linear feet of the South Fork of Lame Deer Creek.
2. Remove/ breach two embankments.
3. Replace four crushed culverts between the South Fork of Lame Deer Creek and the mainstem of Lame Deer Creek with a culvert suitable for fish passage and the estimated high flows.
4. Revegetate one acre of riparian vegetation with a variety of native trees and shrubs using both nursery grown stock and local sources such as willow transplants/stakes and wetland (sedge/rush) sod mats.

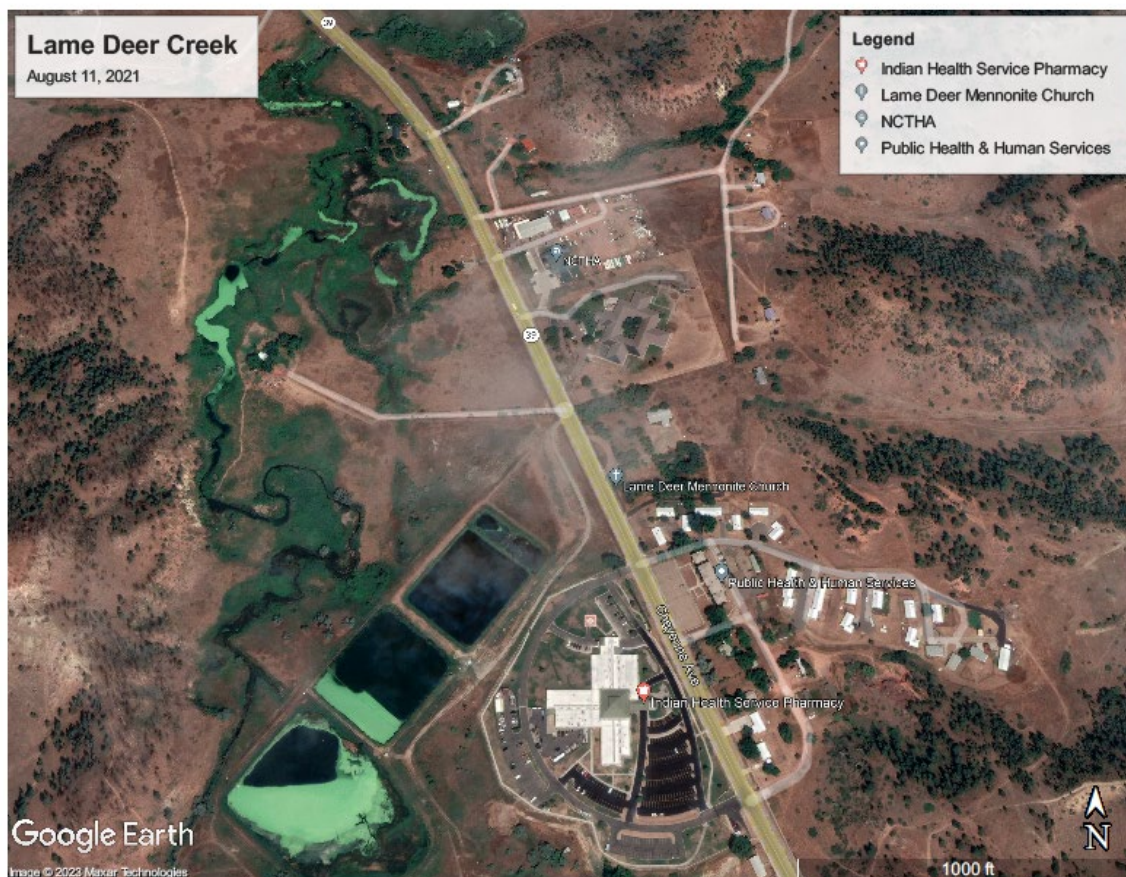
Photograph 2. Reach 3- Middle Lame Deer Creek, Lame Deer Lagoon

Reach 3 – Middle Lame Deer Creek flows 5 river miles north through a predominantly urban area skirting the town of Lame Deer to the east. Reach 3 begins where Lame Deer Creek flows through an eco-arch culvert under Sweet Medicine Road south of the town of Lame Deer and ends where Lame Deer Creek bisects Highway 4. Reach 3 is somewhat low gradient (0-4 percent slopes), maintains adequate sinuosity, and is not channelized. Reach 3 is characterized by low flow and water quality influenced by effluent from the Lame Deer Lagoon. Observations recorded during a site visit conducted by a consulting firm in 2021, included a heavy algal bloom overlaying thick sediments (NPS Assessment, 2021) (**Photograph 2**). No aquatic insects (other than Hemipterans) were observed at the site. It was determined that heavy sedimentation, low dissolved oxygen, and warm water temperatures precluded any aquatic insect colonization (NPS Assessment, 2021).

As previously mentioned, Reach 3 contains a direct pollution point source from the Lame Deer Lagoon. The lagoon operates under the Northern Cheyenne Tribe Utilities Commission (NCUC). The Tribe EPD assumes CWA Section 401 Certification and Section 303 Water Quality Standards Program responsibilities to provide certification to EPA on behalf of the Tribe. In August of 2021, the NCUC reached a joint settlement with EPA and the Justice Department to address sanitary sewer overflows of untreated wastewater that flowed into Lame Deer Creek from 2013 through 2016 and then from 2017-2018 without an NPDES permit authorization (Settlement, 2021). Since 2017, a technical workgroup comprising of Federal, State, and Tribe representatives has assisted NCUC in completing major wastewater infrastructure improvements to the facility's lagoon and collection system. In 2020, the Tribe requested a

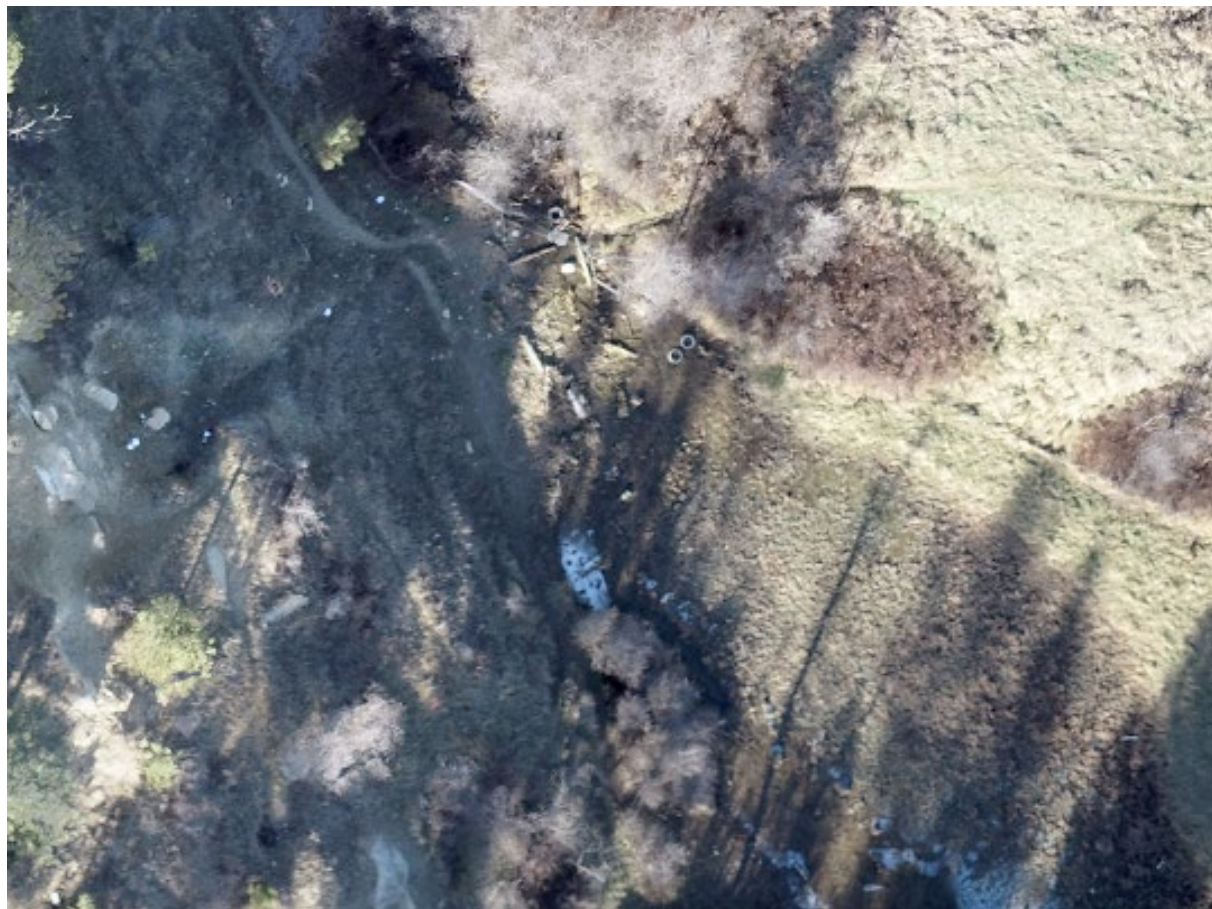
Photograph 3. Reach 3 – Middle Lame Deer Creek Dump Site and Crossing

Reach 3 has a recreation parking site at the south end where garbage dumping occurs, including appliances and other household waste. **Photo 3** is an aerial view of a crossing and dumping site within Reach 3 taken November 11th, 2023. Water quality data summarized from a monitoring site near the center of the town of Lame Deer indicates stream temperatures are often high (above 68° (F)) and dissolved oxygen levels were low. Specific conductance values often exceed the EPA chronic aquatic life criteria of 1,000 micromhos per centimeter (umhos/cm) (NPS Assessment, 2021). There have also been reports of fill dirt deposited in the stream channel at various locations to facilitate creek crossing.

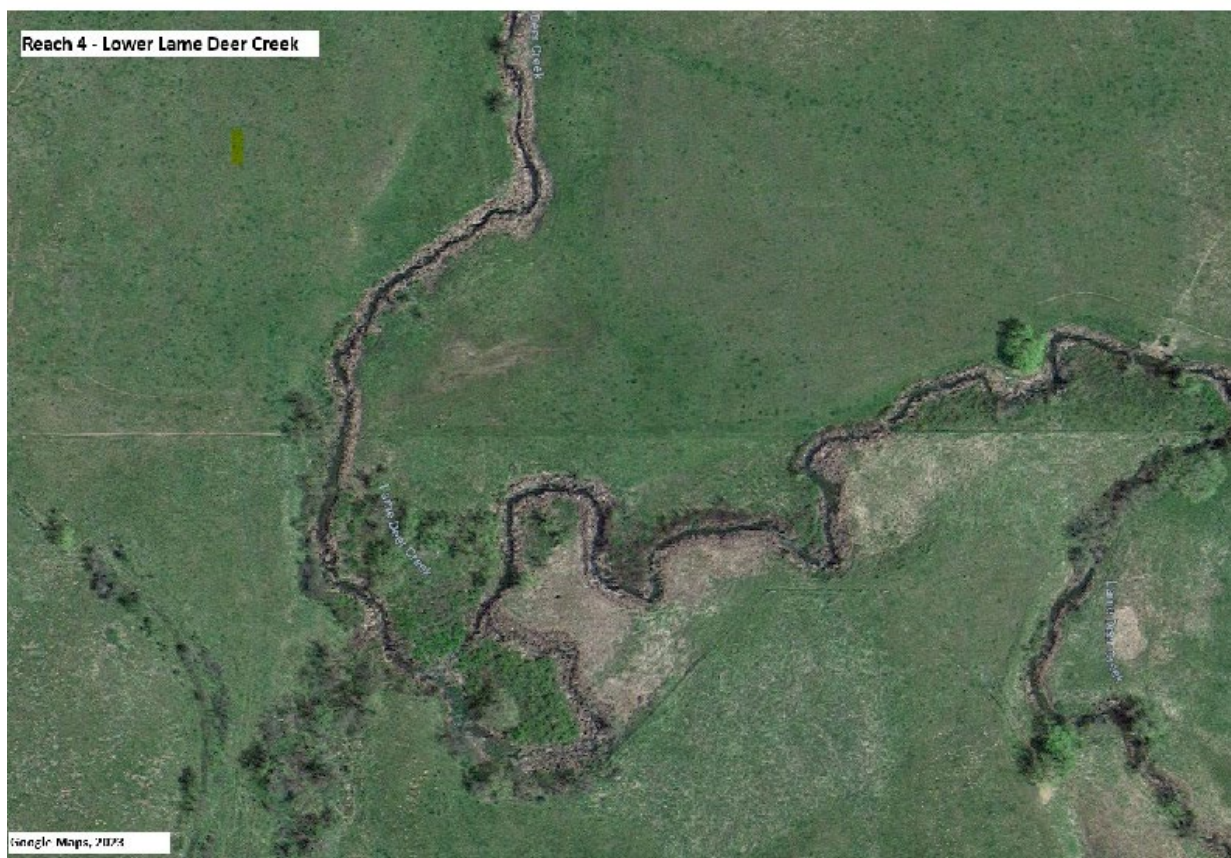
Photograph 4. Reach 4- Lower Lame Deer Creek

Cattle along Reach 4 graze year-round and are not fenced out of Lower Lame Deer Creek. These activities have increased turbidity, nutrient loads, and contributed to sediment supply from streambank erosion. Data summarized for Reach 4 stated that " *TSS and TDS measurements are very elevated in some years as would be expected with these types of agricultural impacts*" (NPS Assessment, 2021). Additionally, crop land is grown right up to the edge of the streambank as evident in **Photograph 4**.

1. On grazing leased land overlapping the riparian corridor, fence up to 2 miles of riparian corridor from cattle along this reach of Lame Deer Creek.
2. On grazing leased land overlapping the riparian corridor, provide up to two cattle off-site stock watering sites and shaded areas or strategically placed watering gaps to concentrate and mitigate impacts to one area.
3. Revegetate critically damaged streambanks that will be fenced on 2 acres or more of riparian corridor with a variety of native trees and shrubs using both nursery grown stock and local sources such as willow transplants/stakes and wetland (sedge/rush) sod mats.
4. Control noxious weeds before and after planting on revegetated riparian corridor.
5. Educate and incentivize crop producers to incorporate riparian setbacks for watershed health.

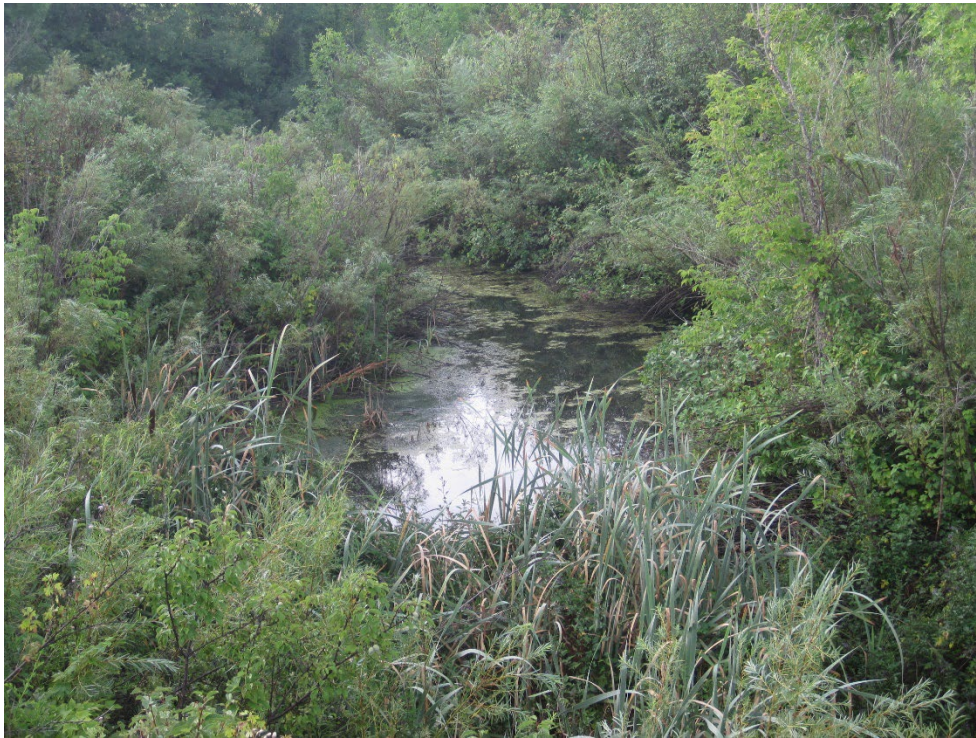
Photo 1

Dense riparian and
wetland vegetation at
pond

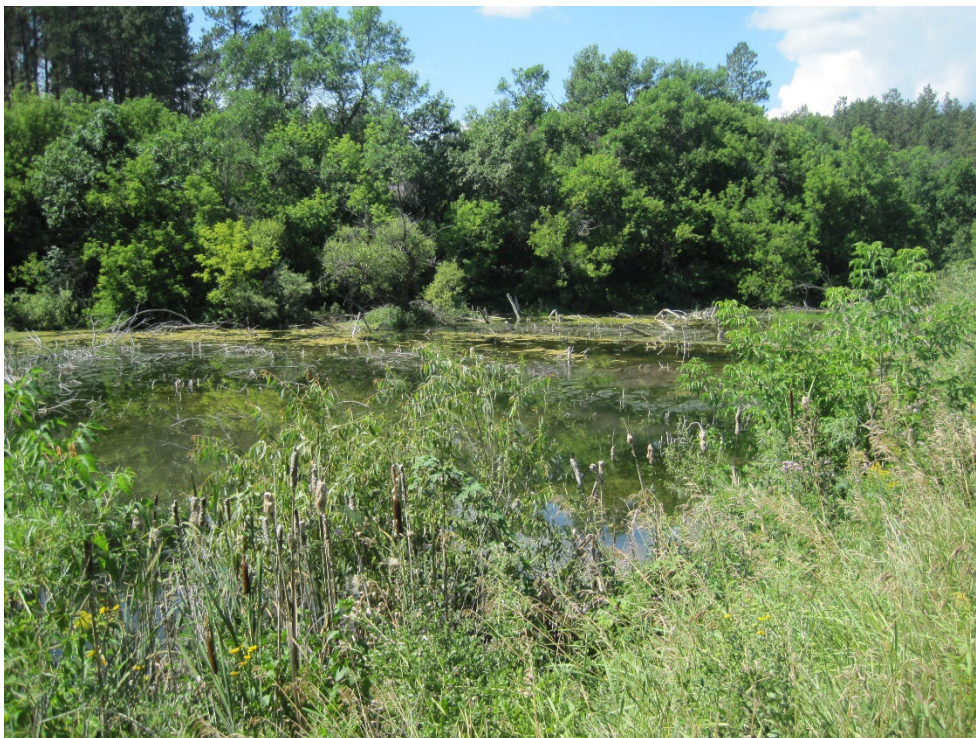
Photo 2

Pond upstream of crushed
culvert with wetland and
riparian vegetation

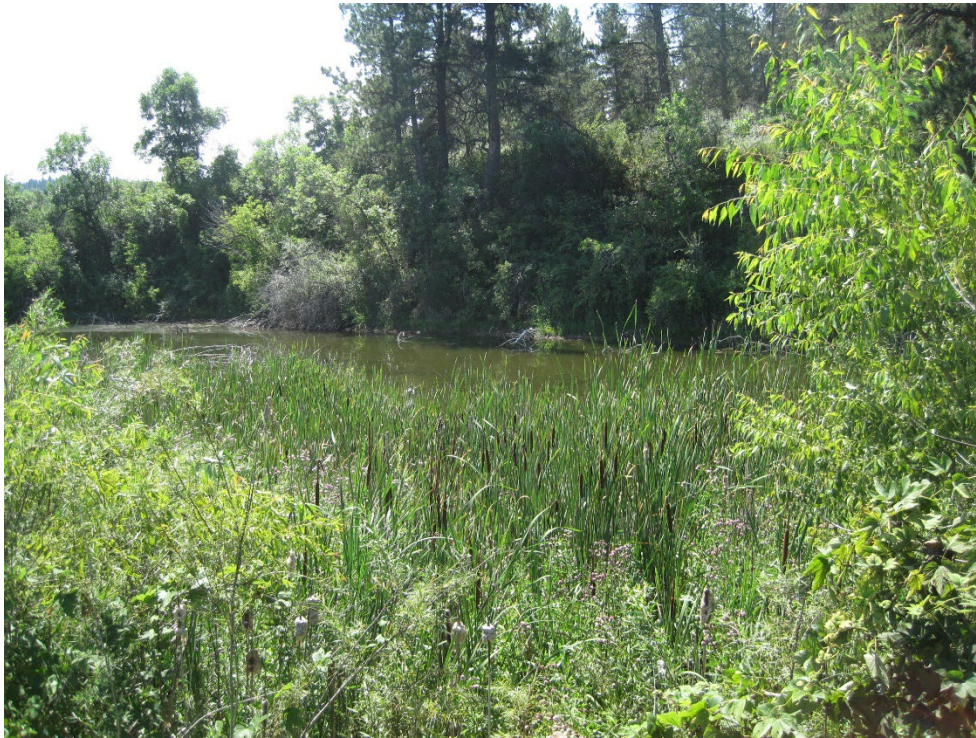
Photo 3

Pond Behind crushed culvert with obligate wetland vegetation

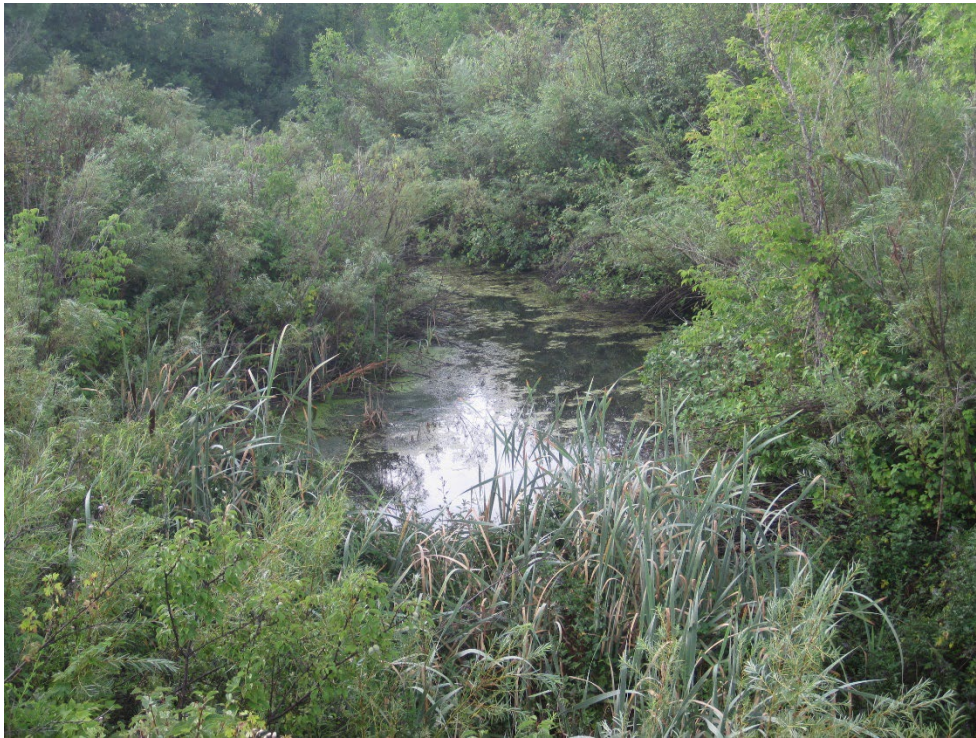
Photo 1

Dense riparian and
wetland vegetation at
pond

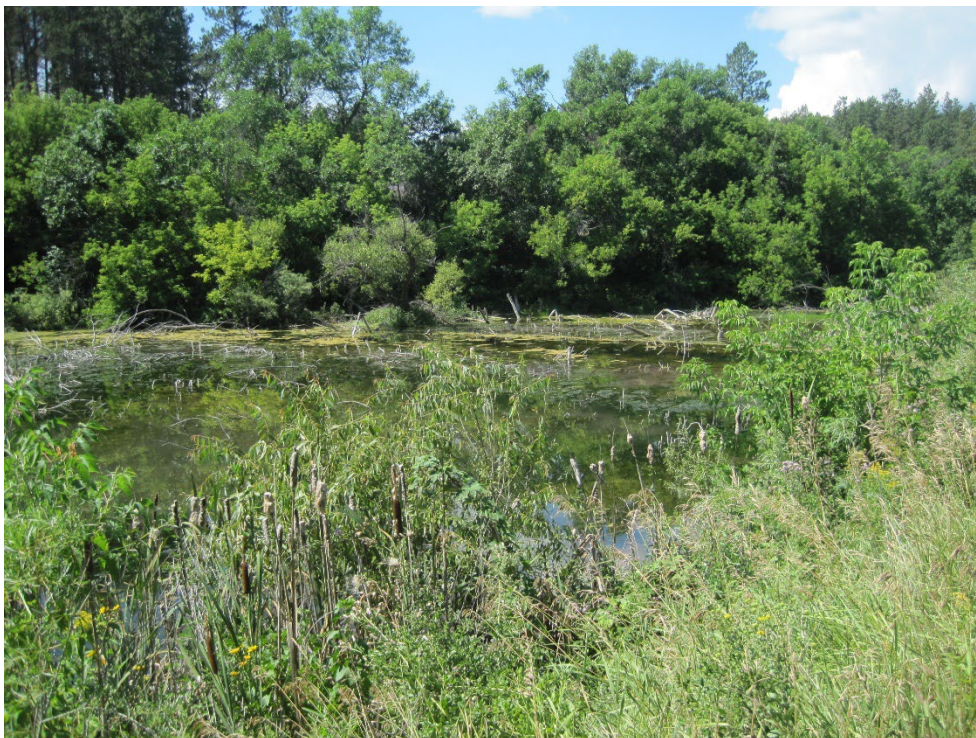
Photo 2

Pond upstream of crushed
culvert with wetland and
riparian vegetation

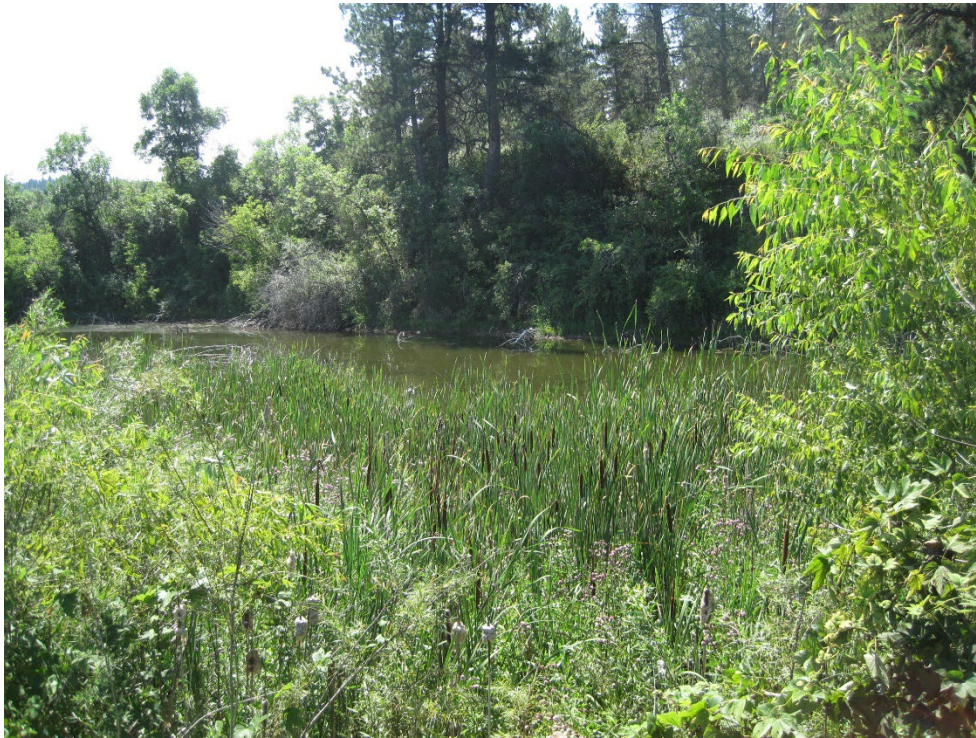
Photo 3

Pond Behind crushed culvert with obligate wetland vegetation

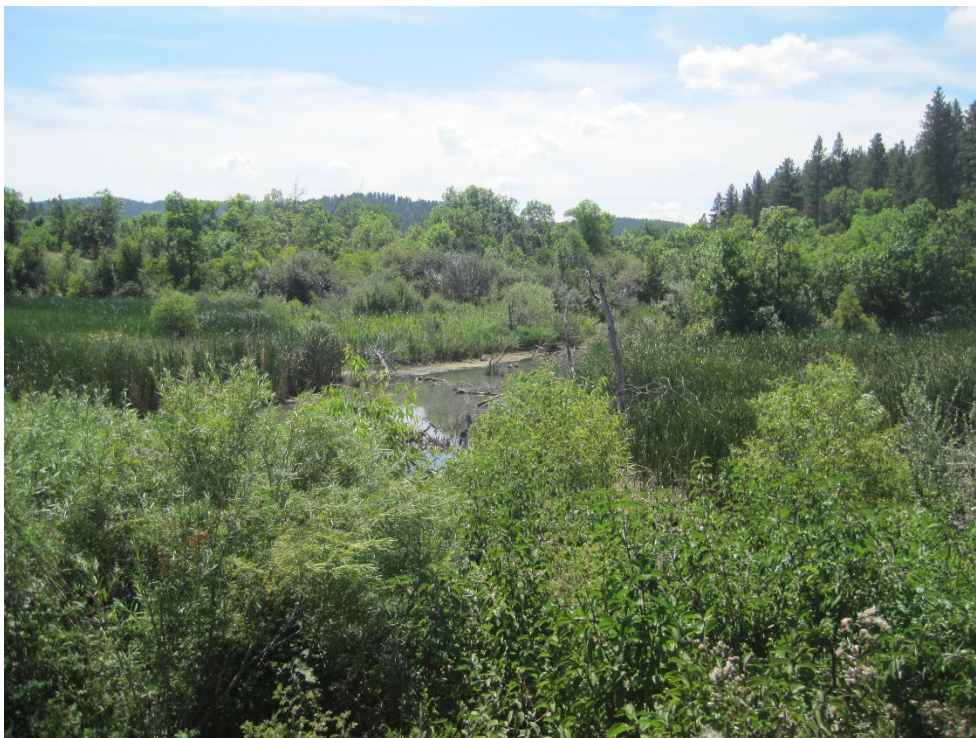
Photo 4

Pond behind crushed culvert with habitat change in background

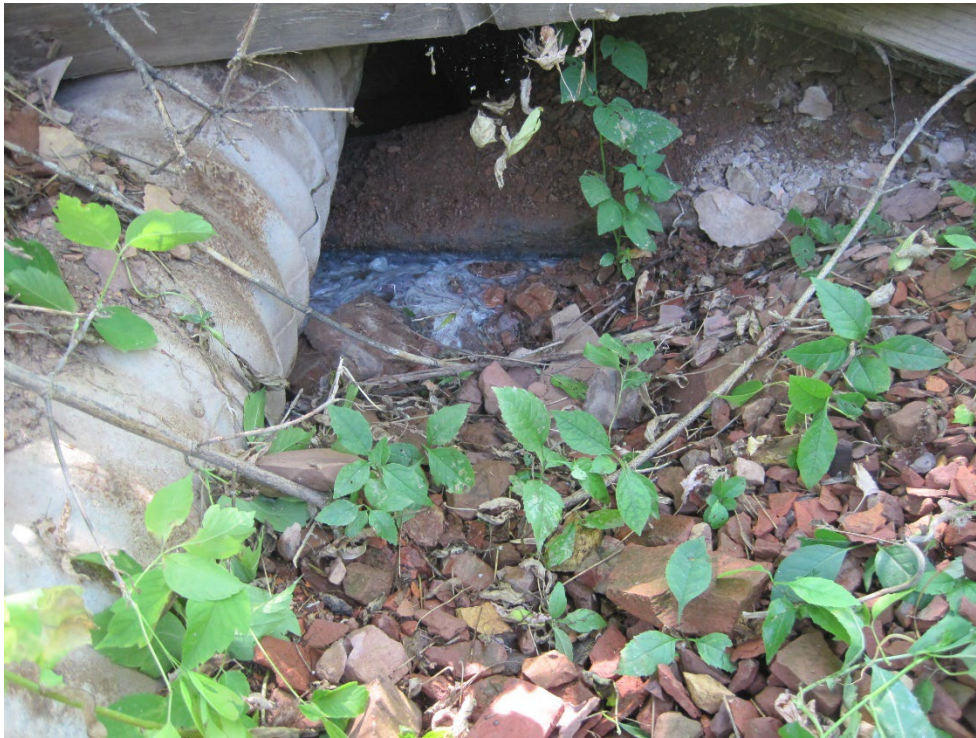
Photo 5
Photo taken 8/8/23

Location:
Facing south. Roadway at headwaters and crushed culverts

Description:
Water flowing around crushed culvert with white algae.

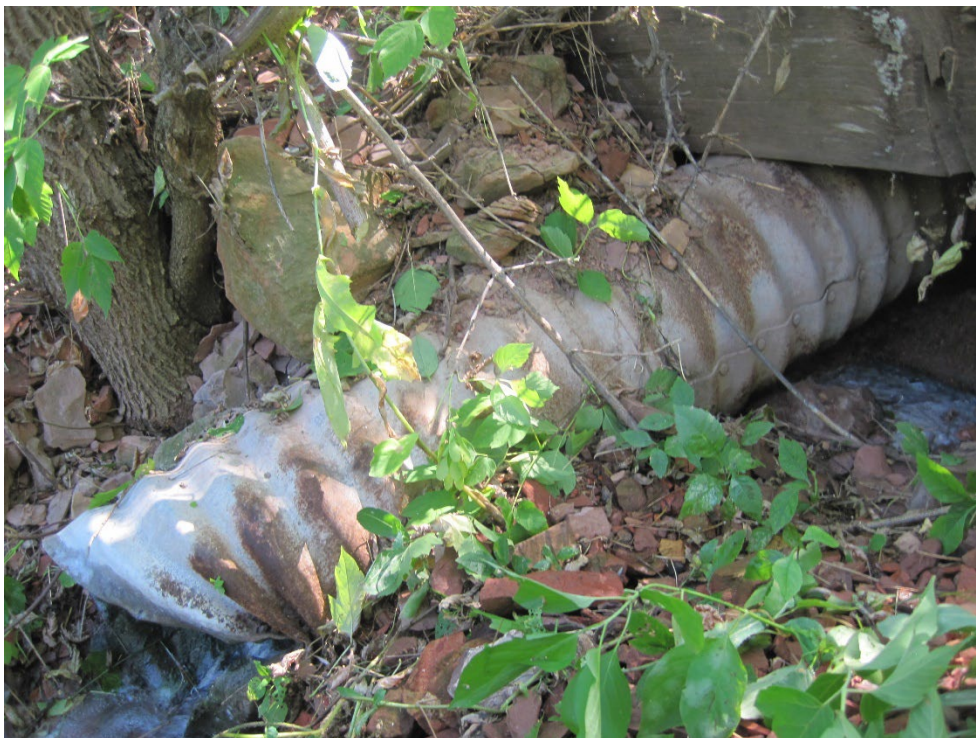
Photo 6
Photo taken 8/8/23

Location:
Facing South. Roadway at headwaters

Description:
Crushed Culvert surrounded by roadbed substrate

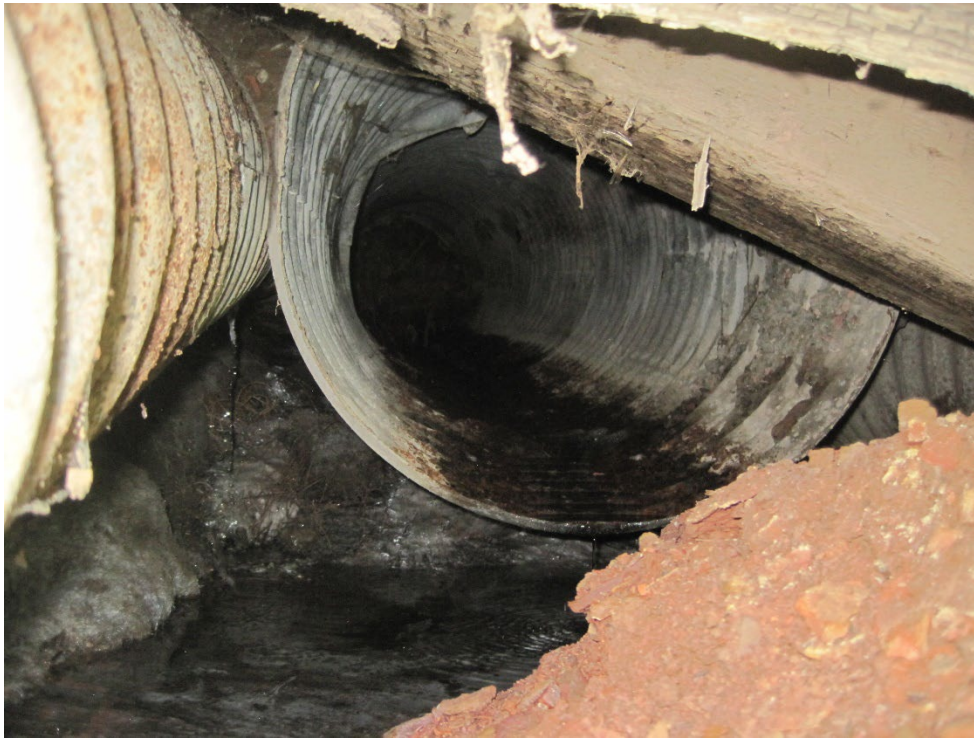
Photo 7

Multiple culverts buried under road.

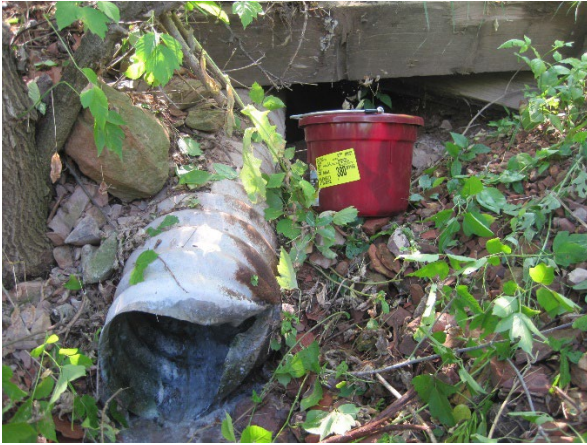
Photo 1. Culvert Outlet at Project Site

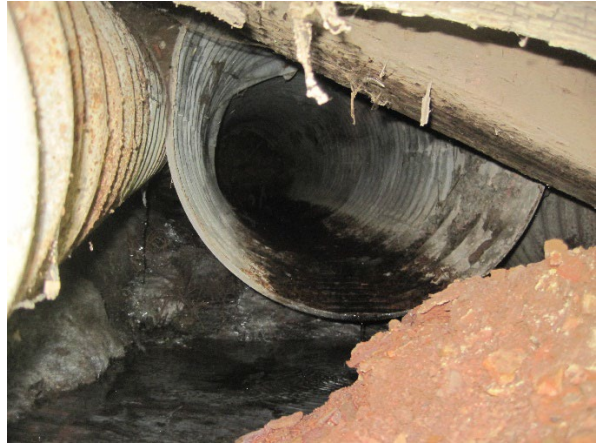
Photo 2. Culvert Outlet at Project Site

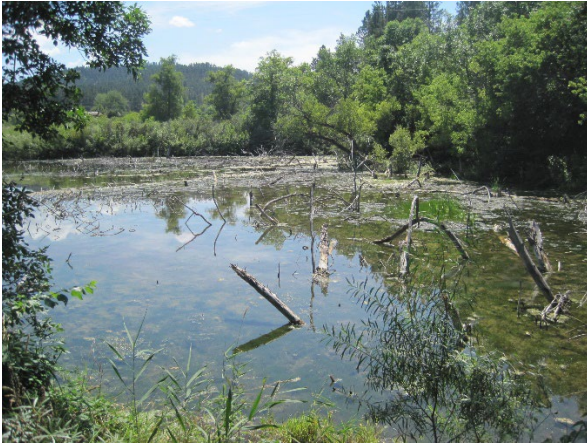
Photo 3. Impoundment Upstream of Project Site

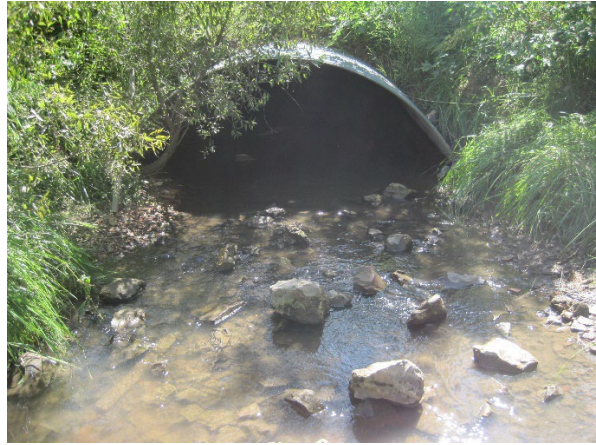
Photo 4. Arch-Type Stream Crossing at Sweet Medicine Rd

9	Flow at the arch culvert crossing Sweet Medicine Rd (Figure 1) was estimated to be 50 gpm (0.11 cfs).
